3. Existing Conditions and Environmental Consequences

3.10 Cultural Resources

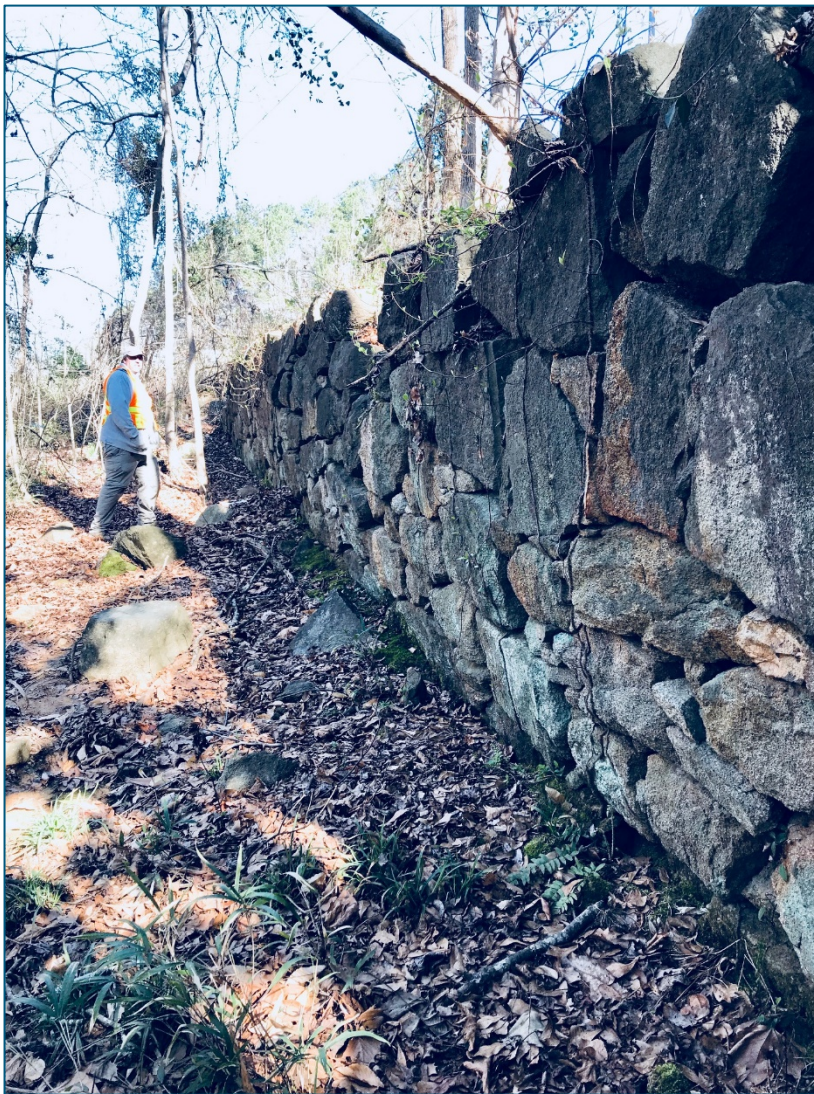
Figure 3.10-1 Typical view of the Saluda Canal, facing west

The newly documented canal segments within the project area are similar in appearance to the segments documented in 1972 by Ryan within the Columbia Zoological Park, but in general somewhat narrow and deeper, averaging around five meters (16.4 feet) wide and one or one and a half meters (3.28 or 4.92 feet) deep. In the northwestern portion of the canal, which was excavated through a granite outcropping, sheared or cleaved stone is found in many sections of the canal walls. Some of these rocks retain the remnants of the small circular holes drilled in the stones to fracture or dislodge them through the use of chisels or explosives. Much of the canal in the project area also serves as a creek bed at this time, as water flows from a drainage pipe into the canal near its northwestern end, eventually emptying into the Saluda River through a blowout in the canal wall. The only substantive feature noted within the present project area was a stone wall stretching for approximately 46

meters (150 feet) parallel to and in between the canal bed and the river, immediately adjacent to the Three Rivers Greenway. The function of this wall and its exact relation to the canal is unclear, but it may have been a “guard wall” designed to protect the head of the canal from washout during flood events. Figures 3.10-1 and 3.10-2 present views of the Saluda Canal.

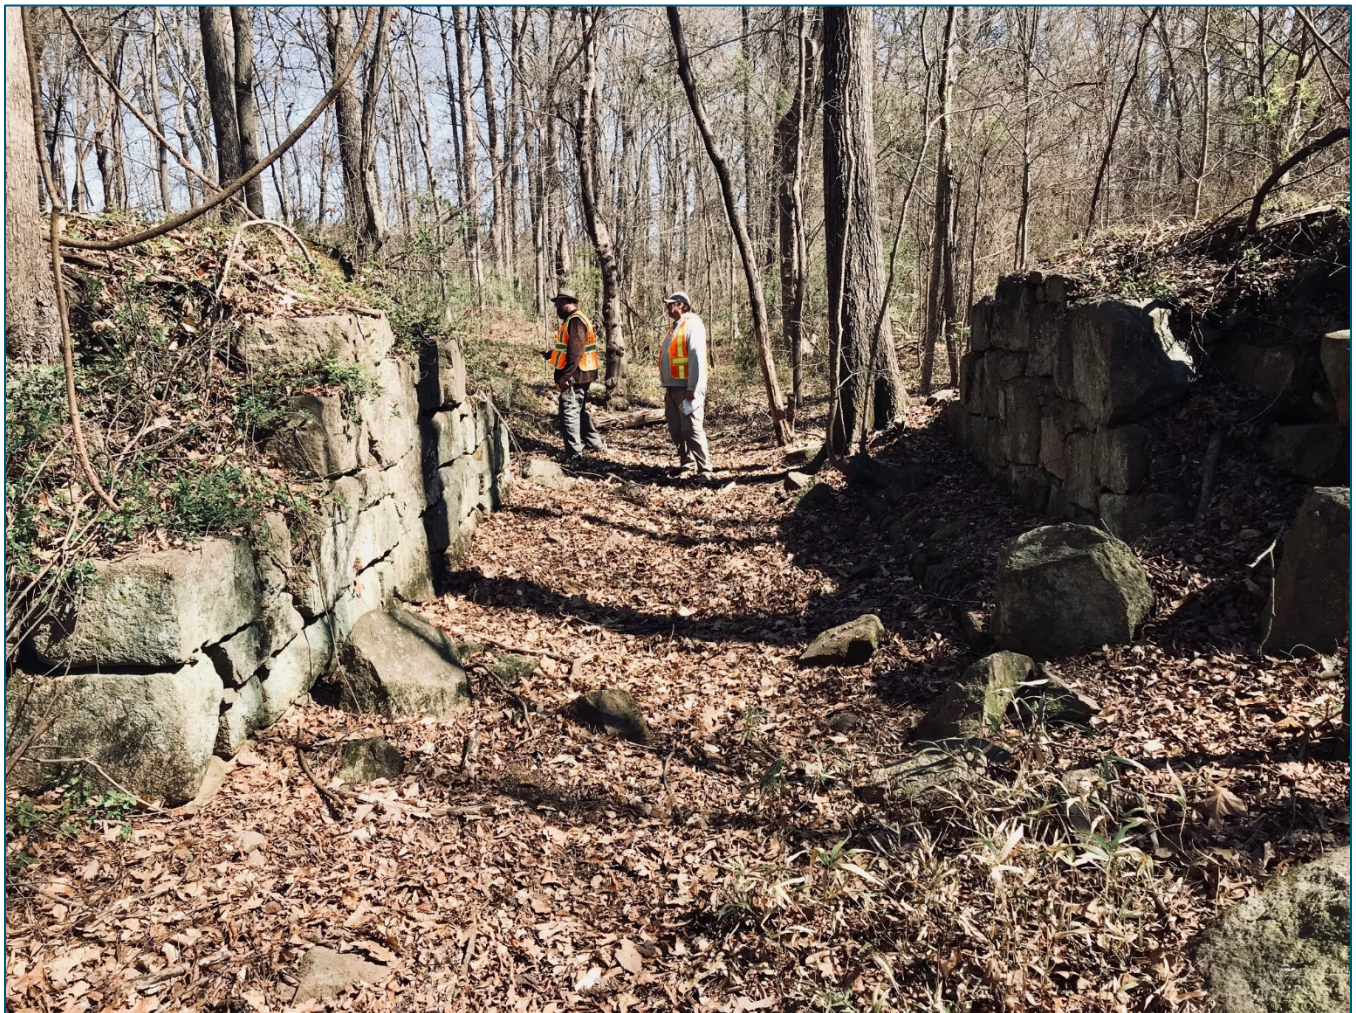
Figure 3.10-2 Typical view of the Saluda Canal, facing east.

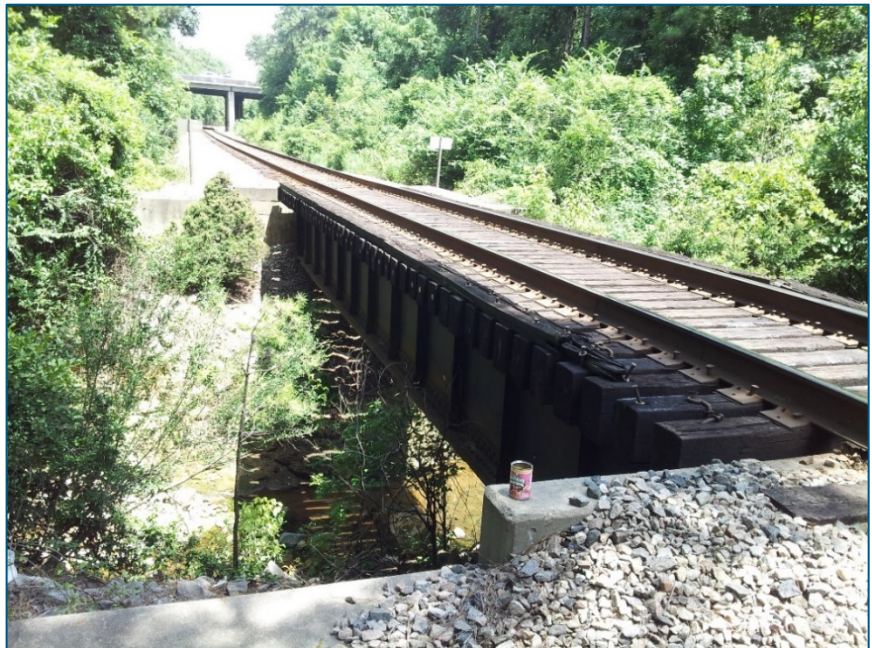
Figure 3.10-3 View of Site 38RD277, facing east

Site 38RD277 consists of a railroad trestle that was recorded over an unnamed tributary of the Saluda River just north of the I-26 Bridge over the Saluda River. Because it was originally recorded as an archaeological site it was addressed during the archaeological portion of this investigation. The trestle was recorded in 1982, but no formal NRHP evaluation was given for the structure.²³ As a result of the revisit during the present investigation, it is clear that the trestle recorded as 38RD277 is no longer present at this location. The resource was described as a substantial brick structure built

over the unnamed creek.²⁴ Currently, the trestle at this location is made of a steel span with a wood plank floor atop a poured concrete frame. Based on this, it is clear that the resource originally recorded as 38RD277 has been destroyed and no further archaeological or historic architectural documentation is necessary. Figure 3.10-3 presents a view of Site 38RD277.
