## A Cultural Resource Survey of the Proposed Improvements to the Carolina Crossroads Corridor

*I-20/26/126 Corridor Project*

*Lexington and Richland Counties, South Carolina*

*Final Report May 2018*

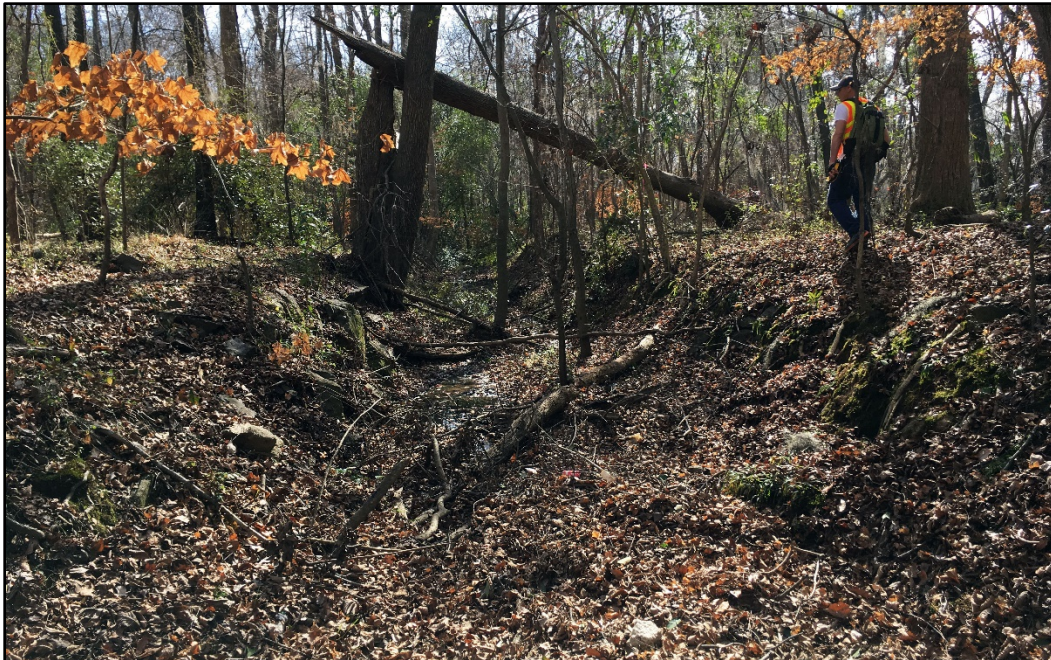
**Figure 4.4. Photograph of a portion of the Saluda Canal near its western end. Facing North.**

As a result of these efforts two long segments and several smaller segments of the canal were mapped. The newly documented canal segments are for the most part consistent in appearance to the segments documented in 1972 within the Columbia Zoological park (Ryan 1972), but in general somewhat narrow and deeper, averaging around five meters wide and one or one and a half meters deep (Figure 4.4). In the northwestern portion of the canal, which was excavated through a granite outcropping, sheared or cleaved stone is found in many sections of the canal walls. Some of these rocks retain the remnants of the small circular holes drilled in the stones to fracture or dislodge them through the use of chisels or explosives. Much of the canal in this area also serves as a creek bed at this time, as water flows from a drainage pipe into the canal near it's northwestern end, eventually emptying into the Saluda River through a blowout in the canal wall.

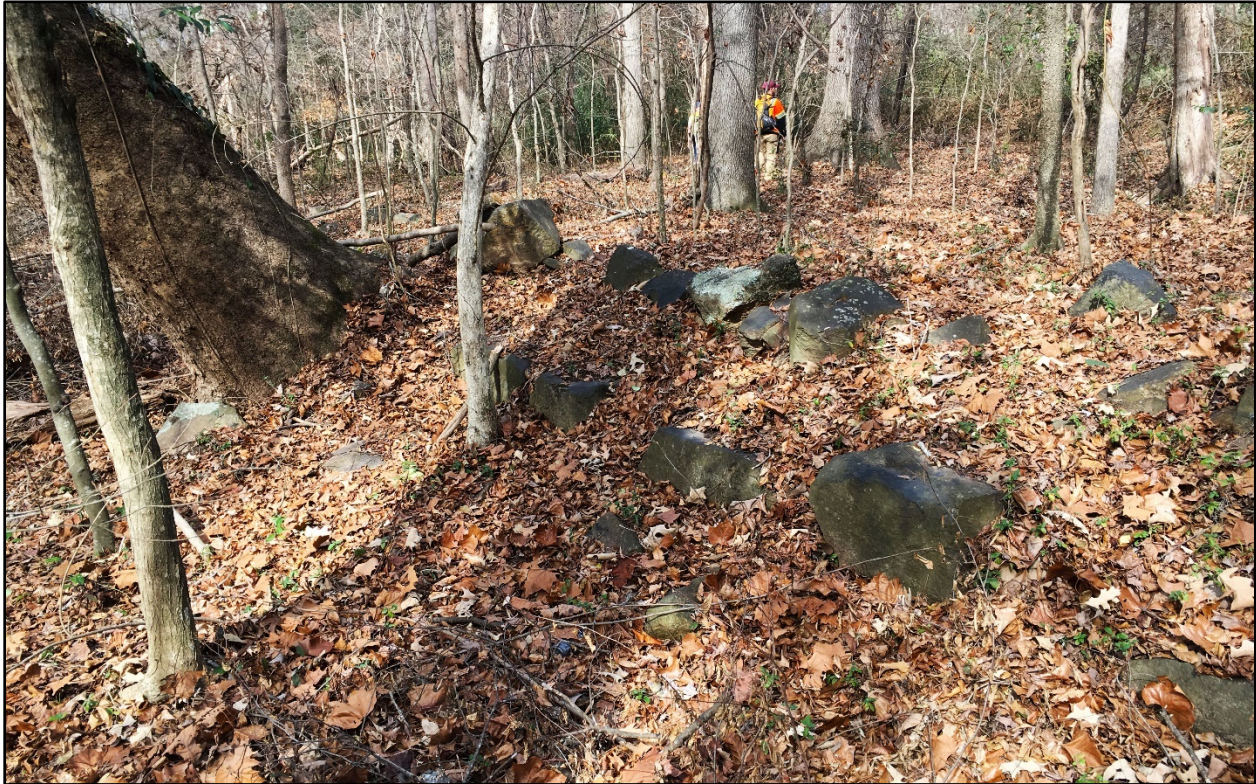
**Figure 4.5. Rock wall at the northwestern end of the canal within the Carolina Crossroads project area, facing north.**

The only substantive feature noted within the present project area was a stone wall stretching for approximately 150 feet parallel to and in between the canal bed and the river, immediately adjacent to the Three Rivers Greenway. The function of this wall and its exact relation to the canal is unclear, but it may have been “guard wall” designed to protect the head of the canal from washout during flood events (Figure 4.5). A second feature consisting of a stone debris pile that probably consists of stone blasted or removed from the canal was also noted within the project area limits.

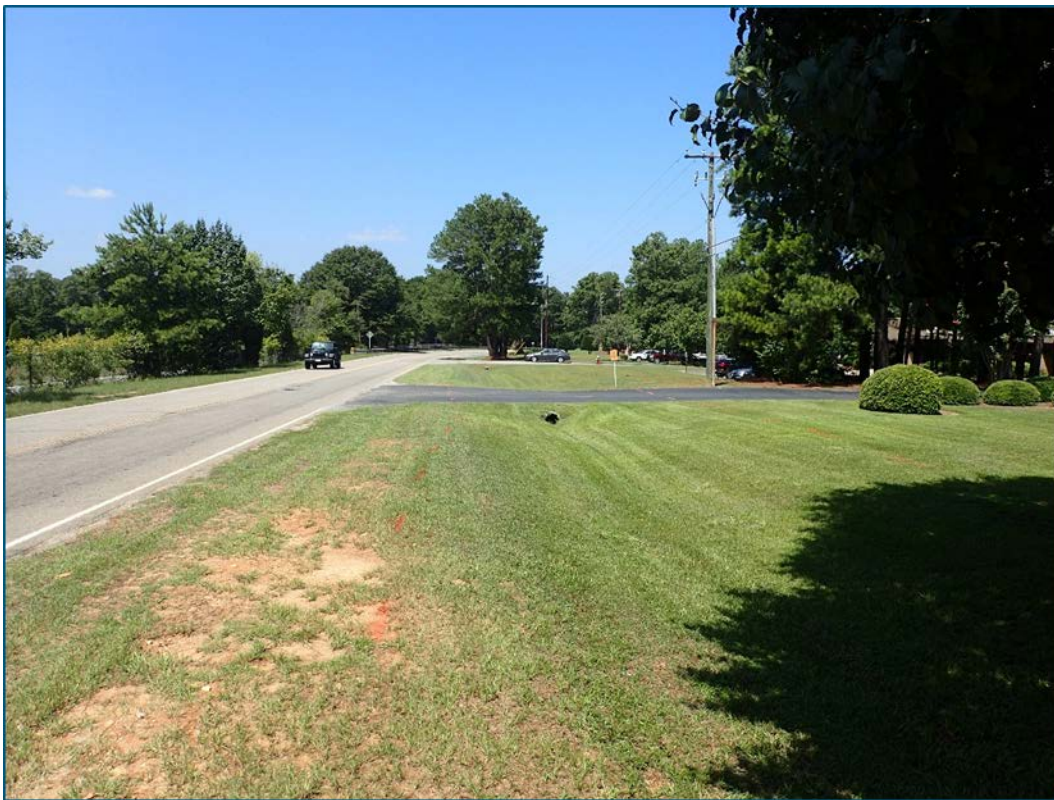
Figure 4.6. Photograph of 38RD133, facing west.

[REDACTED] Fourteen shovel tests were dug at 15-meter intervals in this area in order to investigate for intact deposits associated with Site 38RD133 (Figure 4.5). All tests were negative and revealed shallow, disturbed soil profiles consistent with other graded roadbeds observed during this investigation. A representative soil profile revealed approximately 15 centimeters of yellowish brown (10YR 5/8) loamy sand atop a strong brown (7.5Y 4/5) clay hardpan. Shovel tests were terminated at the clay hardpan.

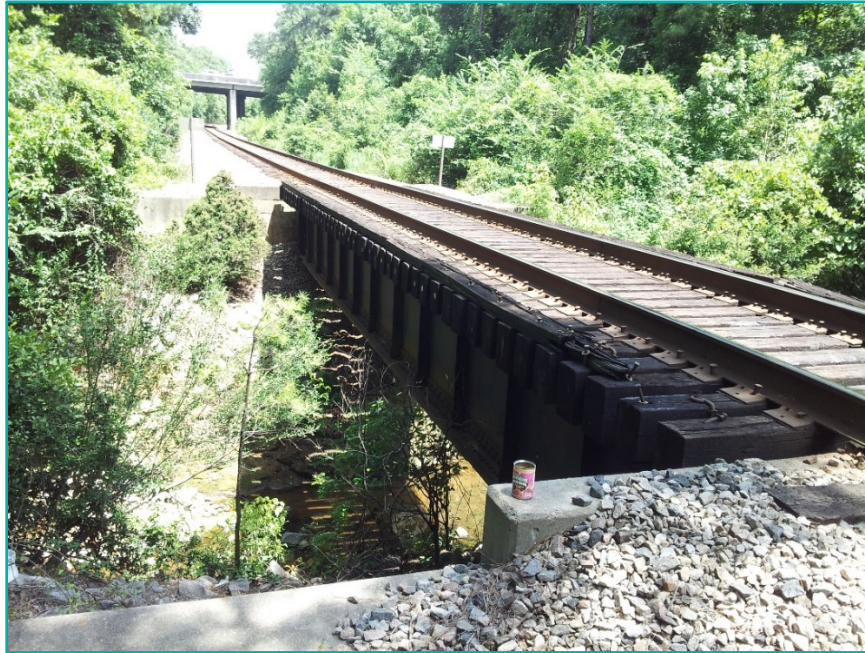
**Figure 4.8. Photograph of current railroad trestle at 38RD277, facing east.**

EPEI staff revisited this resource during the present investigation. As a result of this revisit, it is clear that the trestle recorded as 38RD277 is no longer present at this location. The resource described by Tippitt (1982) was a substantial brick structure built over the unnamed creek. Currently, the trestle at this location is made of a steel span with a wood plank floor atop a poured concrete frame (Figure 4.6). Based on this, it is clear that the resource originally recorded at 38RD277 has been destroyed and no further archaeological or historic architectural documentation is necessary.

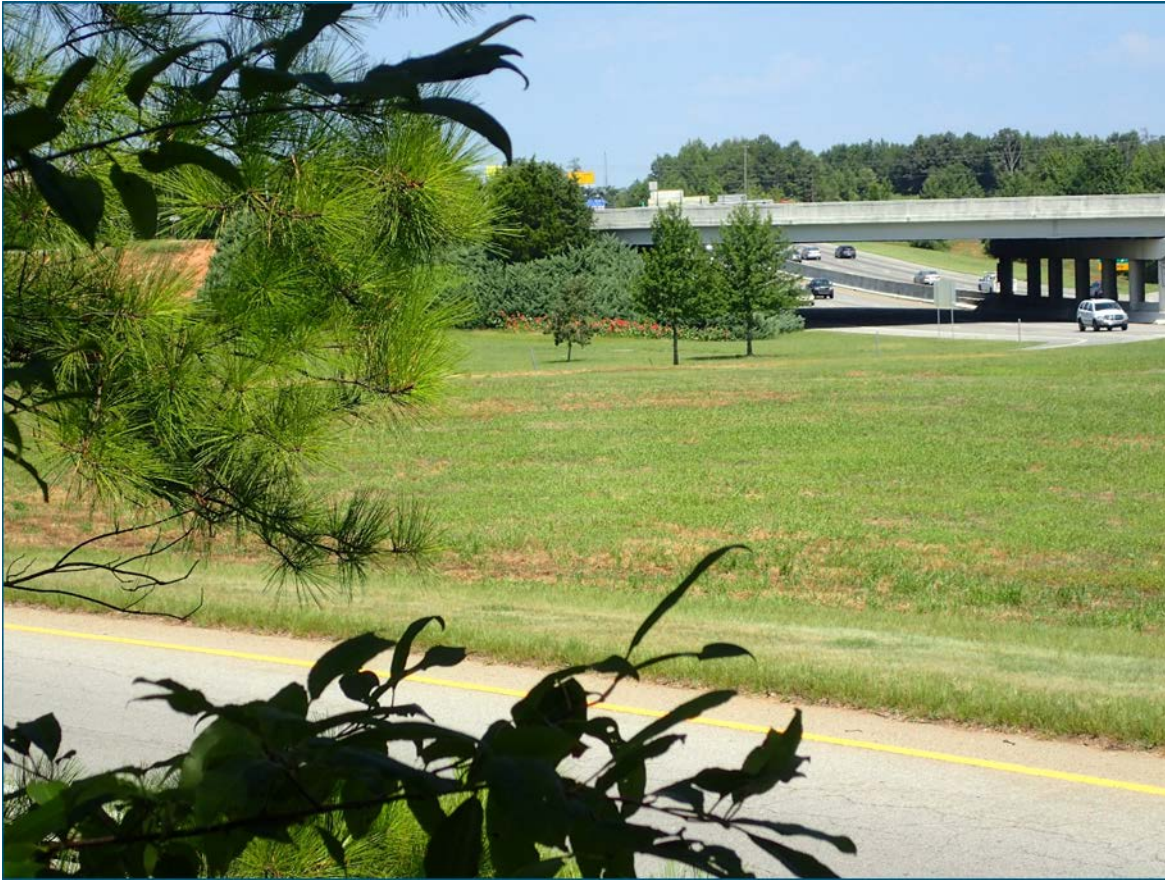
**Figure 4.10. Photograph of 38RD287, facing northwest.**

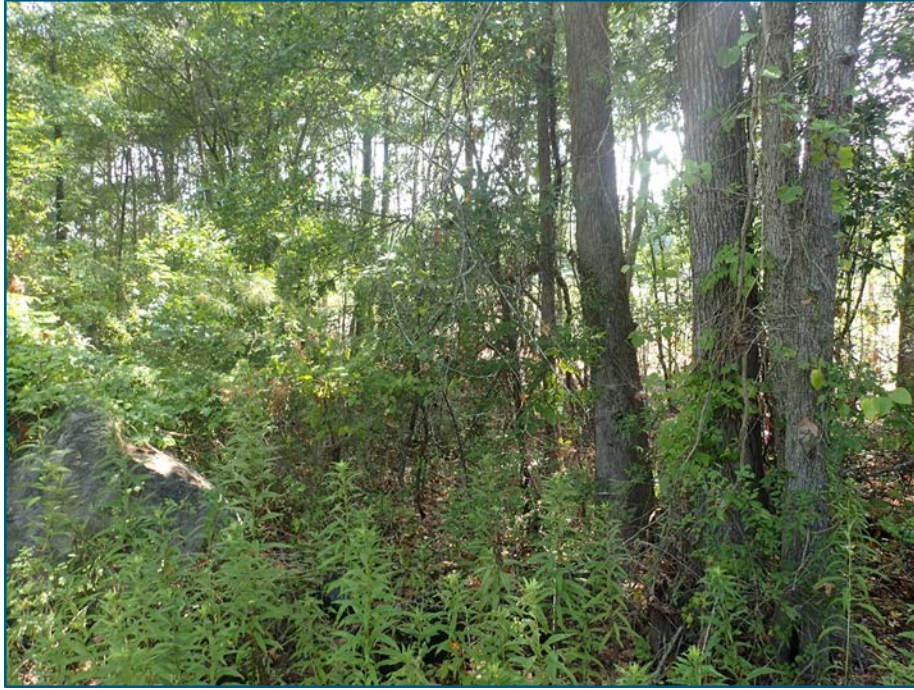
**Figure 4.12.** Photograph of Site 38LX20, facing east.

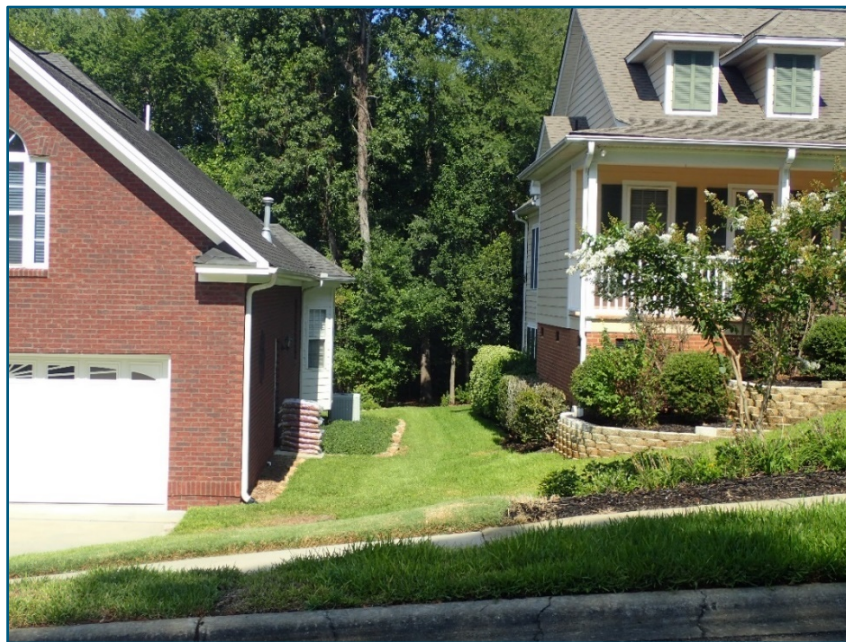
**Figure 4.13. Photograph of 38LX212, facing west.**

Based on the revisit, it is clear that the portion of Site 38LX212 within the survey area has been heavily impacted if not destroyed by residential development. EPEI archaeologists encountered no cultural material associated with the site and recommend that the portion of Site 38LX212 within the project boundaries should be considered non-contributing to the site’s NRHP eligibility status under Criterion D.

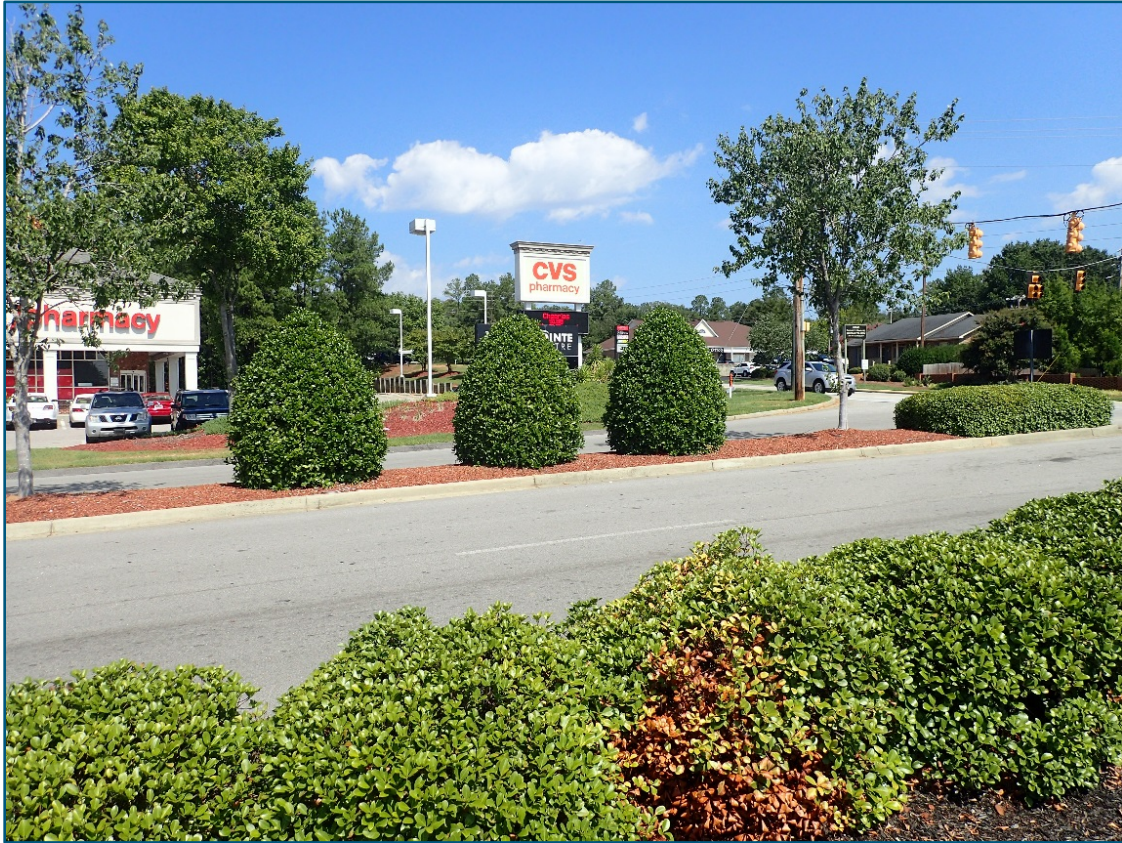
Figure 4.15. Photograph of 38LX235, facing west.

The area encompassing Site 38LX235 has been heavily developed since its initial recordation. Currently, the site is located beneath the [REDACTED] (Figure 4.13). Only the northernmost tip of the site, an area measuring 32 square meters, intersects with the project boundaries (Figure 4.14). The site was revisited during the current survey and no intact portion of the site was accessible, either within the survey area or its entire site boundaries.

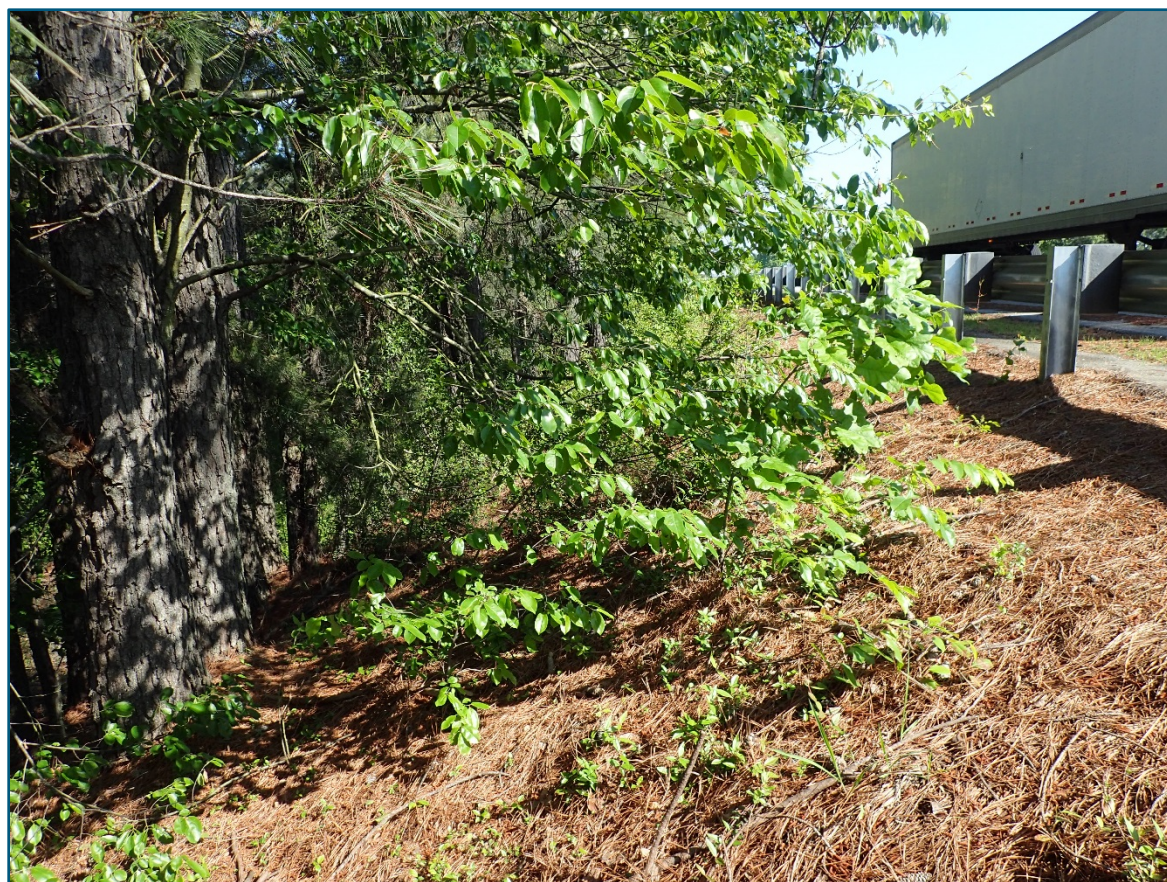
Figure 4.17. Photograph of Site 38LX236, facing southwest.

The site was revisited by EPEI archaeologists during the current survey. Presently, the northern locus of Site 38LX236 corresponds with the heavily disturbed ground that separates the [REDACTED]. Much of this area was graded and artificially raised in order to construct the I-20 on-ramp as well (Figure 4.15). This portion of the site was subjected to pedestrian survey and judgmental shovel testing. No artifacts were identified and subsurface testing revealed that the area was severely disturbed. The southern locus of the site corresponds with the off-ramp itself and a heavily wooded area east of the off ramp. Thirteen shovel tests were dug at 15-meter intervals throughout the portion of the site within the wooded area (Figure 4.16). All tests were negative and revealed disturbed profiles. The site has likely been destroyed or obscured by further development of the interchange occurring after Goodyear’s original site form. A representative soil profile from shovel testing within the boundaries of 38LX236 revealed brown (10YR 5/3) loamy sand to a depth of around 30 centimeters, at which point strong brown (7.5Y 4/5) clay subsoil was encountered.

Based on the original site form and the EPEI revisit, it seems that Site 38LX236 was heavily impacted and then subsequently destroyed or buried by the development of the [REDACTED] at this location. Goodyear’s initial recommendations for no further work implies that the site was probably not eligible for NRHP listing and the EPEI revisit indicates that there are no longer identifiable deposits associated with this site to evaluate. Based on this investigation, no deposits or features associated with this site were encountered that would alter Goodyear’s implied recommendation of ineligible for NRHP listing. No further archaeological consideration is recommended for Site 38LX236.

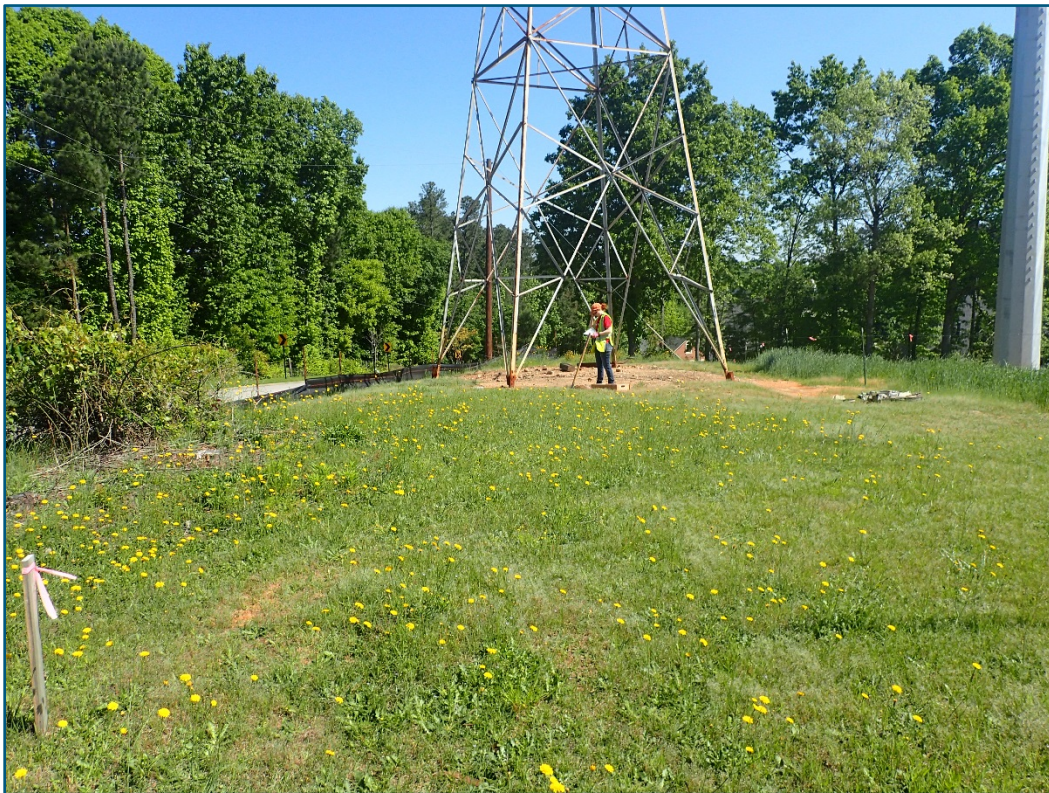
**Figure 4.19. Photograph of 38LX238, facing east.**

Site 38LX238 is located on a prominent landform [REDACTED] (see Figure 4.1G). The site was originally recorded in 1980 as a collection of prehistoric lithics that were not attributed to any specific time period. EPEI archaeologists revisited the site during the present investigation. Currently, the site is located on either side of [REDACTED] in a small wooded area east of I-26. The majority of the site falls within a power line corridor, which, along with the construction of [REDACTED], has greatly disturbed the area (Figure 4.20).

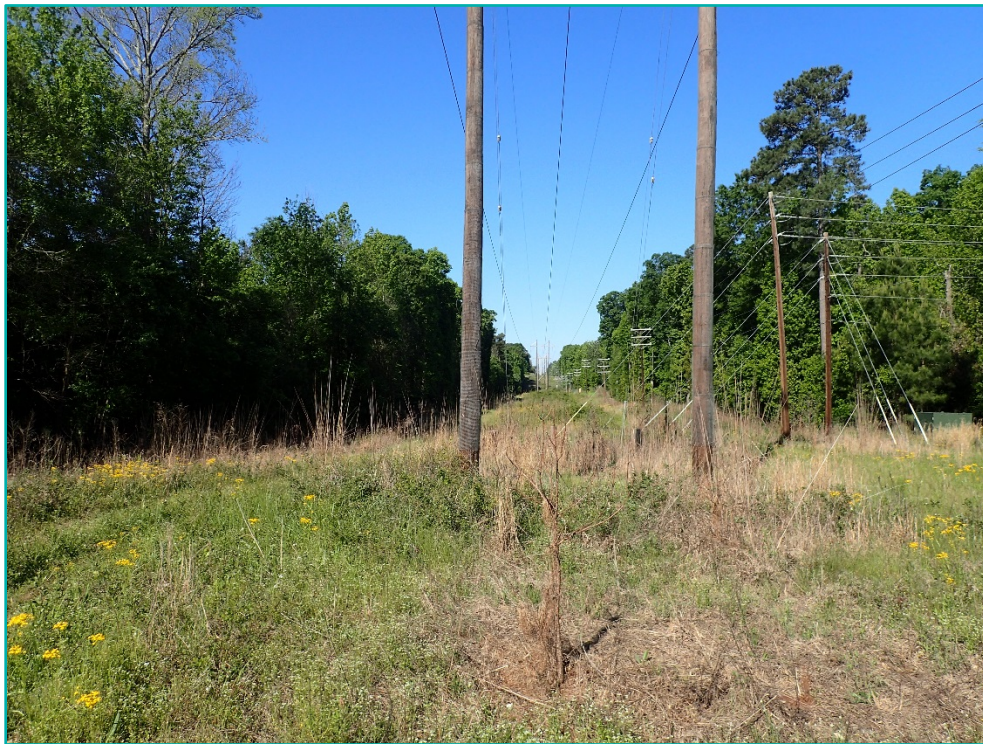
**Figure 4.21. Photograph of Site 38LX655, facing southwest.**

Site 38LX655 was identified on the [REDACTED] (see Figure 4.1G). The site covers the crest of the landform overlooking [REDACTED], a landscape characterized by dense vegetation in the south half of the site and a cleared power line corridor in the north (Figure 4.19). The site is entirely within the survey area on privately owned land. Housing developments surround the parcels to the north, south and west while the site is bound to the east by I-26.

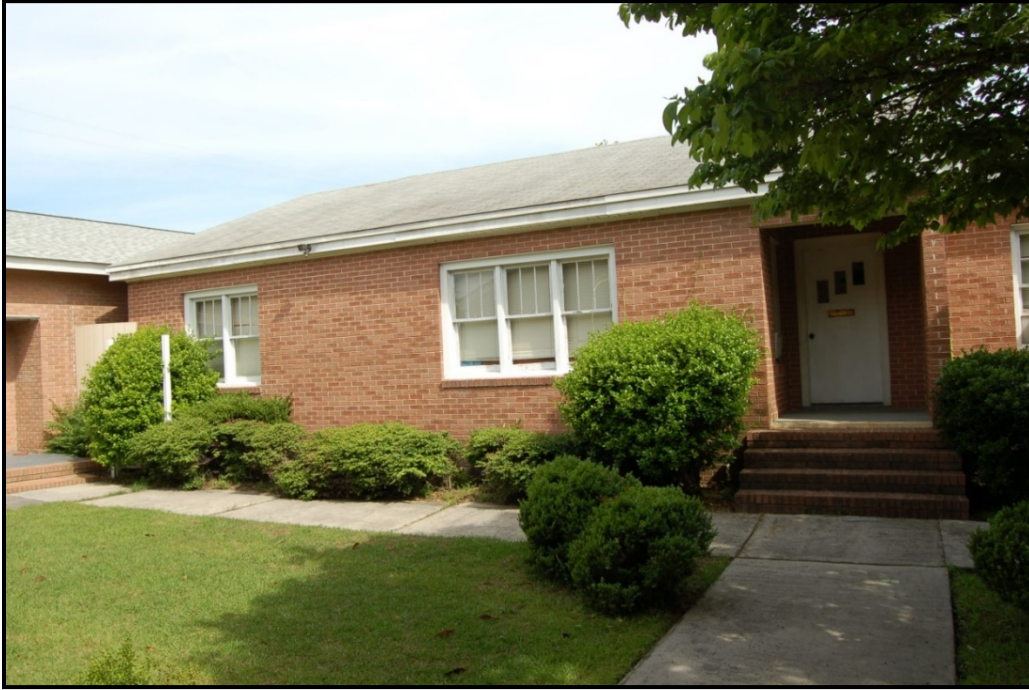
Figure 5.2: Resource 106-0877 (2500 Sunset Boulevard) - View of the façade of the original building facing north.

Boulevard ca 1980. The brick veneer was likely added to the resource at the time the sanctuary was constructed as that material appears consistent across the elements of the campus.

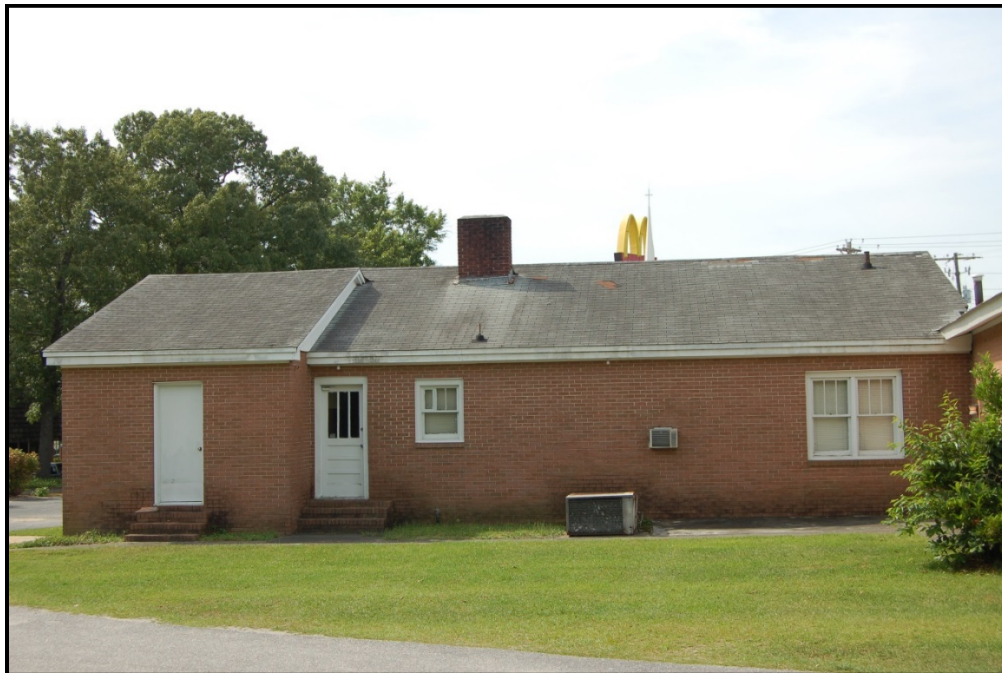
Figure 5.3: Resource 106-0877 (2500 Sunset Boulevard) – View of the rear elevation of the original building, facing south.

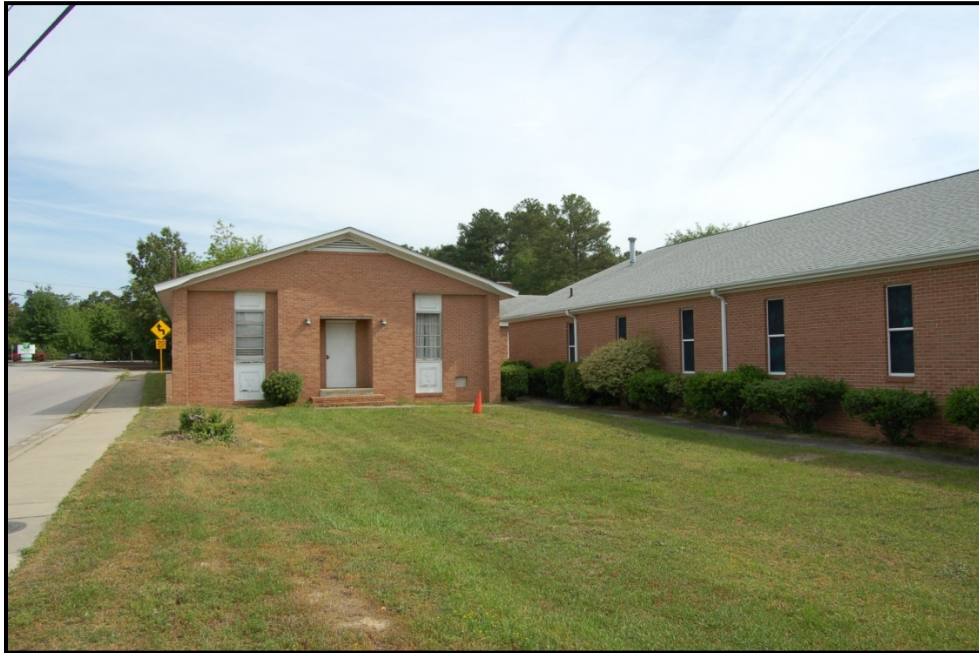
**Figure 5.4: Resource 106-0877 (2500 Sunset Boulevard) – View of the façade of the addition to the west side elevation of the original building, facing south. Non-historic sanctuary building is on right half of photograph.**

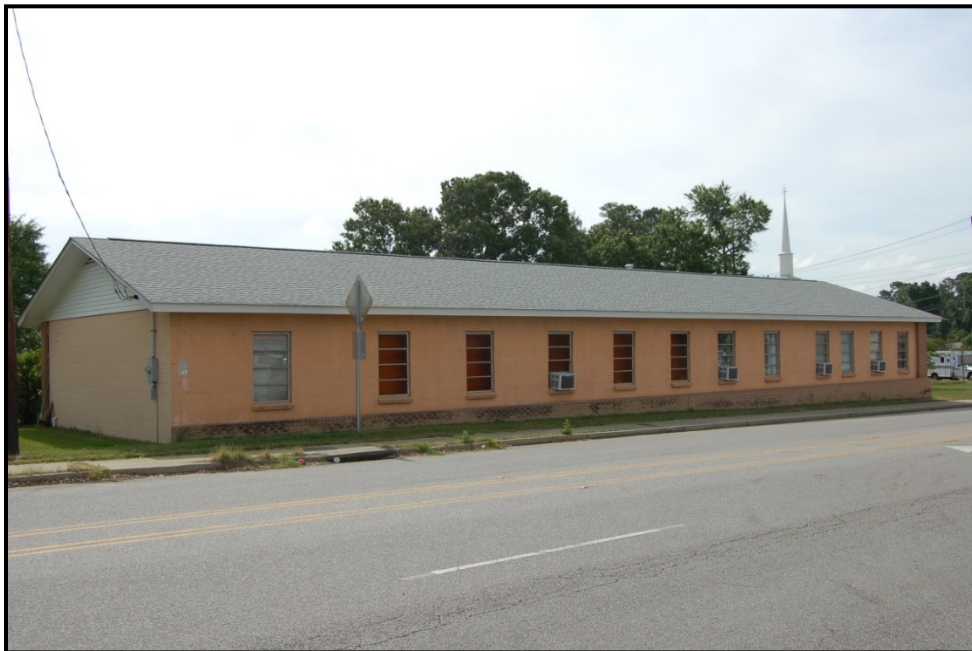
**Figure 5.5: Resource 106-0877 (2500 Sunset Boulevard) - View of the west side elevation of the addition to the west side of the original building, facing southeast.**

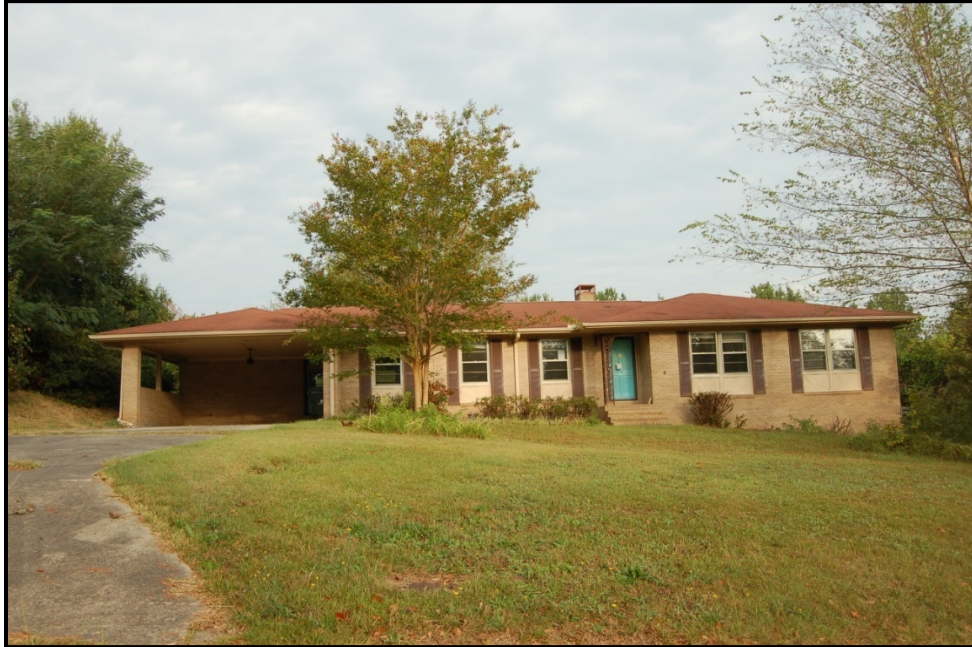
**Figure 5.7: Resource 106-0878.01 (Westover Acres Subdivision) – Representative view of property within the subdivision located at 1814 Robin Crest Drive, facing southeast.**

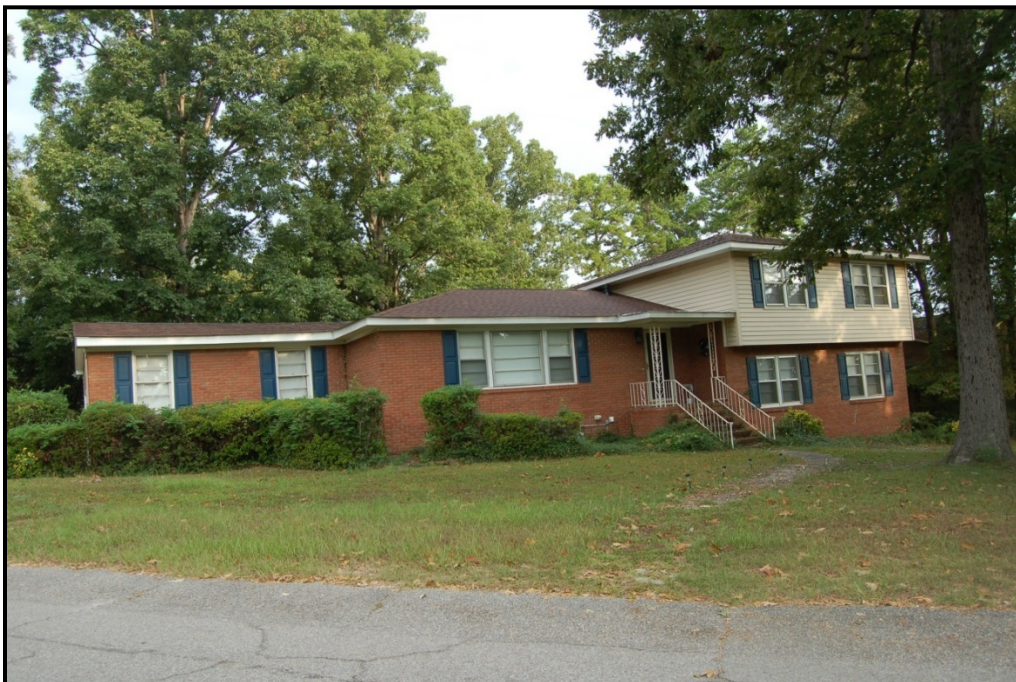
**Figure 5.8: Resource 106-0878.02 (Westover Acres Subdivision) – Representative view of property within the subdivision located at 1836 Terrace View Drive, facing northwest.**

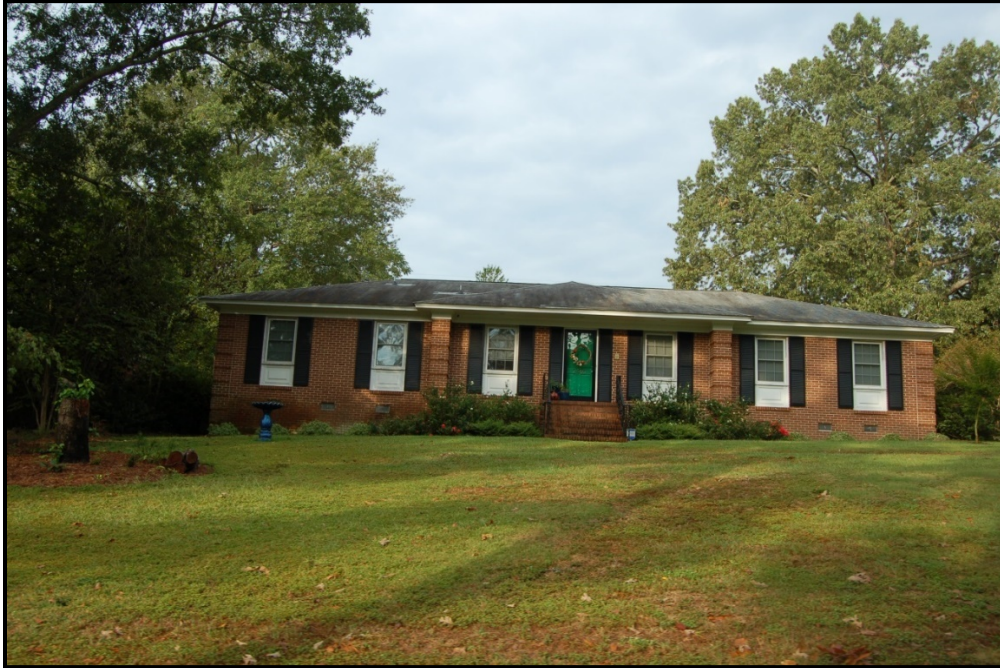
**Figure 5.9: Resource 106-0878.03 (Westover Acres Subdivision) – Representative view of property within the subdivision located at 2460 Robin Crest Drive, facing west.**

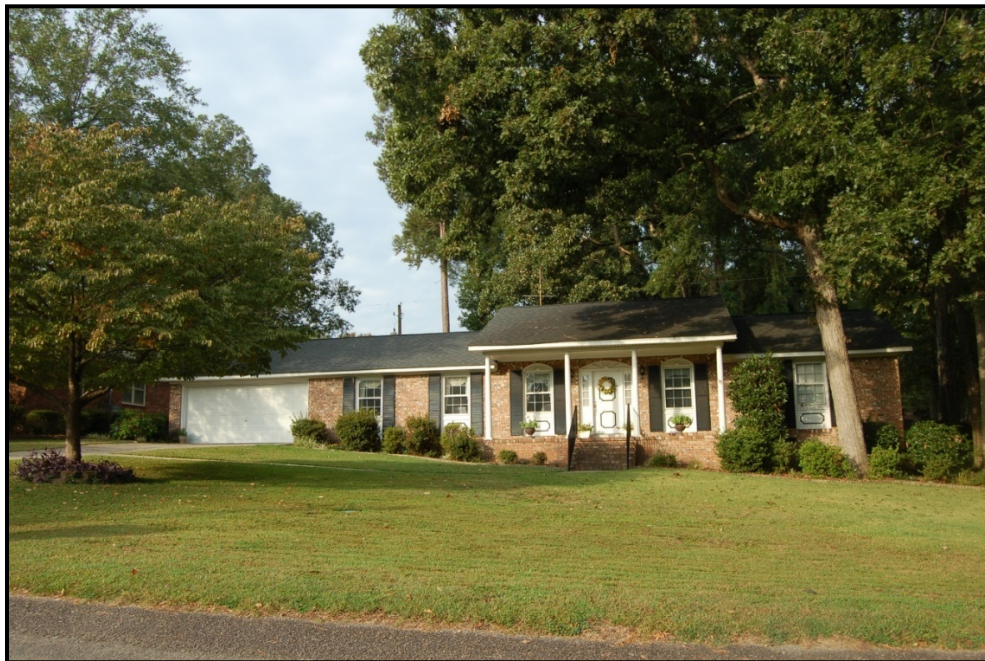
**Figure 5.10: Resource 106-0878.04 (Westover Acres Subdivision) – Representative view of property within the subdivision located at 2448 Robin Crest Drive, facing west.**

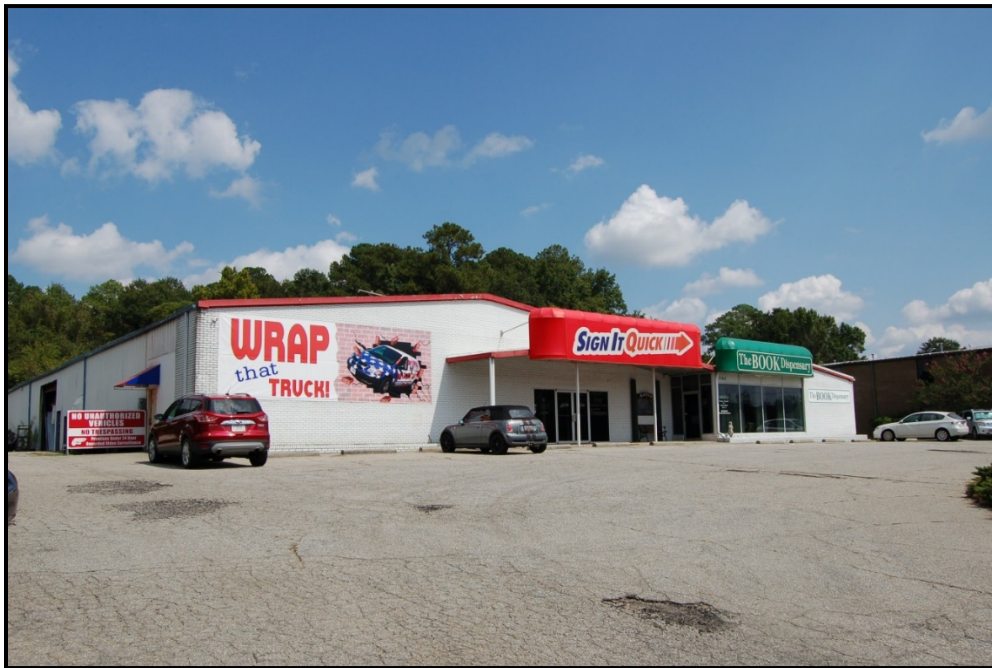
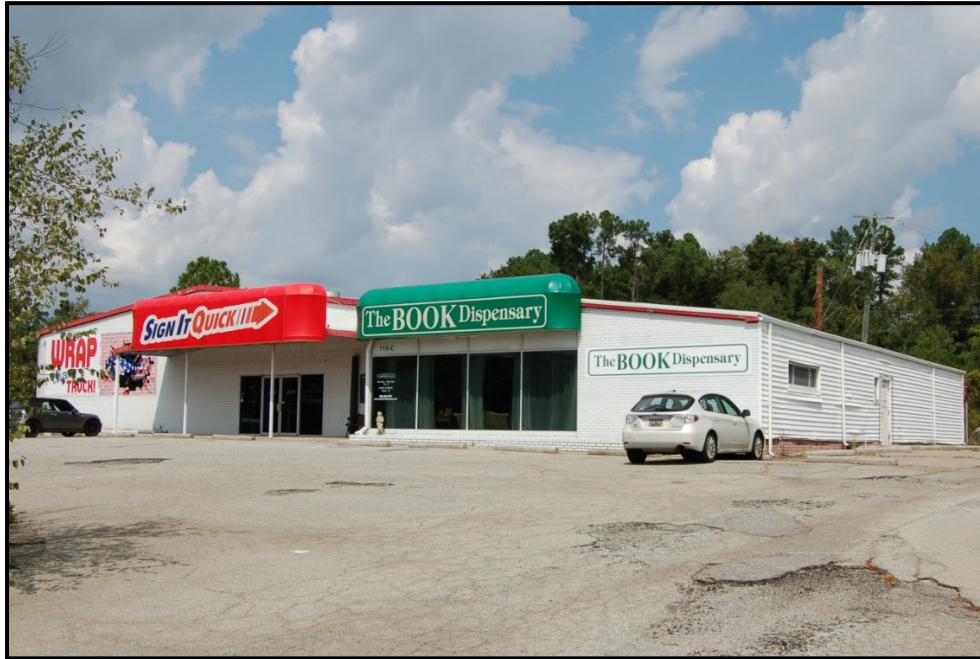
Figure 5.15: Resource 106-6465 (710 Gracern Road) – Oblique view of the façade and west side elevation, facing northeast.

**Figure 5.16: Resource 106-6465 (710 Gracern Road) – Oblique view of the façade and west side elevation, facing northwest.**

The resource is not known to be associated with a significant activity or event and there is not a known connection between the resource and any individual whose activities or achievements are historically significant. Therefore, there was no basis for evaluating the resource under Criterion A or B. Also, there are no indications that the resource is likely to yield information on important research questions in history or prehistory. The resource does not appear to have the potential to be the principal source of important information. Therefore, there was no basis for evaluating the resource under Criterion D. The resource does not represent a recognized architectural type or style and does not otherwise appear to represent a significant trend in South Carolina's architectural history. Therefore, Resource 106-6465 is recommended **Not Eligible** for listing in the NRHP under Criterion C in the area of architecture.

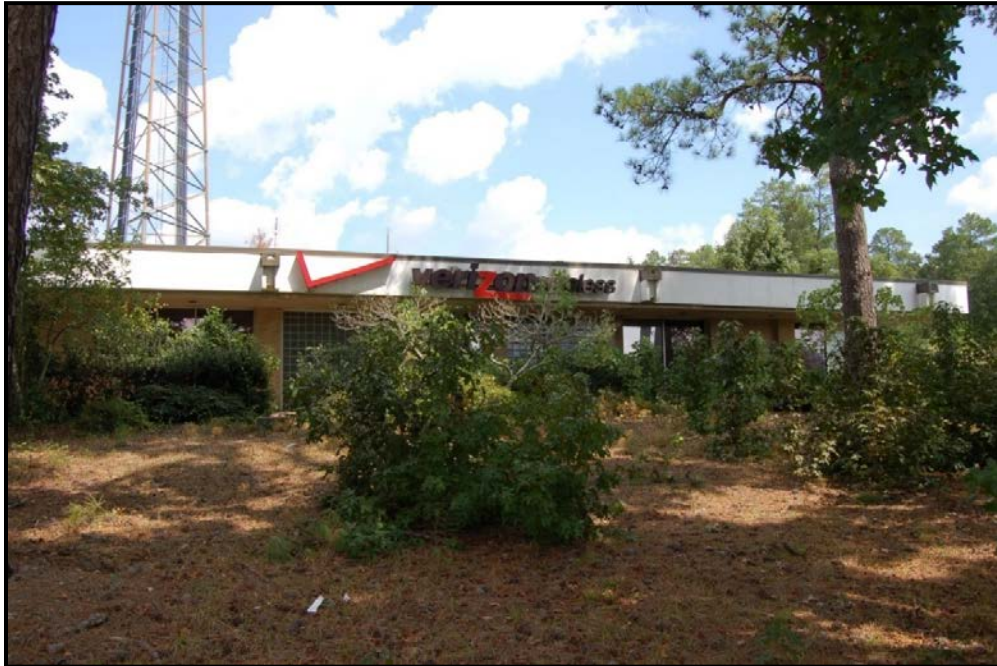
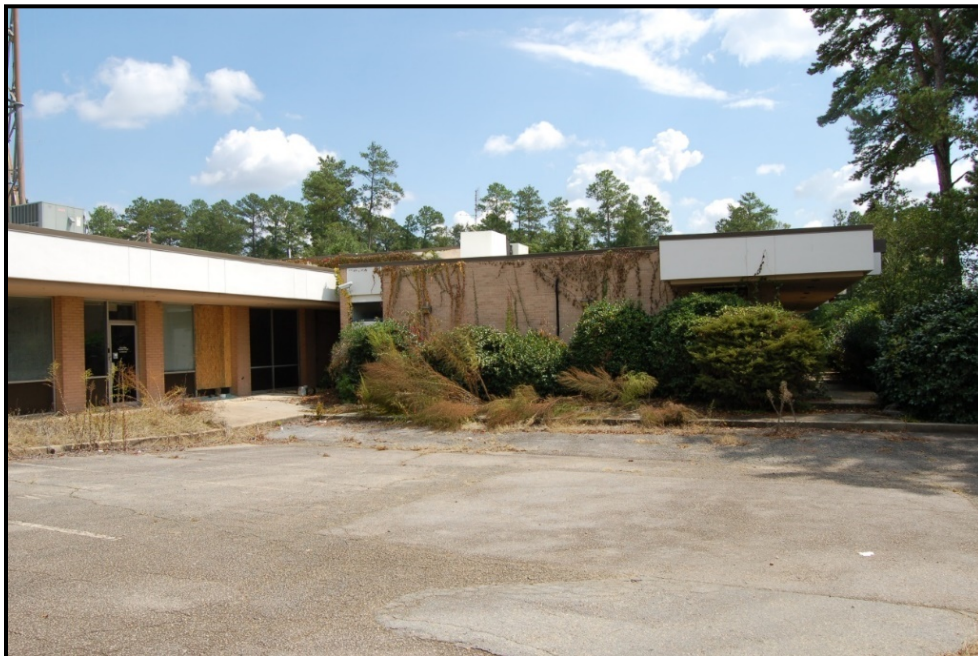
Resource 106-6466 is located at 910 Gracern Road on the north side of the roadway approximately 700 feet southeast of the intersection of Gracern Road and Arrowwood Road in Columbia in Richland County (refer to Figure 5.1A). The Richland County Assessor's record has a 1967 date of construction for the resource. Based on a review of historic aerial photography and topographic maps, and an evaluation of the resource's form and construction materials, this date of construction is considered accurate. The resource is a one-story, asymmetric, office building of concrete block load-bearing wall construction. The building features a flat tar-and-gravel roof; concrete block exterior on three sides with running bond brick veneer on the façade; large metal-framed 2-light display windows on the façade; and large glass block wall segments on the façade. A recessed flat-roofed addition was constructed on the west side elevation ca 1984. The later addition has brick veneer siding on all elevations.

**Figure 5.17: Resource 106-6466 (910 Gracern Road) – View of the façade and west side elevation, facing northwest.**

**Figure 5.18: Resource 106-6466 (910 Gracern Road) – View of the south side elevation of original portion of resource and façade of later addition, facing east.**

The resource is not known to be associated with a significant activity or event and there is not a known connection between the resource and any individual whose activities or achievements are historically significant. Therefore, there was no basis for evaluating the resource under Criterion A or B. Also, there are no indications that the resource is likely to yield information on important research questions in history or prehistory. The resource does not appear to have the potential to be the principal source of important information. Therefore, there was no basis for evaluating the resource under Criterion D. The resource does not represent a recognized architectural type or style and does not otherwise appear to represent a significant trend in South Carolina's architectural history. Additionally, due to a non-historic addition on the west side elevation, the resource does not retain integrity in the area of design. Therefore, Resource 106-6466 is recommended **Not Eligible** for listing in the NRHP under Criterion C in the area of architecture.

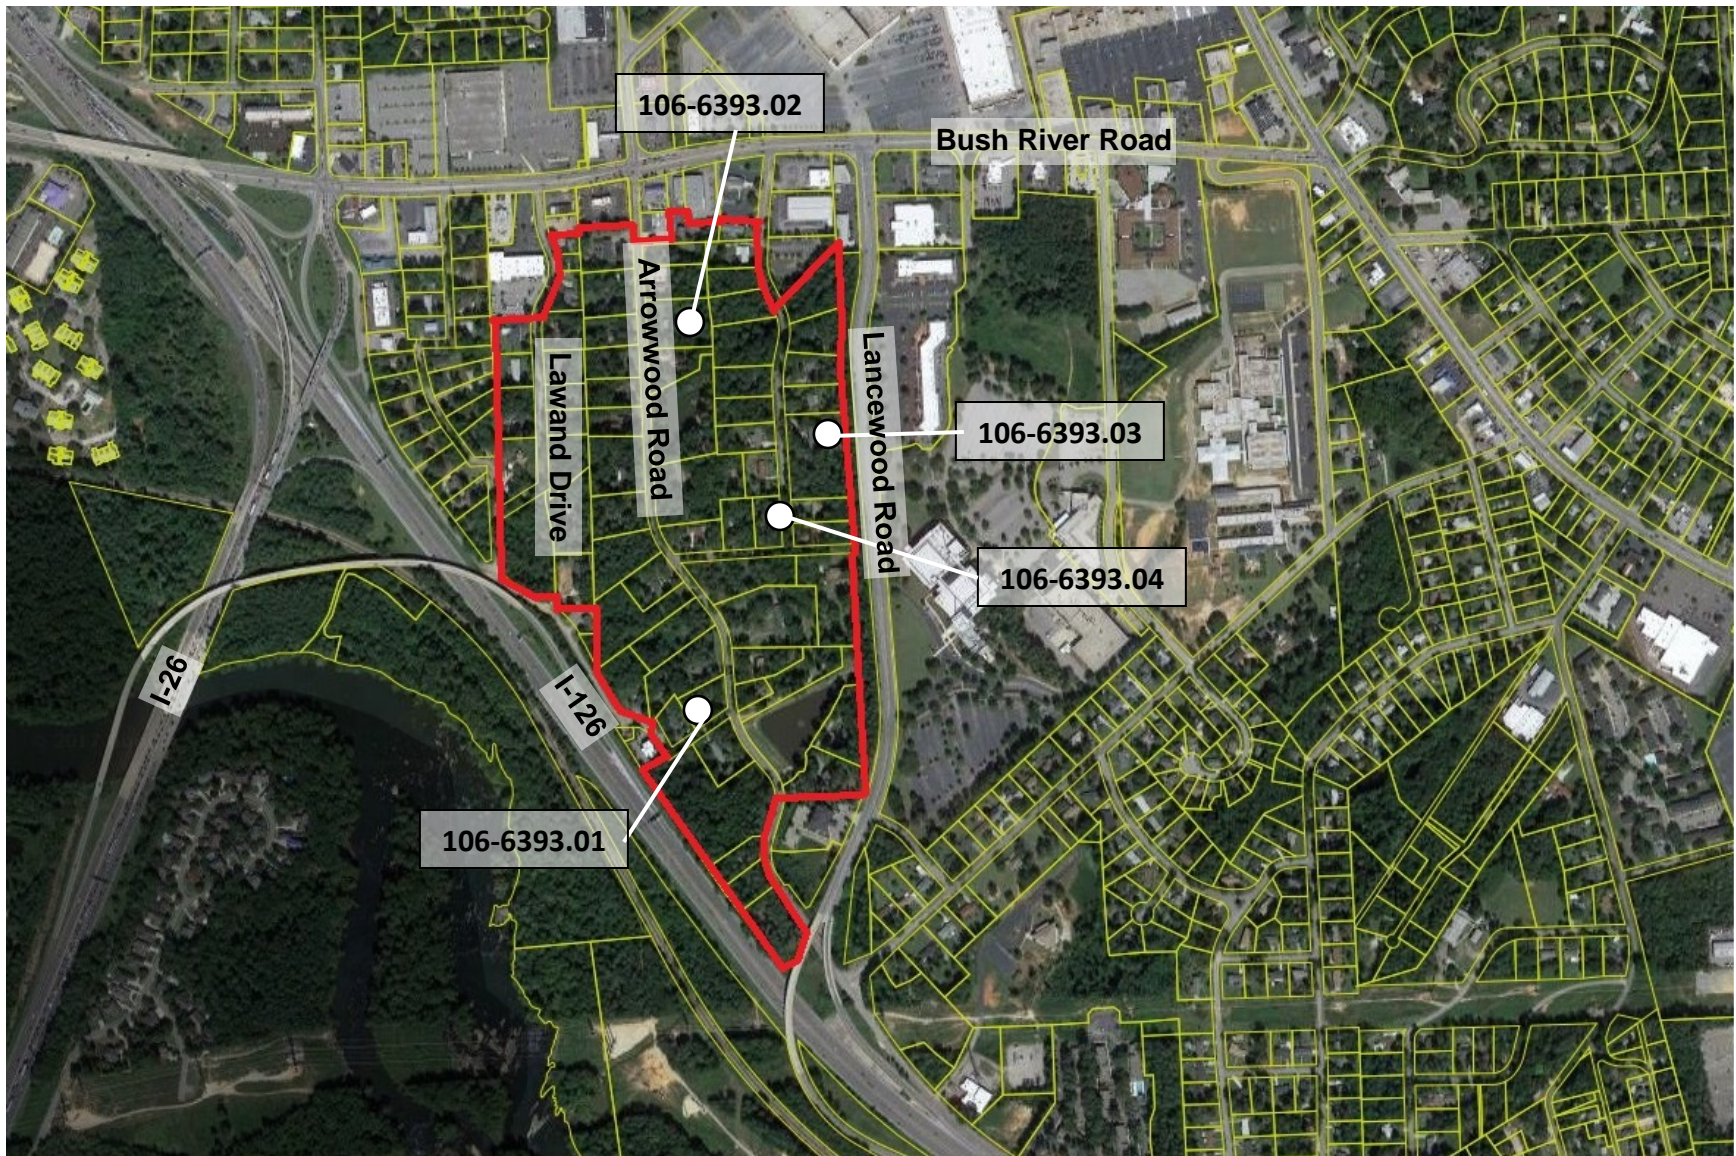
Figure 5.24: Resource 106-6393 (Arrowwood Subdivision).

The residences within the subdivision represent a wide variety of mid twentieth century residential building types that include side-gabled cottages, minimal traditional, Ranches, and Split Levels. Most of the houses are plain without stylistic features. Brick is the predominant exterior siding material on houses from all periods of construction. Roof forms are side-gabled, cross-gabled, hipped, cross-hipped, and complex. The lots within district vary dramatically in shape and size, and the building setbacks also vary considerably. No schools, churches, community buildings or parkland were incorporated into the development.

The resource is not known to be associated with a significant activity or event and there is not a known connection between the resource and any individual whose activities or achievements are historically significant. Therefore, there was no basis for evaluating the resource under Criterion A or B. Also, there are no indications that the resource is likely to yield information on important research questions in history or prehistory. The resource does not appear to have the potential to be the principal source of important information. Therefore, there was no basis for evaluating the resource under Criterion D. The 65-lot subdivision is of plain design and consists of irregularly-sized lots along both sides of three relatively parallel roads and there were no community buildings or parkland associated with the subdivision. The individual properties within the subdivision are undistinguished examples of the traditional linear Ranch and Split-Level types, and there are no significant or noteworthy landscape or design features of the subdivision beyond generally uniform lot size and building setback. Therefore, Resource 106-6393 is recommended **Not Eligible** for listing in the NRHP under Criteria A and C in the areas of community planning and development, architecture, and landscape architecture.
