## A Cultural Resource Survey of the Proposed Improvements to the Carolina Crossroads Corridor

*I-20/26/126 Corridor Project*

*Lexington and Richland Counties, South Carolina*

*Final Report May 2018*

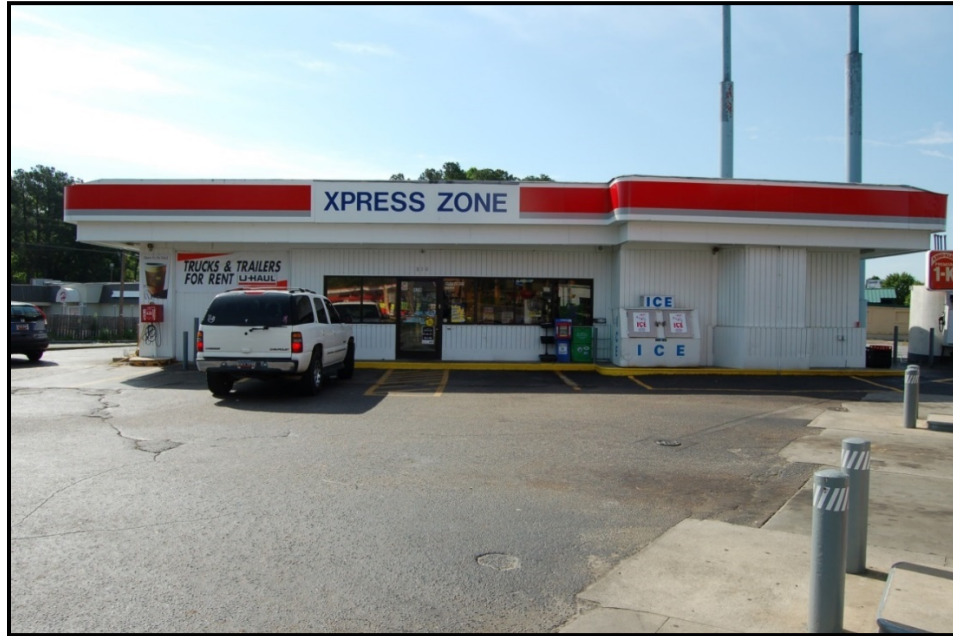
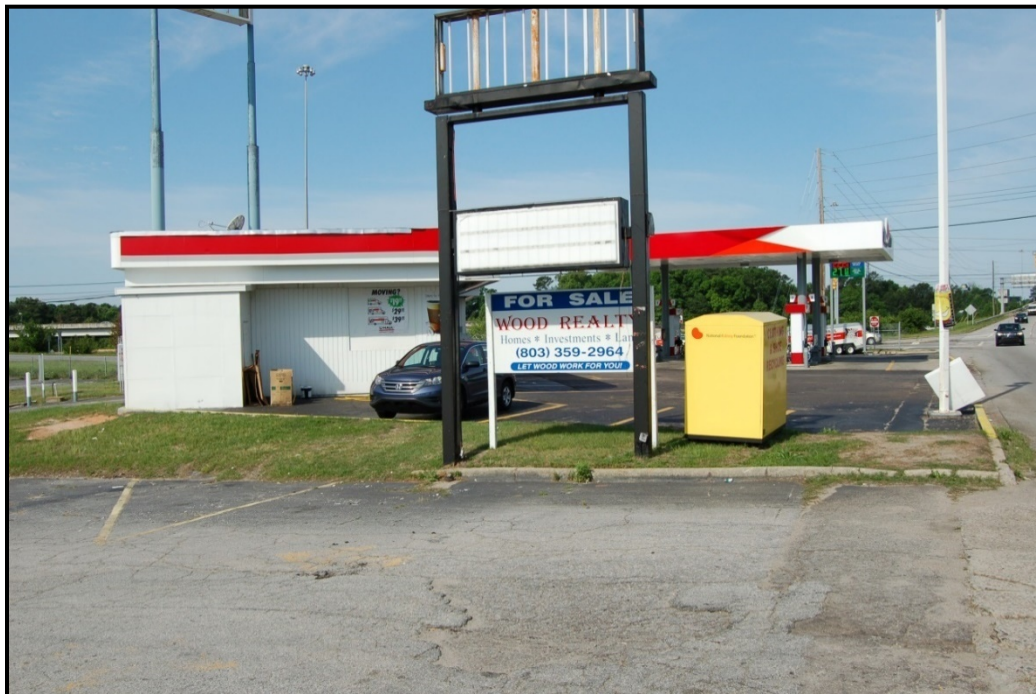
Resource 106-6395 is located at 830 Bush River Road in the southeast corner of the intersection of Bush River Road and Morninghill Drive outside the city limits of Columbia in Richland County (refer to Figure 5.1C). The Richland County Assessor's record has a 1962 date of construction for the resource. Based on a review of historic aerial photography and topographic maps, and an evaluation of the resource's form and construction materials, this date of construction is considered reliable. The resource is a one-story, asymmetric, convenience store of concrete block load-bearing wall and steel frame construction. The building features a flat tar-and-gravel roof; concrete block and metal sheet exterior; and a metal-framed glass door and metal-framed display windows on the façade. The resource has been significantly altered by the enclosure of many original windows and the application of a continuous decorative canopy at the roofline around all sides of the building. The resource is located on a paved asphalt lot and is oriented toward the northeast corner of the parcel to face the intersection of Bush River Road and Morninghill Drive and not directly toward either road.

Figure 5.34: Resource 106-6395 (830 Bush River Road) – View of the façade, facing southeast.

Figure 5.35: Resource 106-6395 (830 Bush River Road) – View of the east side elevation, facing west.

The resource is not known to be associated with a significant activity or event and there is not a known connection between the resource and any individual whose activities or achievements are historically significant. Therefore, there was no basis for evaluating the resource under Criterion A or B. Also, there are no indications that the resource is likely to yield information on important research questions in history or prehistory. The resource does not appear to have the potential to be the principal source of important information. Therefore, there was no basis for evaluating the resource under Criterion D. Due to exterior alterations, the resource has lost integrity in the areas of design, materials, workmanship, and feeling and cannot convey significance in the area of architecture. Therefore, Resource 106-6395 is recommended **Not Eligible** for listing in the NRHP under Criterion C in the area of architecture.

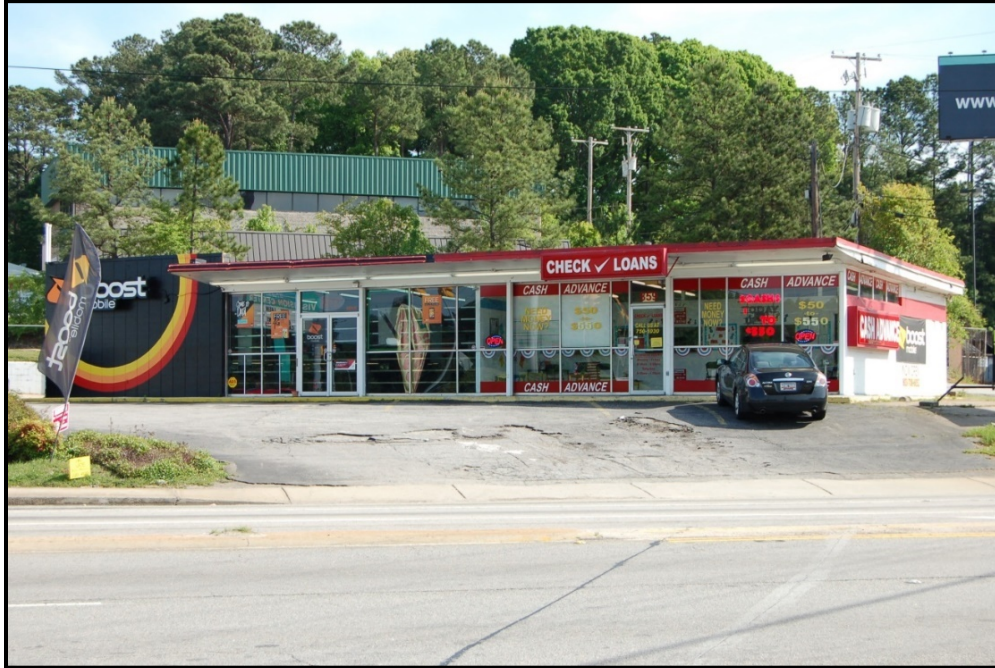
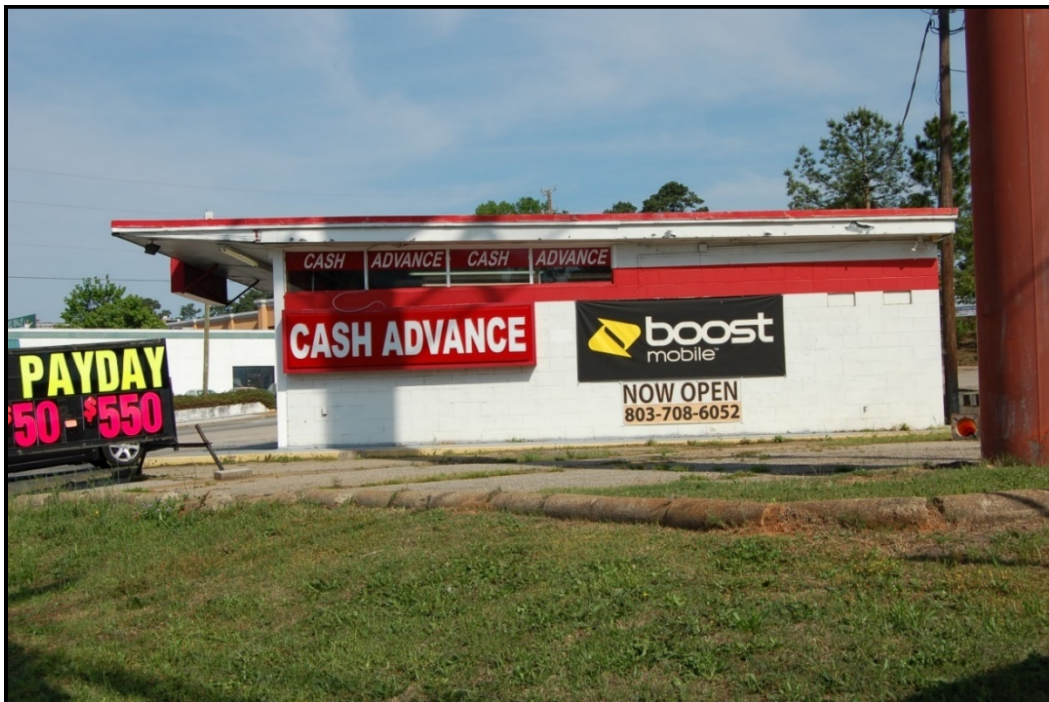
Resource 106-6396 is located at 859 Bush River Road in the northeast corner of the intersection of Bush River Road and Morninghill Drive outside the city limits of Columbia in Richland County (refer to Figure 5.1C). The Richland County Assessor's record has a 1964 date of construction for the resource. Based on a review of historic aerial photography and topographic maps, and an evaluation of the resource's form and construction materials, this date of construction is considered reliable. The resource is a one-story, asymmetric, commercial building of concrete block load-bearing wall construction. The building features a flat tar-and-gravel roof; concrete block exterior; and metal-framed single- and double-leaf glass doors and metal-framed display windows on the façade. The resource is located on a paved asphalt lot and is oriented toward the northeast corner of the parcel to face the intersection of Bush River Road and Morninghill Drive and not directly toward either road.

Figure 5.36: Resource 106-6396 (859 Bush River Road) – View of the facade, facing northeast.

Figure 5.37: Resource 106-6396 (859 Bush River Road) – View of the east side elevation, facing northwest.

The resource is not known to be associated with a significant activity or event and there is not a known connection between the resource and any individual whose activities or achievements are historically significant. Therefore, there was no basis for evaluating the resource under Criterion A or B. Also, there are no indications that the resource is likely to yield information on important research questions in history or prehistory. The resource does not appear to have the potential to be the principal source of important information. Therefore, there was no basis for evaluating the resource under Criterion D. The resource does not represent a recognized architectural type or style and does not otherwise appear to represent a significant trend in South Carolina's architectural history. Therefore, Resource 106-6396 is recommended Not Eligible for listing in the NRHP under Criterion C in the area of architecture.

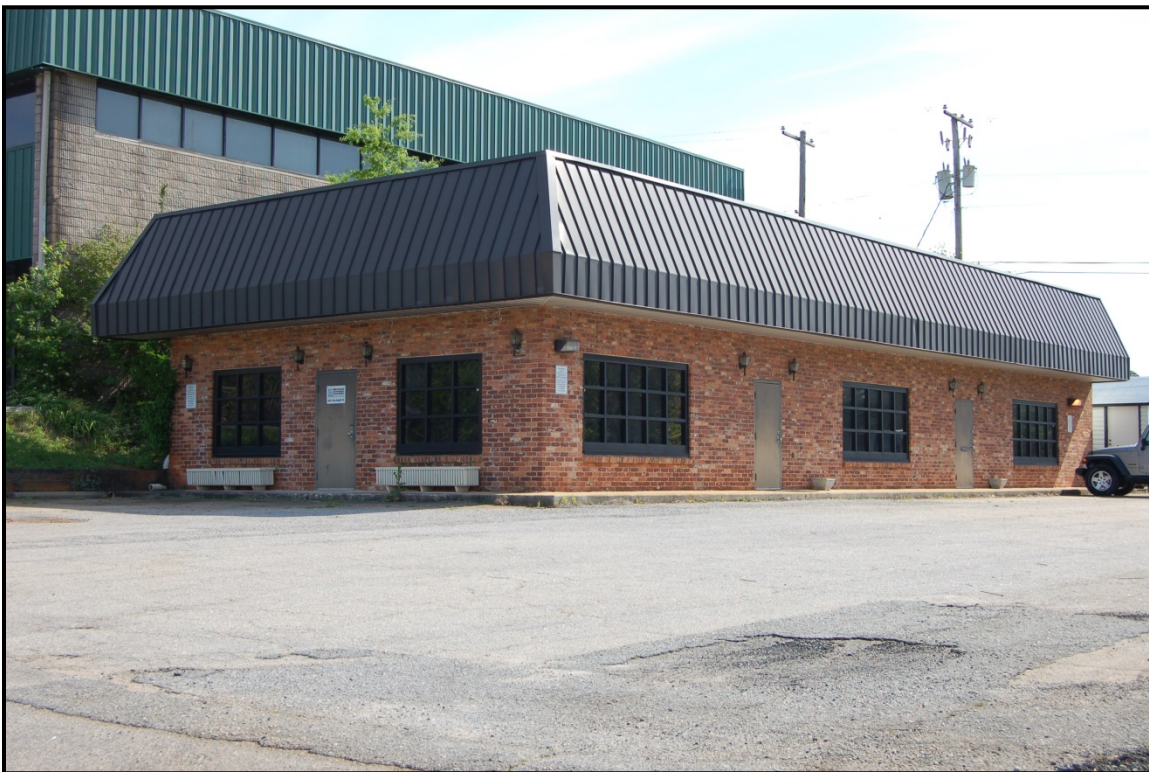
**Figure 5.38: Resource 106-6397 (1504 Morninghill Drive) – Oblique view of the west and south side elevation, facing northeast.**

Resource 106-6397 is located at 1504 Morninghill Drive on the east side of the roadway in the northeast corner of the intersection of Sunset Boulevard and Oakwood Drive outside the city limits of Columbia in Richland County (refer to Figure 5.1C). The Richland County Assessor's record has a 1965 date of construction for the resource. Based on a review of historic aerial photography and topographic maps, and an evaluation of the resource's form and construction materials, this date of construction is considered reliable. The resource is a tall, one-story, rectangular office building of frame construction with little, if any, original construction material still evident. The building has a flat tar-and-gravel roof atop a massive steel mansard-like roof structure; running bond brick exterior; metal-framed 9- and 15-light windows; and steel slab doors. These materials are non-historic replacements. The resource is located on a paved asphalt lot and is oriented with the narrow end parallel to Morninghill Drive.

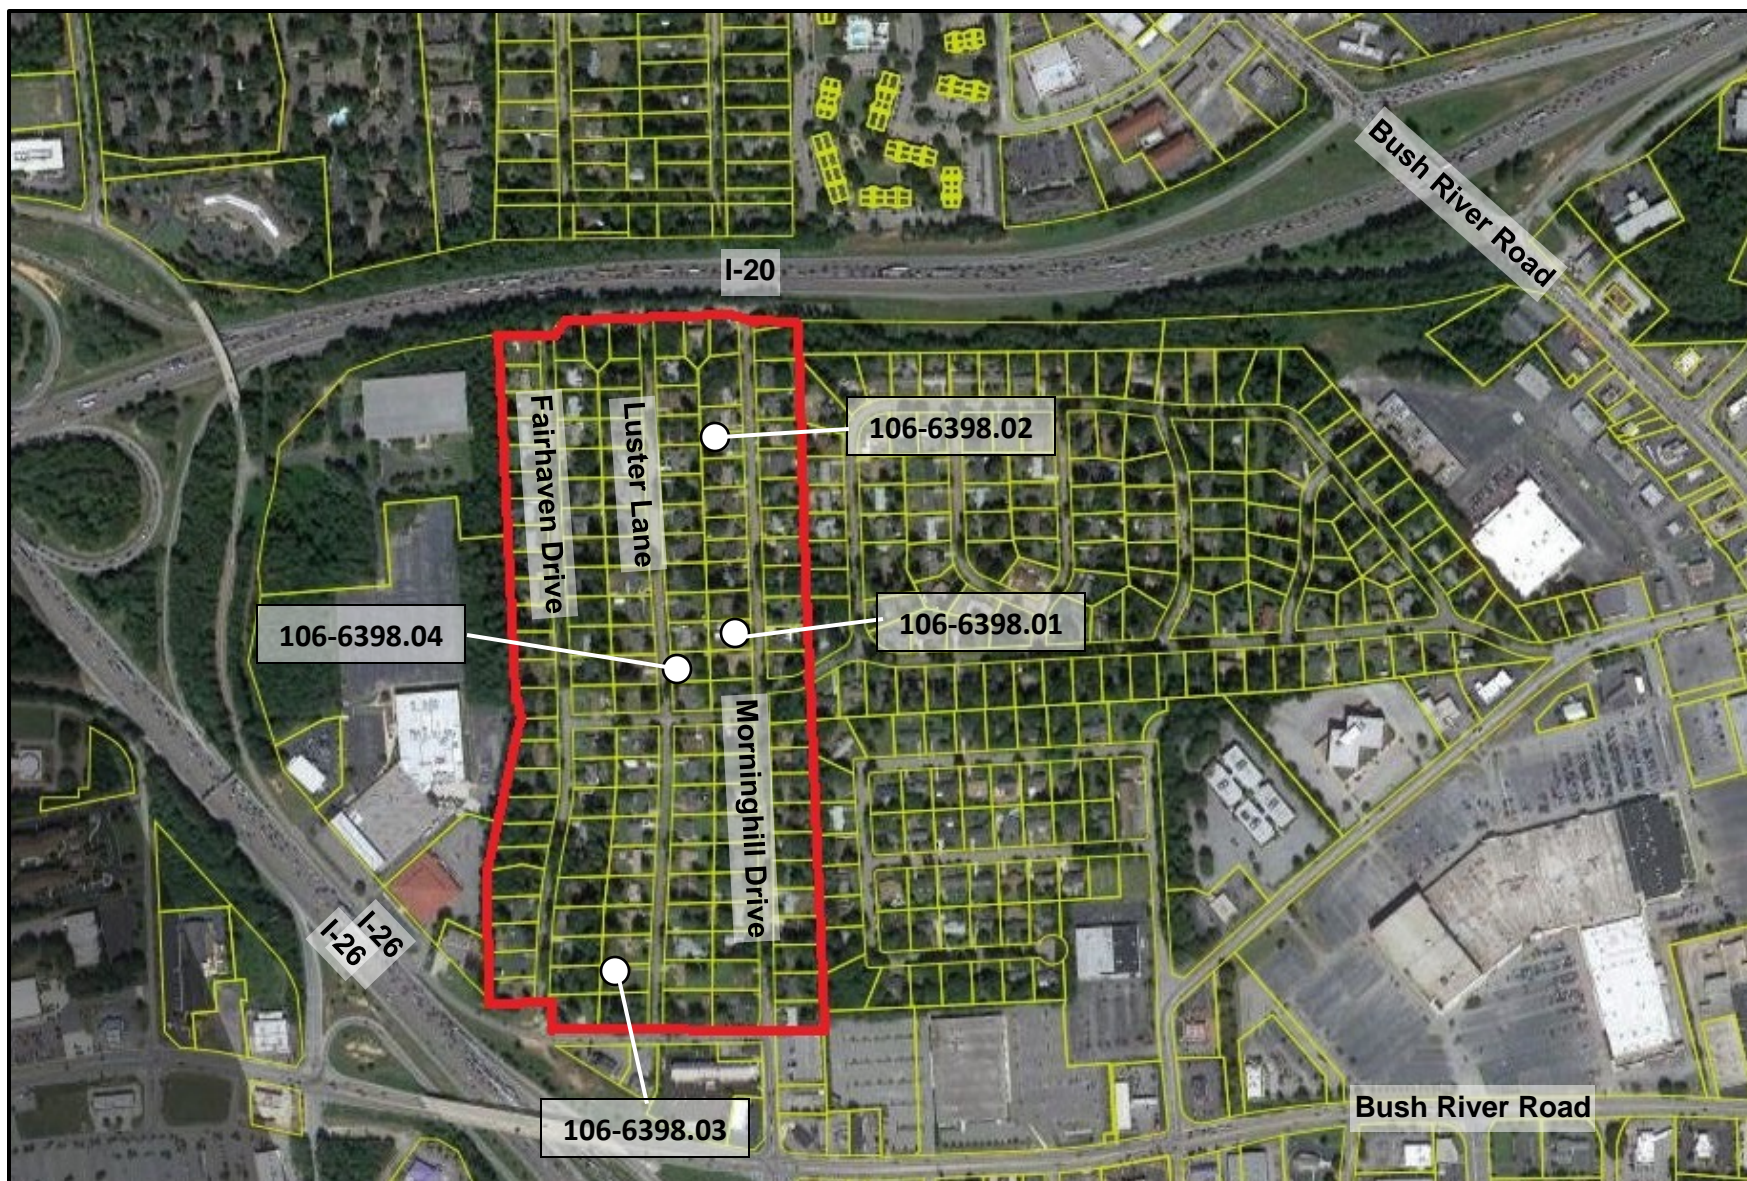
Figure 5.39: Resource 106-6398 (Skyview Terrace Subdivision).

Resource 106-6398, the Skyview Terrace Subdivision, is located in the southeast quadrant of the I-20 and I-26 interchange along Fairhaven Drive, Luster Lane, and Morninghill Drive outside the city limits of Columbia in Richland County (refer to Figure 5.1C and Figure 5.39). A review of estimated dates of construction in Richland County Assessor's records for properties in the neighborhood revealed that houses within the neighborhood were constructed from 1956 to 1975. A review of the Columbia North, SC, topographic map dated 1972 and aerial photography dated 1971 available on the [www.historicaerials.com](http://www.historicaerials.com) website supported the Assessor's dates of construction. The subdivision contains approximately 140 lots and is comprised of residences located along both side of three roughly parallel north-south roads: Fairhaven Drive, Luster Land, and Morninghill Drive. Most of the lots are rectangular and vary from 0.3 to 0.4 acre in size, and a small number of residences are sited across two adjacent lots.

The resource is not known to be associated with a significant activity or event and there is not a known connection between the resource and any individual whose activities or achievements are historically significant. Therefore, there was no basis for evaluating the resource under Criterion A or B. Also, there are no indications that the resource is likely to yield information on important research questions in history or prehistory. The resource does not appear to have the potential to be the principal source of important information. Therefore, there was no basis for evaluating the resource under Criterion D. The 140-lot subdivision is formed by three roughly parallel north-south roads and there are no community buildings or parkland associated with the subdivision. The individual properties within the subdivision are

undistinguished examples of the traditional linear Ranch and Split-Level types, and there are no significant or noteworthy landscape or design features of the subdivision beyond generally uniform lot size and building setback. Therefore, Resource 106-6398 is recommended **Not Eligible** for listing in the NRHP under Criteria A and C in the areas of community planning and development, architecture, and landscape architecture.

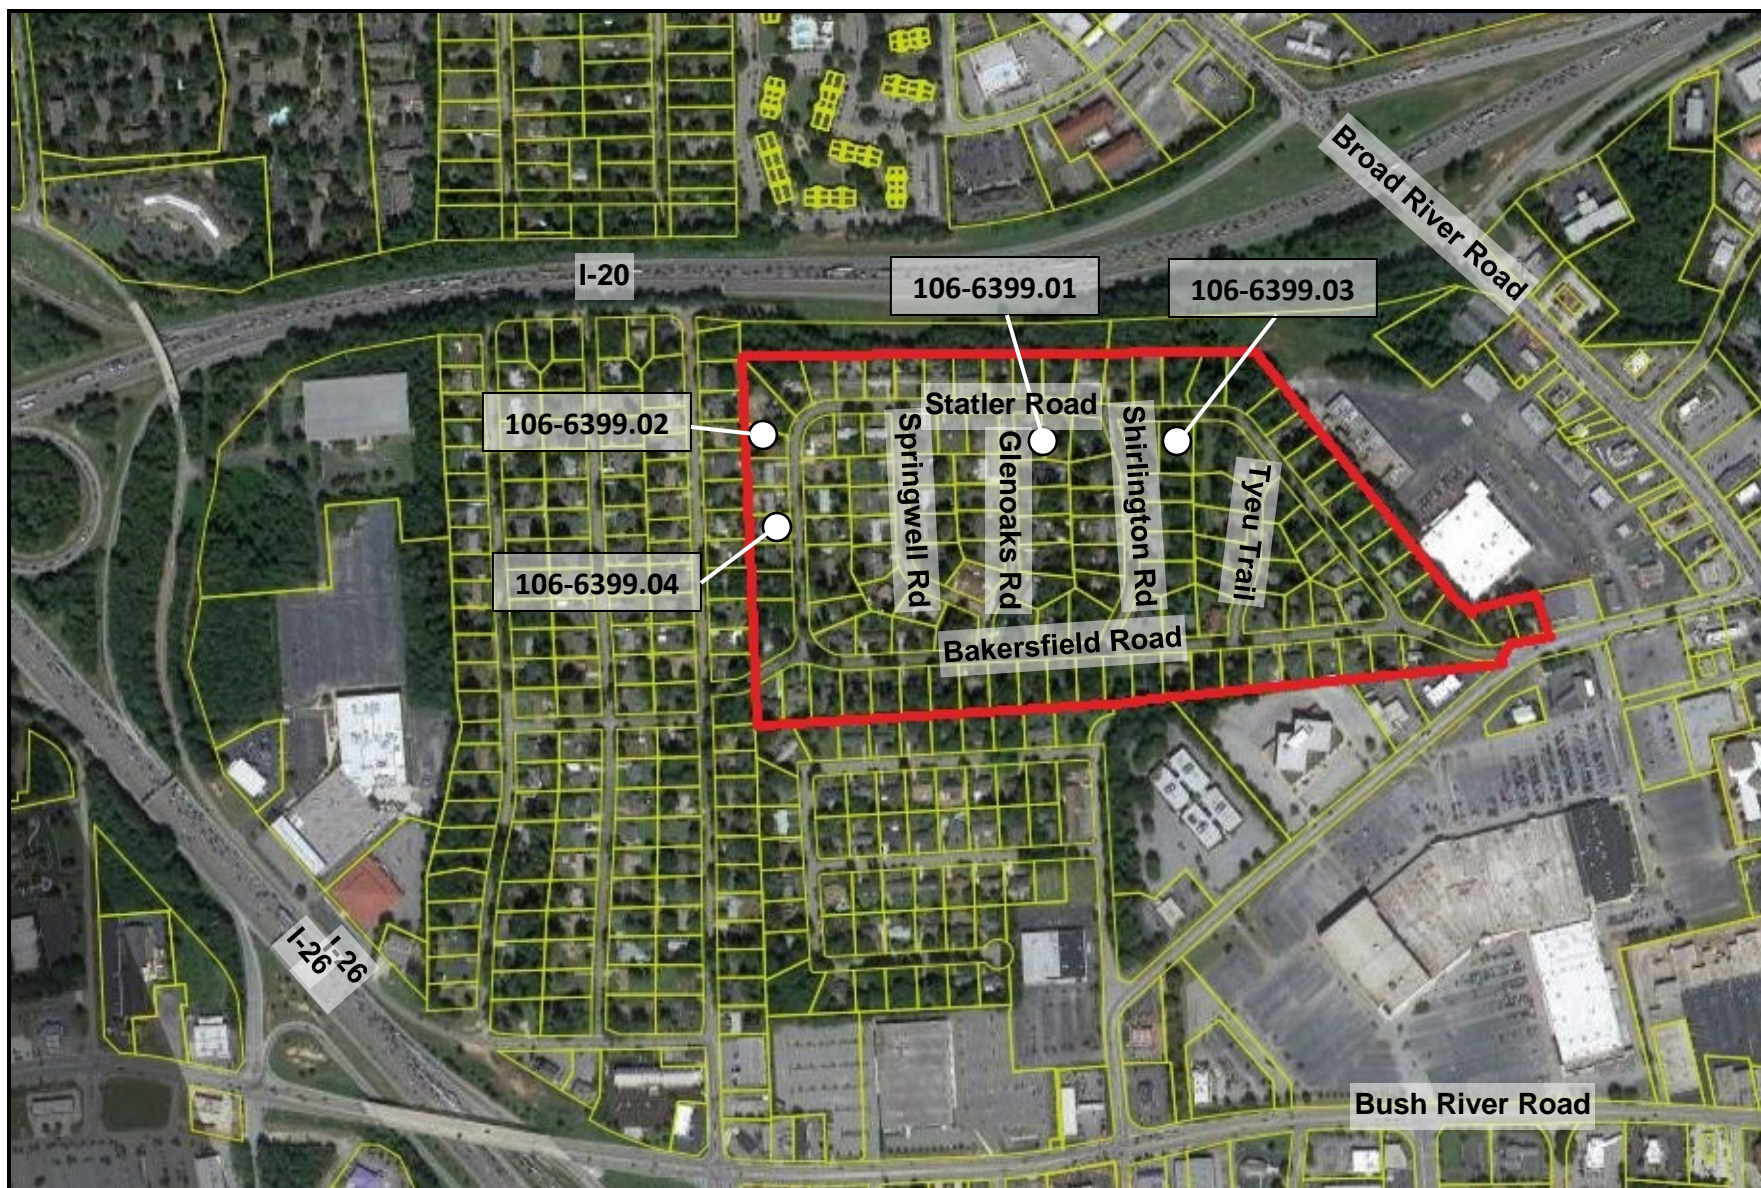
Figure 5.43: Resource 106-6399 (Belmont Estates Subdivision).

Resource 106-6399, the Belmont Estates Subdivision, is located south of I-20 between I-26 and Broad River Road outside the city limits of Columbia in Richland County (refer to Figure 5.1C and Figure 5.43). A review of estimated dates of construction in Richland County Assessor's records for properties in the neighborhood revealed that houses within the neighborhood were constructed from 1958-1976. A review of the Columbia North, SC, topographic map dated 1972 and aerial photography dated 1971 available on the [www.historicaerials.com](http://www.historicaerials.com) website supported the Assessor's dates of construction. The subdivision contains approximately 130 lots and is comprised of residences located along both side of a large loop created by Bakersfield Road to the south and Staler Road to the east, west, and north, and along both sides of four north-south connector roads within the loop. Most of the lots vary from 0.3 to 0.4 acre in size and there is great variety in the shape of the lots.

The residences within the subdivision are exclusively traditional one-story Ranch houses with integral carports and garages, and Split-Level houses with integral carports. Most of the houses are plain without stylistic features, but there are examples with Colonial Revival stylistic features. Brick is the predominant exterior siding material and roof forms are side-gabled, cross-gabled, hipped, cross-hipped, and complex. The lot sizes are fairly uniform, but the lot shapes vary. The building setbacks are generally uniform. No schools, churches, community buildings or parkland were incorporated into the development, but commercial development on the western edge of the neighborhood near Dutch Square Mall dates to the same period as the subdivision.

The resource is not known to be associated with a significant activity or event and there is not a known connection between the resource and any individual whose activities or achievements are historically significant. Therefore, there was no basis for evaluating the resource under Criterion A or B. Also, there are no indications that the resource is likely to yield information on important research questions in history or prehistory. The resource does not appear to have the potential to be the principal source of important information. Therefore, there was no basis for evaluating the resource under Criterion D. The 130-lot subdivision is formed by two roads that form a loop with three north-south connector roads that link the north and south sides of the loop. There are no community buildings or parkland associated with the subdivision. The individual properties within the subdivision are undistinguished examples of the traditional linear Ranch and Split-Level types, and there are no significant or noteworthy landscape or design features of the subdivision beyond generally uniform lot size and building setback. Therefore, Resource 106-6399 is recommended **Not Eligible** for listing in the NRHP under Criteria A and C in the areas of community planning and development, architecture, and landscape architecture.

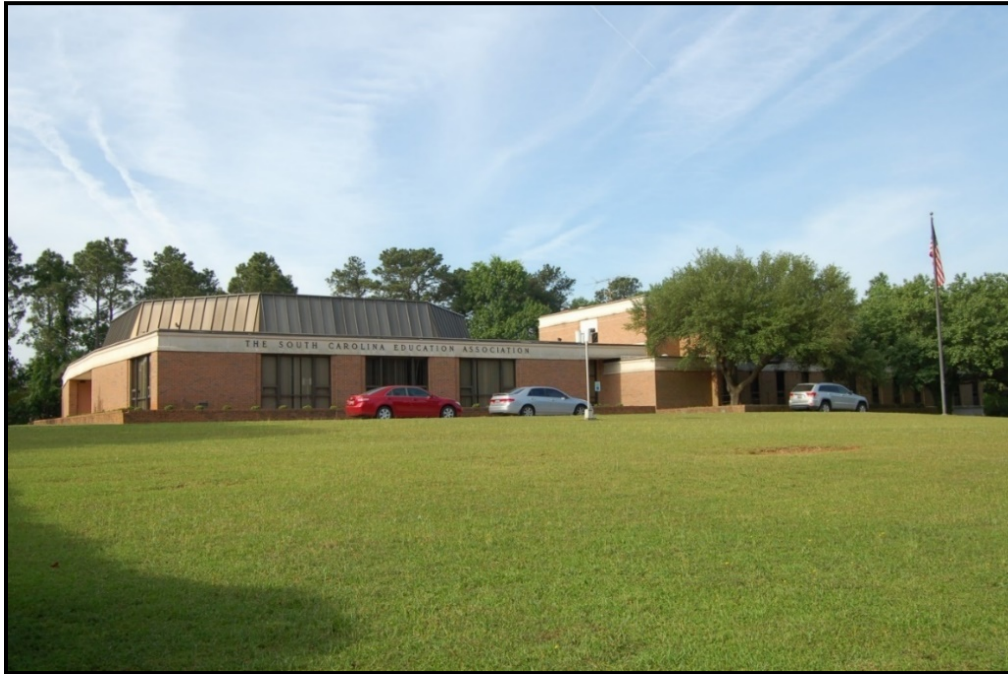
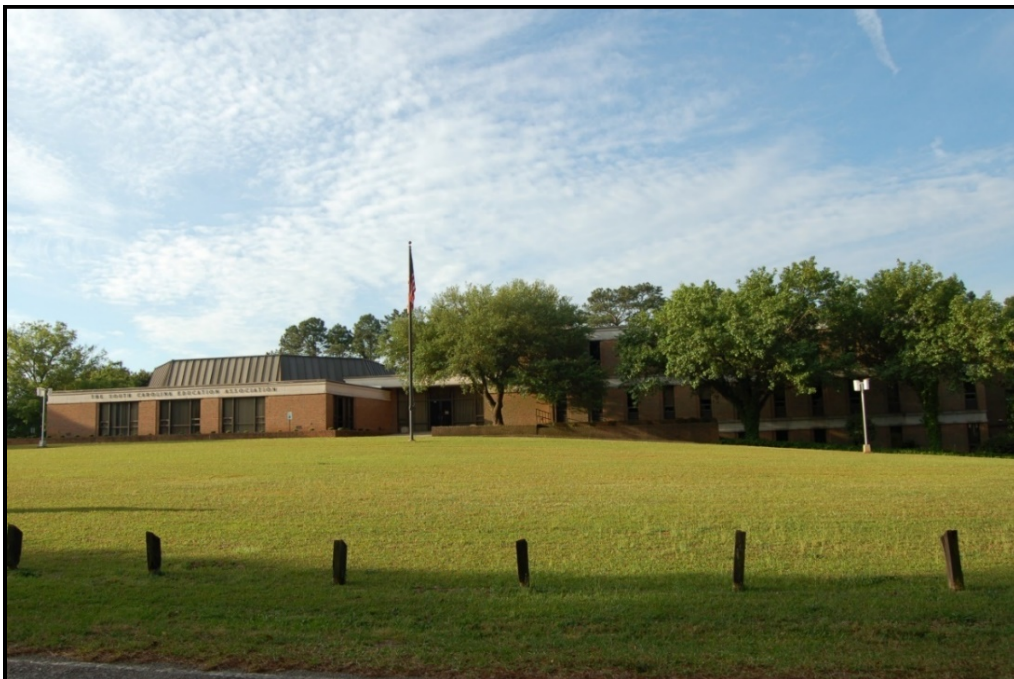
Resource 106-0880 is located at 421 Zimalcrest Drive on the south side of the roadway immediately south of the I-20 and I-26 cloverleaf interchange in Lexington County (refer to Figure 5.1C). The Lexington County Assessor's record does not have an estimated date of construction for the resource. Based on a review of historic topographic maps and an evaluation of the resource's form and construction materials, Resource 106-0880 appears to have been constructed ca. 1969. The building serves as the offices of the South Carolina Education Association and is a three-part building comprised of a one-story auditorium and office element, a two-story office element, and a square-shaped connector between those east and west wings. The auditorium and office element is rectangular with the narrow side parallel to Zimalcrest Drive. The two-story office element is rectangular with the long side parallel to Zimalcrest Drive. Each of the three elements has running bond brick exterior, plain concrete frieze ornamentation, and large metal-framed, multi-light windows with integral hopper windows.

Figure 5.48: Resource 106-0880 (421 Zimalcrest Drive) – View of the facade, facing northeast.

Figure 5.49: Resource 106-0880 (421 Zimalcrest Drive) – View of the facade, facing northeast.

The resource is not known to be associated with a significant activity or event and there is not a known connection between the resource and any individual whose activities or achievements are historically significant. Therefore, there was no basis for evaluating the resource under Criterion A or B. Also, there are no indications that the resource is likely to yield information on important research questions in history or prehistory. The resource does not appear to have the potential to be the principal source of important information. Therefore, there was no basis for evaluating the resource under Criterion D. The resource does not represent a recognized architectural type or style and does not otherwise appear to represent a significant trend in South Carolina's architectural history. Therefore, Resource 106-0880 is recommended **Not Eligible** for listing in the NRHP under Criterion C in the area of architecture.

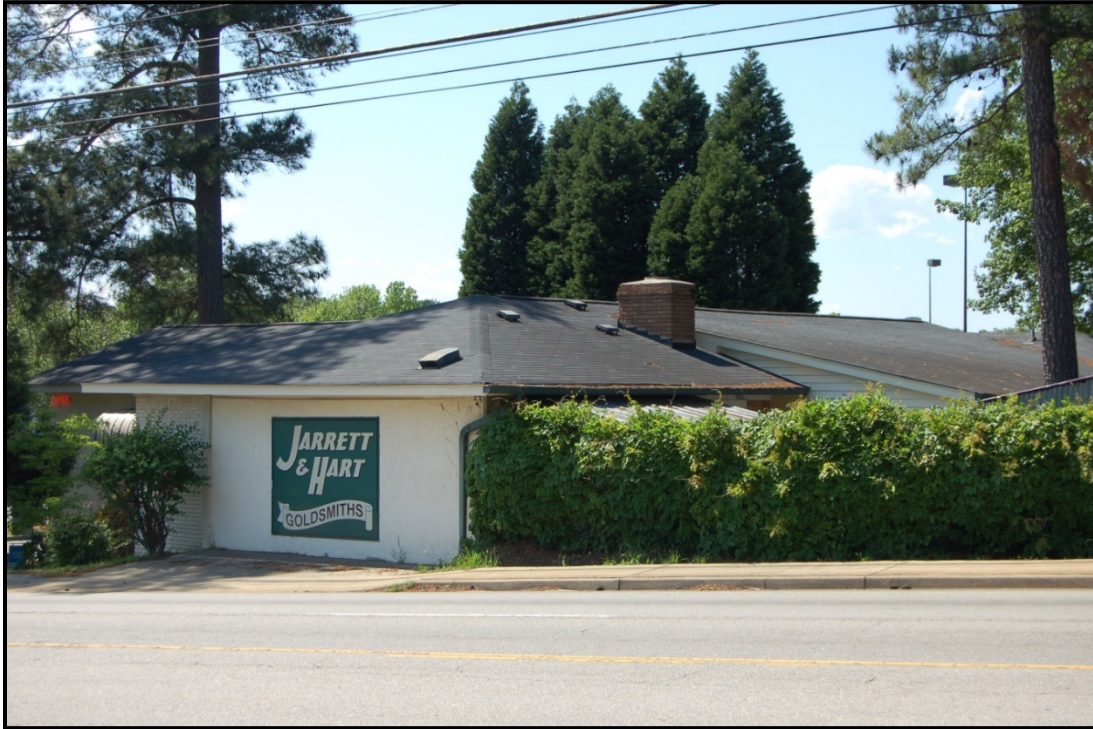
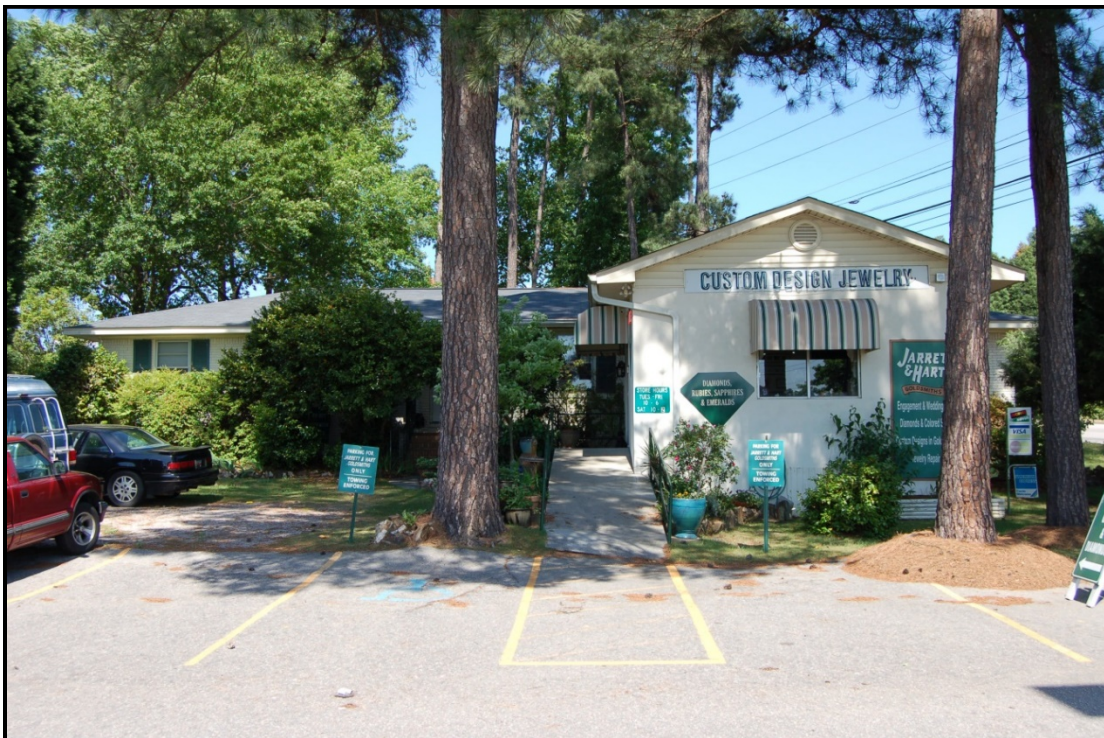
Resource 106-6401 is located at 3102 Greenore Drive in the northeast quadrant of the intersection of Greenore Drive and St. Andrews Road in Richland County (refer to Figure 5.1B). The Richland County Assessor's record has a 1965 date of construction for the resource. Based on a review of historic aerial photography and topographic maps, this date of construction is considered reliable. The resource is a one-story, asymmetric, L-shaped building currently used for commercial purposes that was originally a single-family residential property. It is suspected that the building was originally a Ranch type that has had additions constructed on the original façade (west) and rear (east) elevation. The building features a complex hipped asphalt shingle roof with wide eaves; running bond brick exterior with a soldier course below the eaves on the original portion of the building; a small brick interior roof surface chimney on the rear elevation; 2/2-light horizontal double-hung sash windows. A large shed-roofed addition of frame construction with synthetic exterior siding has been constructed on the rear elevation and projecting gable-roofed addition of frame construction has been constructed on the façade. An apparent carport on the south side elevation has been enclosed.

Figure 5.60: Resource 106-6401 (3102 Greenore Drive) – View of the south elevation, facing northwest.

Figure 5.61: Resource 106-6401 (3102 Greenore Drive) – View of the west elevation, facing east.

The resource is not known to be associated with a significant activity or event and there is not a known connection between the resource and any individual whose activities or achievements are historically significant. Therefore, there was no basis for evaluating the resource under Criterion A or B. Also, there are no indications that the resource is likely to yield information on important research questions in history or prehistory. The resource does not appear to have the potential to be the principal source of important information. Therefore, there was no basis for evaluating the resource under Criterion D. The resource no longer represents a recognized architectural type and due to substantial alterations and additions the resources has lost integrity in the areas of design, materials, workmanship, and feeling and cannot convey significance in the area of architecture. Therefore, Resource 106-6401 is recommended **Not Eligible** for listing in the NRHP under Criterion C in the area of architecture.

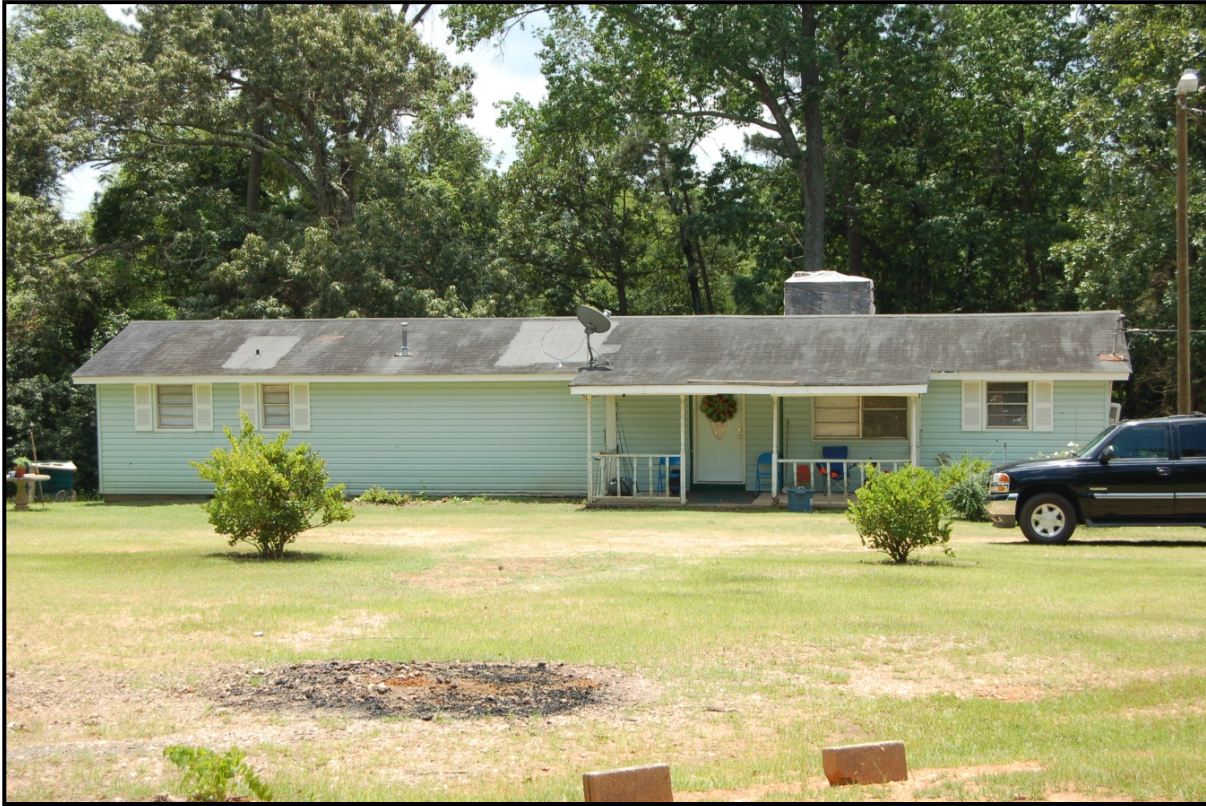
**Figure 5.62: Resource 243-0882 (128 Steward Drive) – View of the west elevation, facing south.**

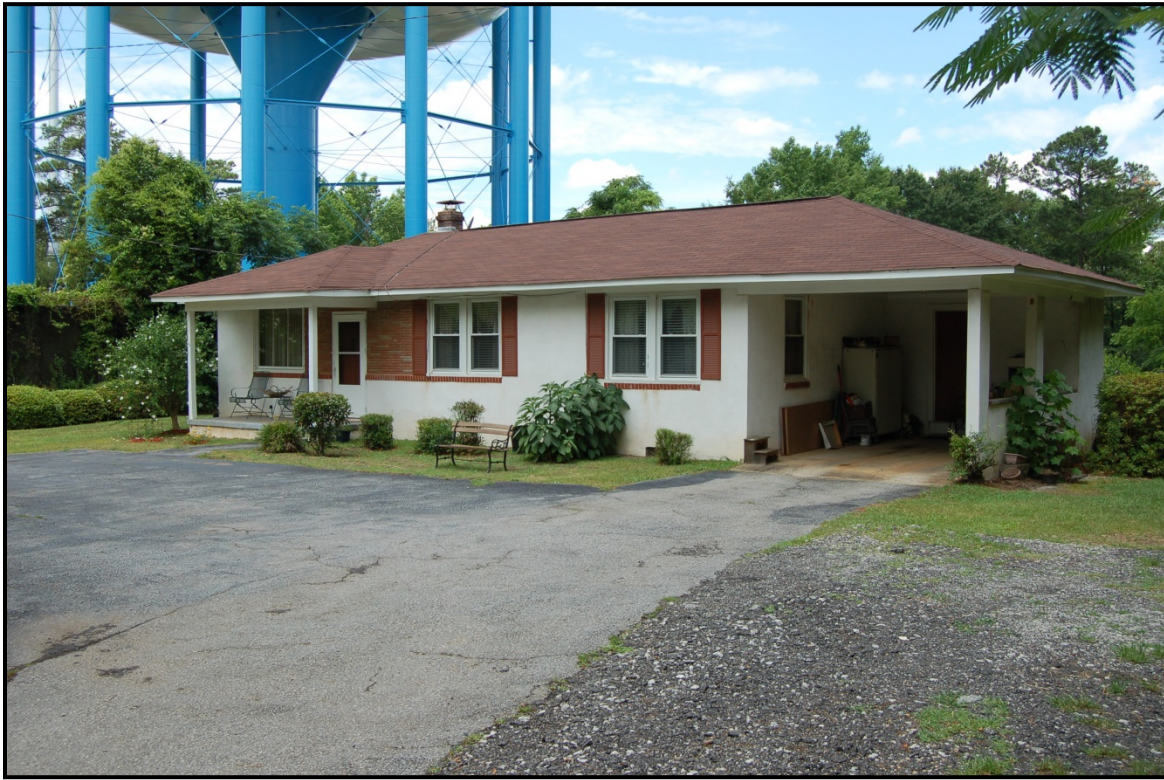
Resource 243-0882 is located at 129 Steward Drive on the north side of the roadway approximately 375 feet east of the intersection of Steward Drive and Fernandina Road in Lexington County (refer to Figure 5.1B). The Lexington County Assessor's record has a 1959 date of construction for the resource. This date of construction was supported by the review of historic aerial photography and topographic maps, and an evaluation of the resource's form and construction materials. The resource is a one-story, asymmetric, cross-hipped residence of masonry load-bearing wall construction. The house features a cross-hipped asphalt shingle roof with wide eaves; a small brick interior roof surface chimney on the rear elevation; stucco over masonry exterior siding with brick siding around the door on the façade; a small projecting hipped-roof porch on the façade; and a carport on the east side elevation. The porch has two square support posts and the floor is a poured concrete slab. The windows have brick sills and most of the original windows have been replaced with non-historic 1/1-light double-hung sash windows. There is a large square-shape three-part picture window to the west side of the doorway on the façade.

**Figure 5.63: Resource 243-0883 (129 Steward Drive) – Oblique view of the facade, facing northwest.**

The resource is not known to be associated with a significant activity or event and there is not a known connection between the resource and any individual whose activities or achievements are historically significant. Therefore, there was no basis for evaluating the resource under Criterion A or B. Also, there are no indications that the resource is likely to yield information on important research questions in history or prehistory. The resource does not appear to have the potential to be the principal source of important information. Therefore, there was no basis for evaluating the resource under Criterion D. The resource does not represent a recognized architectural type or style and does not otherwise appear to represent a significant trend in South Carolina's architectural history. Additionally, due to the replacement of most of the original windows, the integrity of the resource in the areas materials, workmanship, and feeling has been diminished. Therefore, Resource 243-0883 is recommended **Not Eligible** for listing in the NRHP under Criterion C in the area of architecture.

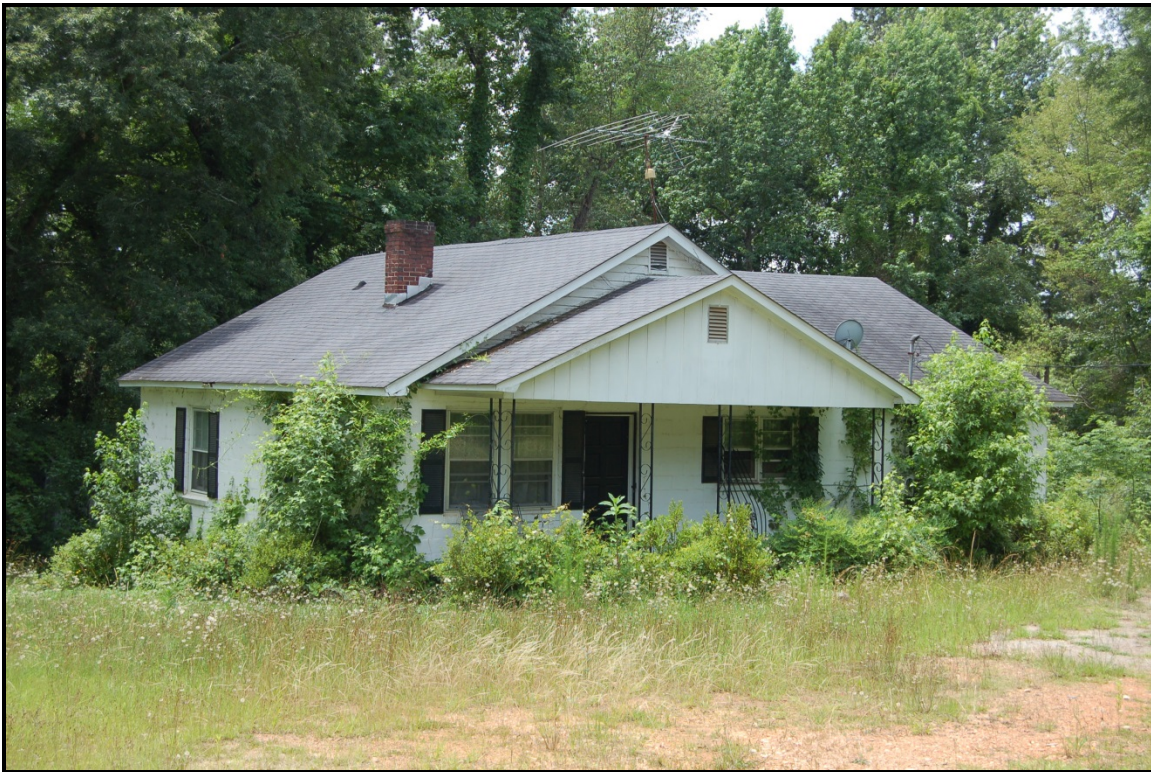
small brick interior roof surface chimney; a partial-width, projecting, gable-roofed porch on the façade with decorative metal posts; and 2/2-light double-hung sash windows.

**Figure 5.64: Resource 243-0884 (130 Steward Drive) – Oblique view of the façade and east side elevation, facing southwest.**

The resource is not known to be associated with a significant activity or event and there is not a known connection between the resource and any individual whose activities or achievements are historically significant. Therefore, there was no basis for evaluating the resource under Criterion A or B. Also, there are no indications that the resource is likely to yield information on important research questions in history or prehistory. The resource does not appear to have the potential to be the principal source of important information. Therefore, there was no basis for evaluating the resource under Criterion D. The resource does not represent a good and representative example of its architectural type and Resource 243-0884 is recommended **Not Eligible** for listing in the NRHP under Criterion C in the area of architecture.

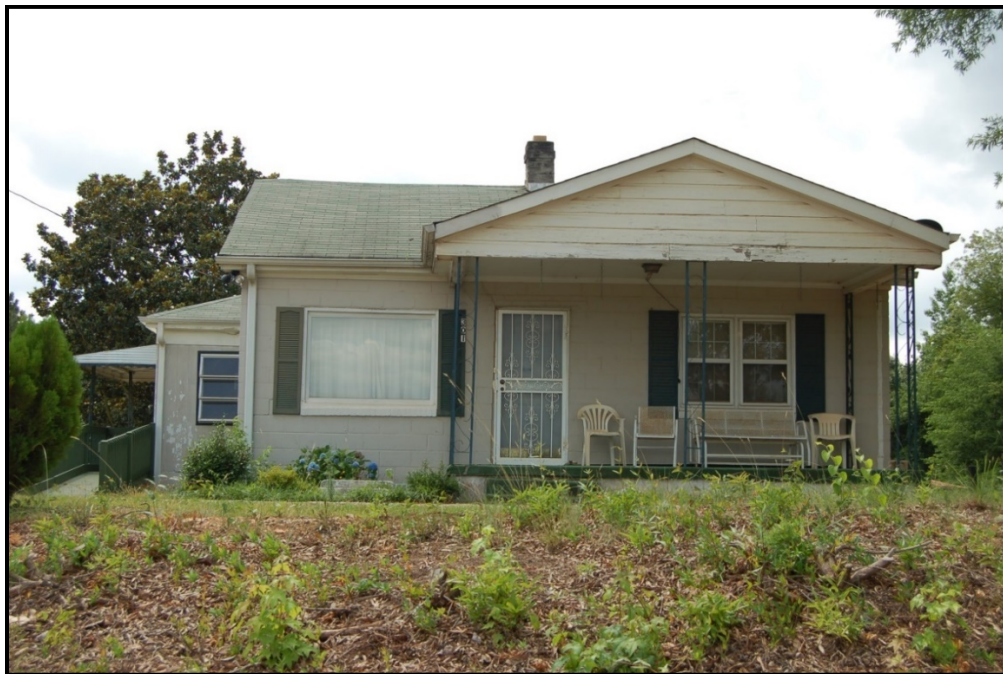
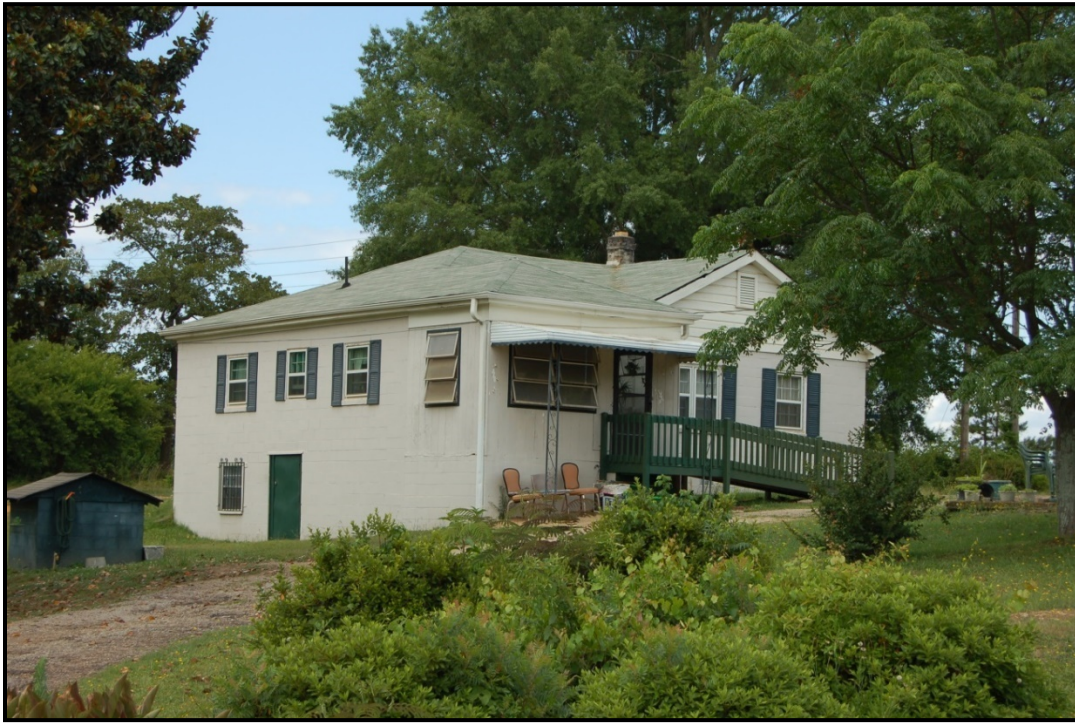
load-bearing wall construction. The house features a complex cross-gable-and-hipped asphalt shingle roof with narrow eaves; concrete block exterior; an interior ridgeline concrete block chimney; a partial-width, projecting, gable-roofed porch on the façade with decorative metal posts on the façade; a metal canopy porch on the east side elevation; and a mix of wood-framed 6/6-light double-hung sash windows and metal-framed 3-light awning windows. Most of the windows have brick sills. The awning windows are located on the walls of an enclosed porch on the east side elevation that has been enclosed with wood panel siding. A large rectangular fixed-light picture window is also located on the façade.

Figure 5.65: Resource 243-0885 (301 Paris Road) – View of the façade, facing south.

Figure 5.66: Resource 243-0885 (301 Paris Road) – Oblique view of the rear and east side elevation, facing northwest.

The resource is not known to be associated with a significant activity or event and there is not a known connection between the resource and any individual whose activities or achievements are historically significant. Therefore, there was no basis for evaluating the resource under Criterion A or B. Also, there are no indications that the resource is likely to yield information on important research questions in history or prehistory. The resource does not appear to have the potential to be the principal source of important information. Therefore, there was no basis for evaluating the resource under Criterion D. The resource does not represent a recognized architectural type or style and does not otherwise appear to represent a significant trend in South Carolina's architectural history. Additionally, due to the enclosure of former porch on the east side elevation, the installation of awning windows into the walls of the enclosed porch, and the addition of a metal canopy porch, the resource has diminished integrity in the areas of design, materials, and workmanship and cannot convey significance in the area of architecture. Therefore, Resource 243-0885 is recommended **Not Eligible** for listing in the NRHP under Criterion C in the area of architecture.
