## A Cultural Resource Survey of the Proposed Improvements to the Carolina Crossroads Corridor

*I-20/26/126 Corridor Project*

*Lexington and Richland Counties, South Carolina*

*Final Report May 2018*

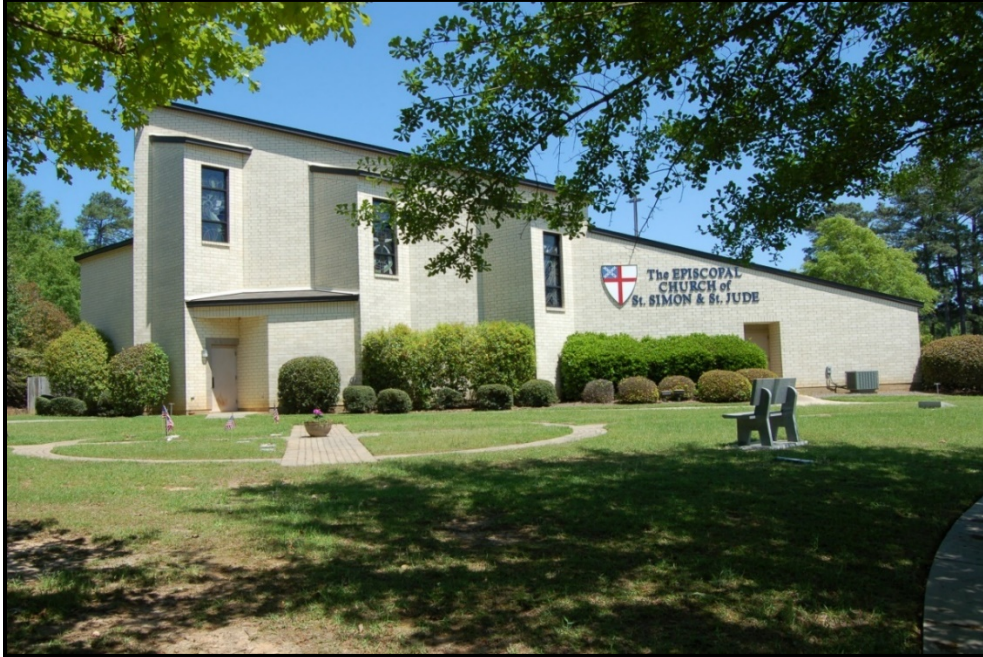
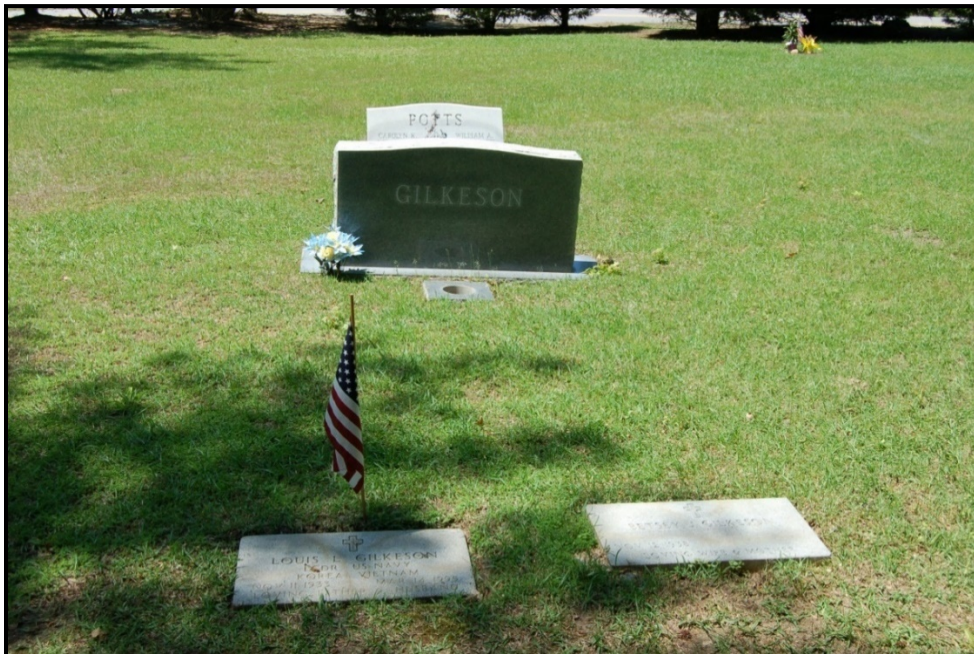
Resource 243-6402 is located at 100 Gaillard Street in the northwest corner of the intersection of Gaillard Street and Evergreen Drive partially within the city limits of Irmo in Richland County (refer to Figure 5.1A). The resource is a non-historic cemetery located on the campus of the Episcopal Church of St. Simon and St. Jude. The Richland County Assessor's record has a 1989 date of construction for the church building. The small number of monuments within the cemetery (less than a dozen were observed during the field survey) date from the early 1990s to the present. The monuments are widely dispersed in a grassed and wooded portion of the church campus on a separate legal parcel from that upon which the church building is located. There is no evident organizational plan in the siting of the interments, no walkways, no fences or ornamental vegetation in the area of the burials. The monuments are limited to headstone and lawn types. An ash garden organized in a Celtic cross design plan is located adjacent to the south elevation of the church building.

Figure 5.67: Resource 243-6402 (1110 Kinley Road) – View of non-historic church and in-ground cremains burial area, facing northeast.

Figure 5.68: Resource 243-6402 (100 Gaillard Street) – Representative view of non-historic cemetery monuments, facing northwest.

243-6402 is recommended **Not Eligible** for listing in the NRHP under Criterion C in the areas of architecture or landscape architecture.

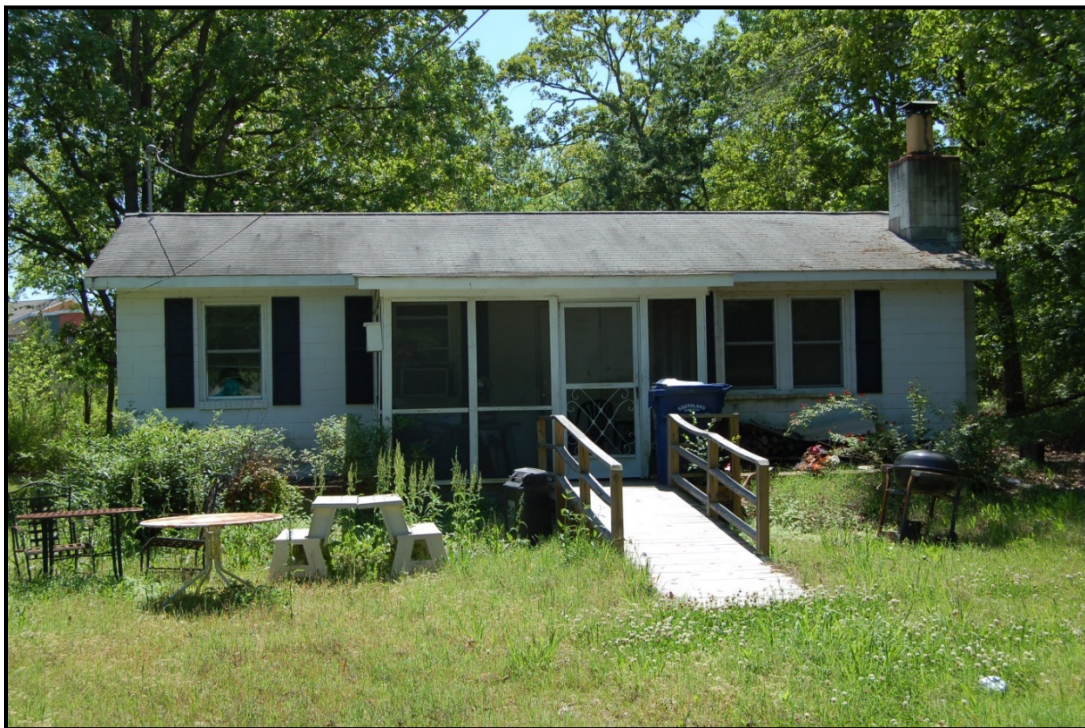
Resource 243-6403 is located at 37 Bluebird Trail on the west side of the roadway approximately 570 feet northwest of the intersection of Bluebird Trail and Columbiana Drive in Irmo in Richland County (refer to Figure 5.1A). The Richland County Assessor's record has a 1940 date of construction for the resource. Based on a review of historic aerial photography and topographic maps, and an evaluation of the resource's form and construction materials, this date of construction is considered reliable. The resource is a one-story, asymmetric, side-gabled residence of concrete block load-bearing wall construction. The house features a side-gabled asphalt shingle; concrete block exterior; a large concrete block exterior end wall chimney on the west side elevation; a small partial-width shed-roofed screened porch on the façade; and 1/1-light double-hung sash windows. The windows have brick sills.

Figure 5.69: Resource 243-6403 (37 Bluebird Trail) – View of the façade, facing southwest.

The resource is not known to be associated with a significant activity or event and there is not a known connection between the resource and any individual whose activities or achievements are historically significant. Therefore, there was no basis for evaluating the resource under Criterion A or B. Also, there are no indications that the resource is likely to yield information on important research questions in history or prehistory. The resource does not appear to have the potential to be the principal source of important information. Therefore, there was no basis for evaluating the resource under Criterion D. The resource does not represent a recognized architectural type or style and does not otherwise appear to represent a significant trend in South Carolina's architectural history. Therefore, Resource 243-6403 is recommended **Not Eligible** for listing in the NRHP under Criterion C in the area of architecture.

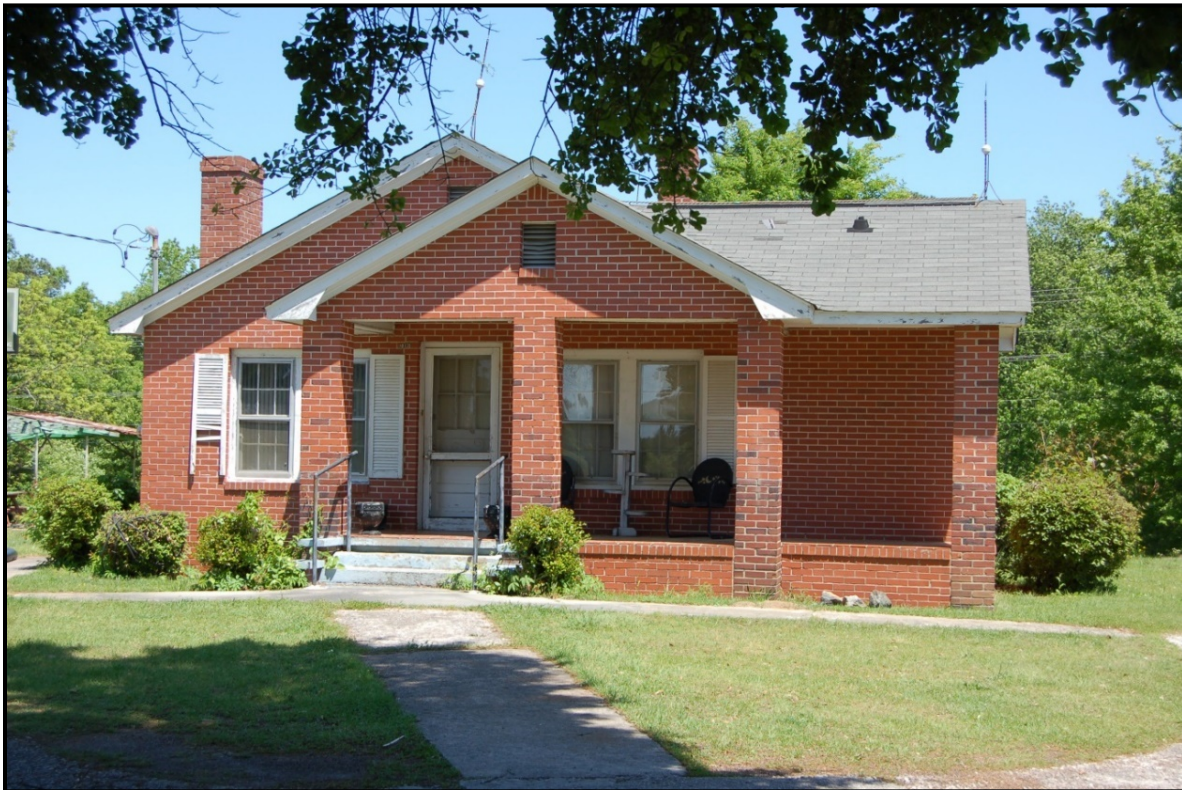
Resource 243-6404 is located at 1013 North Wingard Road in the southwest corner of the intersection of Wingard Road and Western Lane outside the city limits of Irmo in Richland County (refer to Figure 5.1A). The Richland County Assessor's record has a 1940 date of construction for the resource. Based on a review of historic aerial photography and topographic maps, and an evaluation of the resource's form and construction materials, this date of construction is considered reliable. The resource is a one-story, asymmetric, front-gabled bungalow without stylistic features. The house features a cross-gabled asphalt shingle roof with narrow eaves; running bond brick exterior siding; a massive brick exterior chimney on the north side elevation and a small interior roof surface brick chimney on the south side; a partial-width, extended and integral porch on the façade with four massive brick columns; and a mix of 6/6-light double-hung sash, 2/2-light double-hung sash, and 2-light awning windows.

Figure 5.70: Resource 243-6404 (1013 North Wingard Road) – View of the façade, facing northeast.

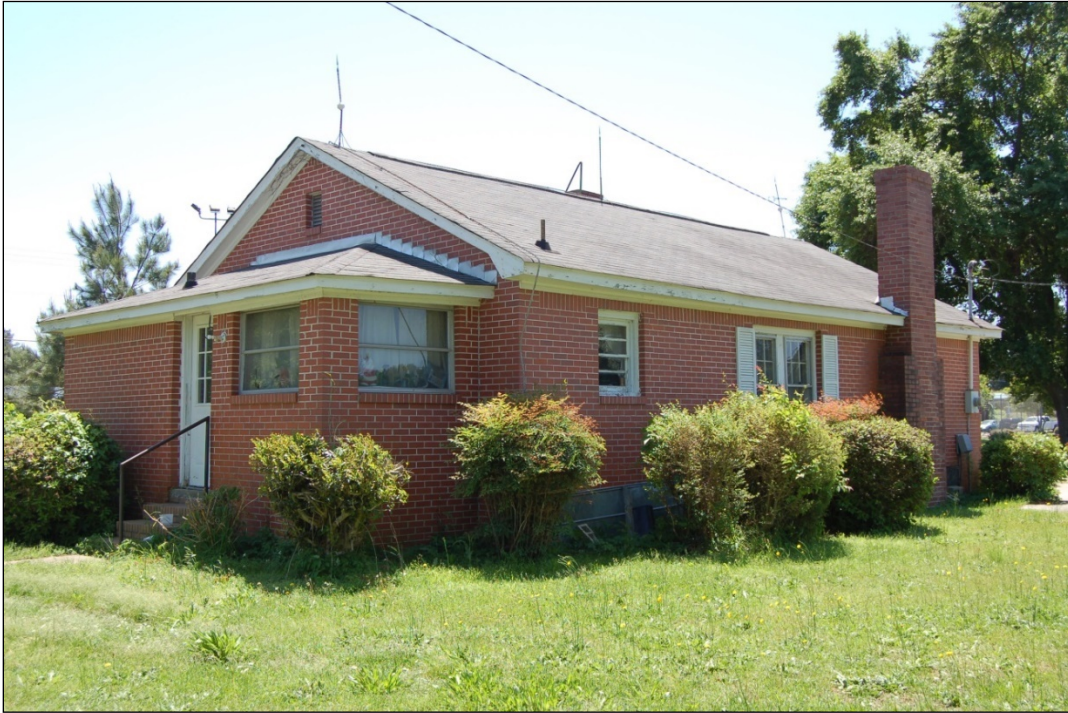
**Figure 5.71: Resource 243-6404 (1013 North Wingard Road) – Oblique view of the rear and west side elevation, facing south.**

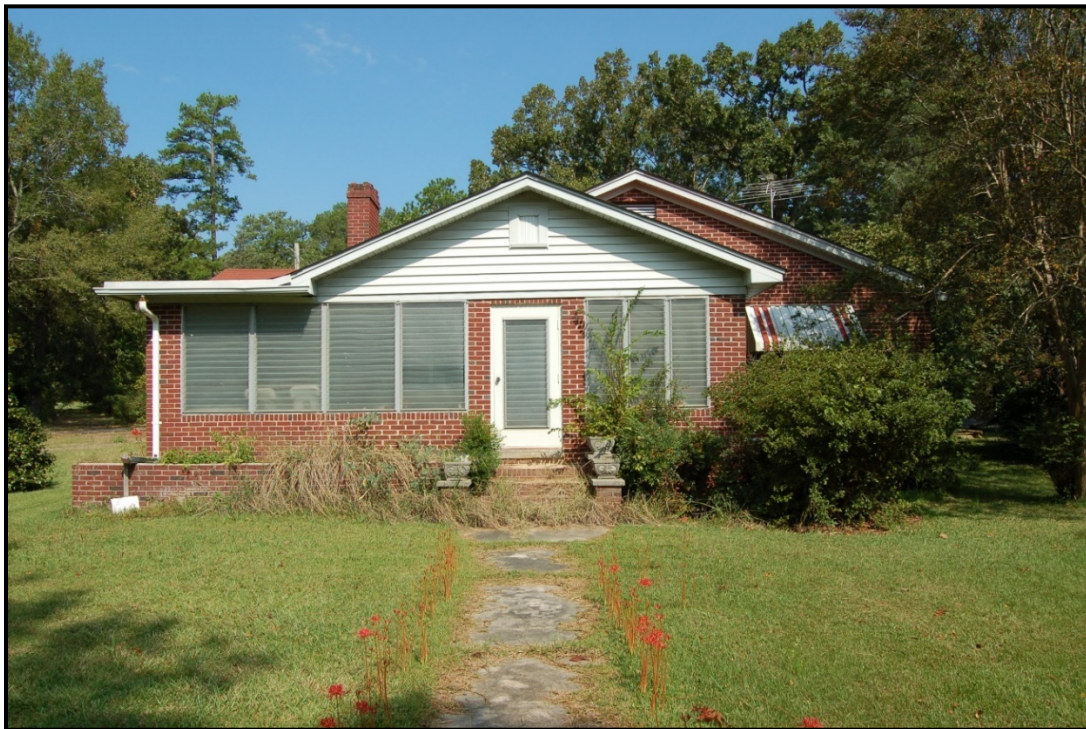
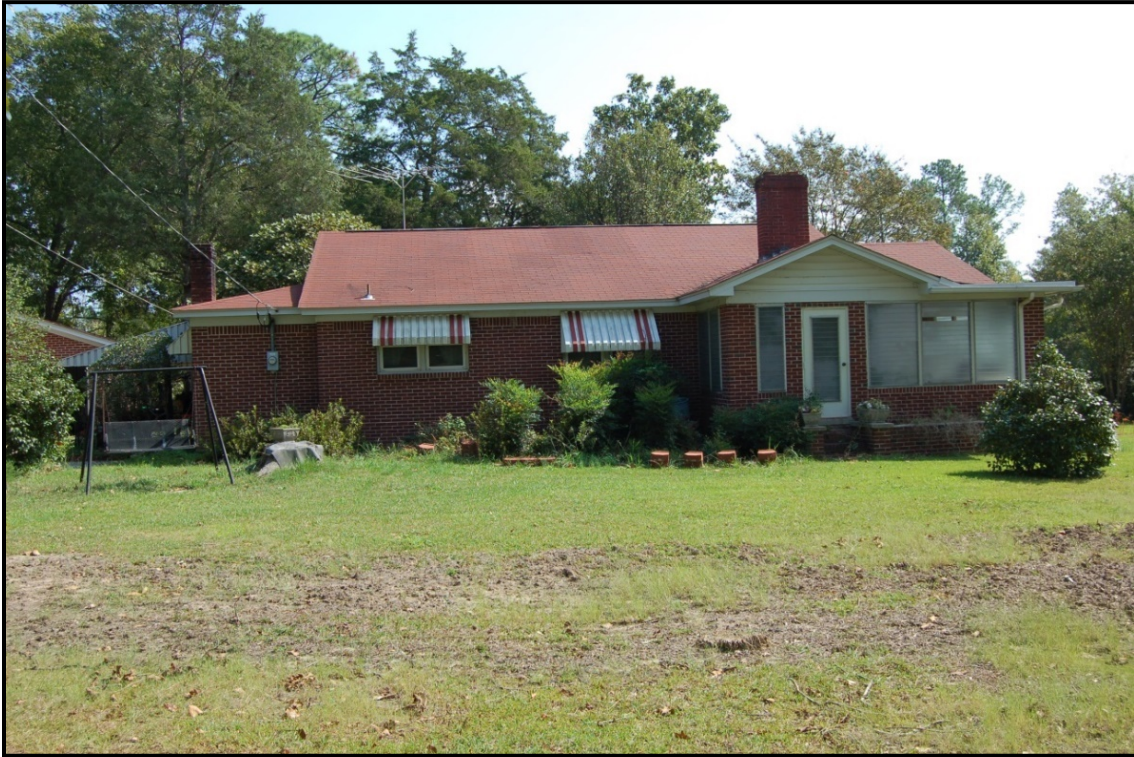
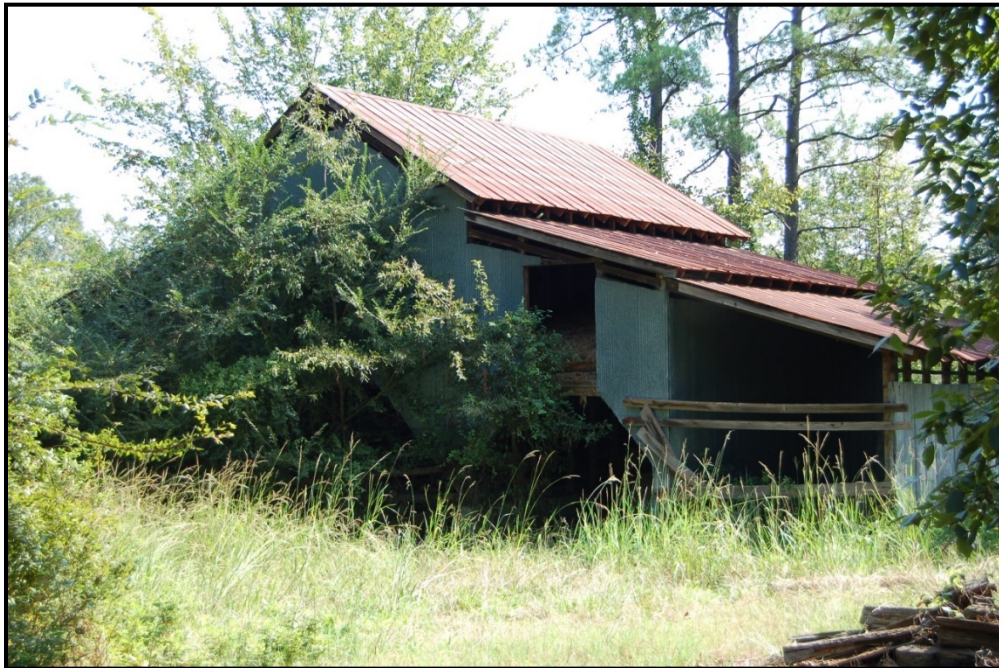
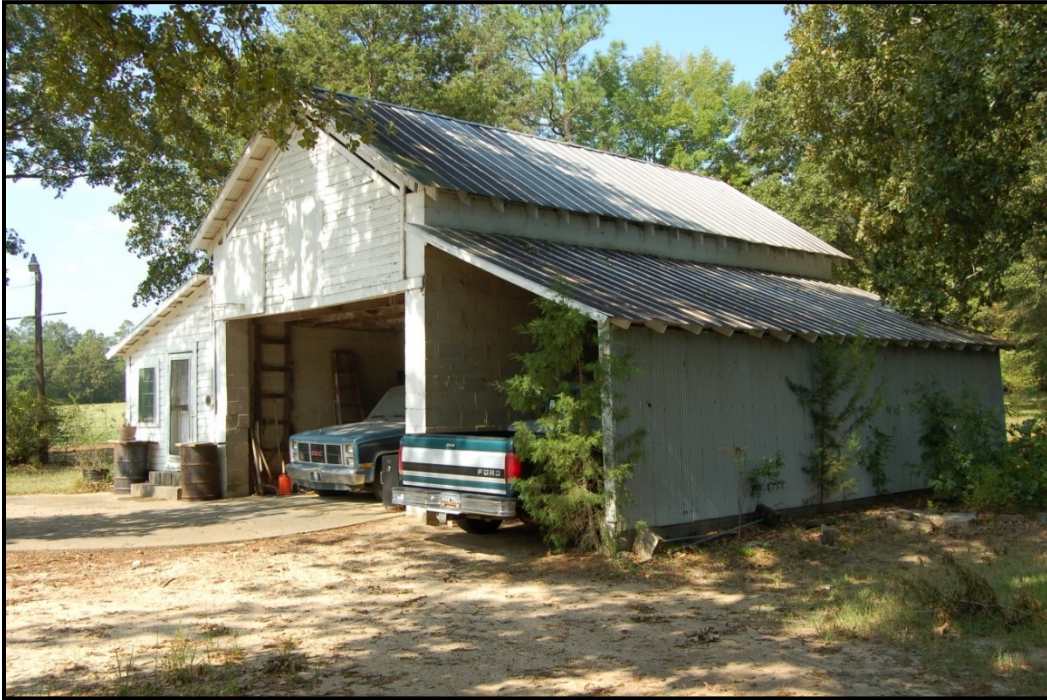
enclosed wrap-around porch on the façade and the south end of the west side elevation; and 1/1-light double-hung sash windows. Each of the windows has a metal canopy awning. The enclosed porch has several bays of jalousie windows. The barn is obscured with vegetation, but appears to be a three-portal type of wood frame construction with a tall gabled roof and lower stepped shed roofs on each side. The roof and exterior siding are both metal sheet. A second substantial outbuilding is of similar size and design to the barn, but the inner walls are of concrete block construction and the outer walls are a mix of drop wood and metal sheet.

Figure 5.72: Resource 243-6467 (200 Roof Lowman Road) – View of the façade, facing north.

Figure 5.73: Resource 243-6467 (200 Roof Lowman Road) – View of the west side elevation, facing east.

Figure 5.74: Resource 243-6467.01 (200 Roof Lowman Road) – View of barn associated with resource, facing east.

**Figure 5.75: Resource 243-6467.02 (200 Roof Lowman Road) – View of outbuilding associated with the resource, facing northwest.**

The resource is not known to be associated with a significant activity or event and there is not a known connection between the resource and any individual whose activities or achievements are historically significant. Therefore, there was no basis for evaluating the resource under Criterion A or B. Also, there are no indications that the resource is likely to yield information on important research questions in history or prehistory. The resource does not appear to have the potential to be the principal source of important information. Therefore, there was no basis for evaluating the resource under Criterion D. The house and outbuildings are late and undistinguished examples of their architectural types and do not otherwise appear to represent a significant trend in South Carolina's architectural history. Therefore, Resource 243-6467 is recommended **Not Eligible** for listing in the NRHP under Criterion C in the area of architecture.

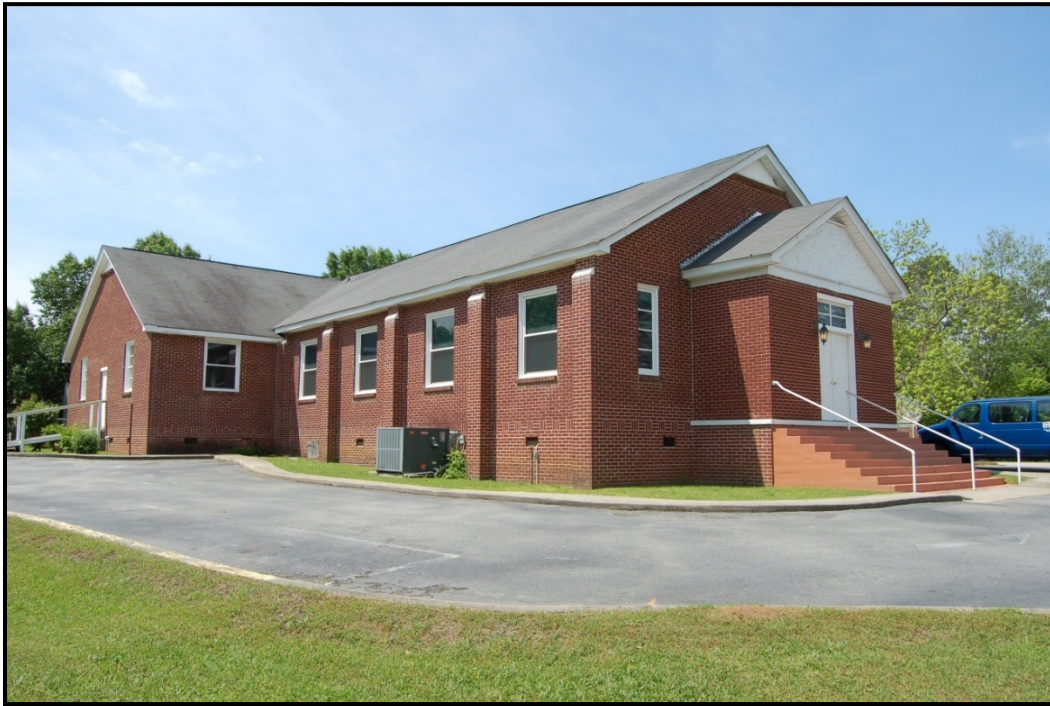
the houses have brick chimneys and are plain without stylistic features. Roof forms are side-gabled, cross-gabled, and complex. The church located within the subdivision is front-gabled with a projecting gabled entry foyer with double-leaf wood doors and a large multi-light transom. The church has running bond brick exterior, ornamental buttresses on the east and west side elevations, and 1/1-light double-hung sash vinyl replacement windows.

**Figure 5.79: Resource 106-6405.03 (Cherokee Gardens Subdivision) – View of the church located at 216 Stucawa Drive, facing southwest.**

The resource is not known to be associated with a significant activity or event and there is not a known connection between the resource and any individual whose activities or achievements are historically significant. Therefore, there was no basis for evaluating the resource under Criterion A or B. Also, there are no indications that the resource is likely to yield information on important research questions in history or prehistory. The resource does not appear to have the potential to be the principal source of important information. Therefore, there was no basis for evaluating the resource under Criterion D. The residences and church in the subdivision are undistinguished examples of common architectural building types and there is inconsistency in lot size, building size, and building orientation within the subdivision. Therefore, Resource 106-6405 is recommended **Not Eligible** for listing in the NRHP under Criteria A and C in the areas of community planning and development, architecture, and landscape architecture.

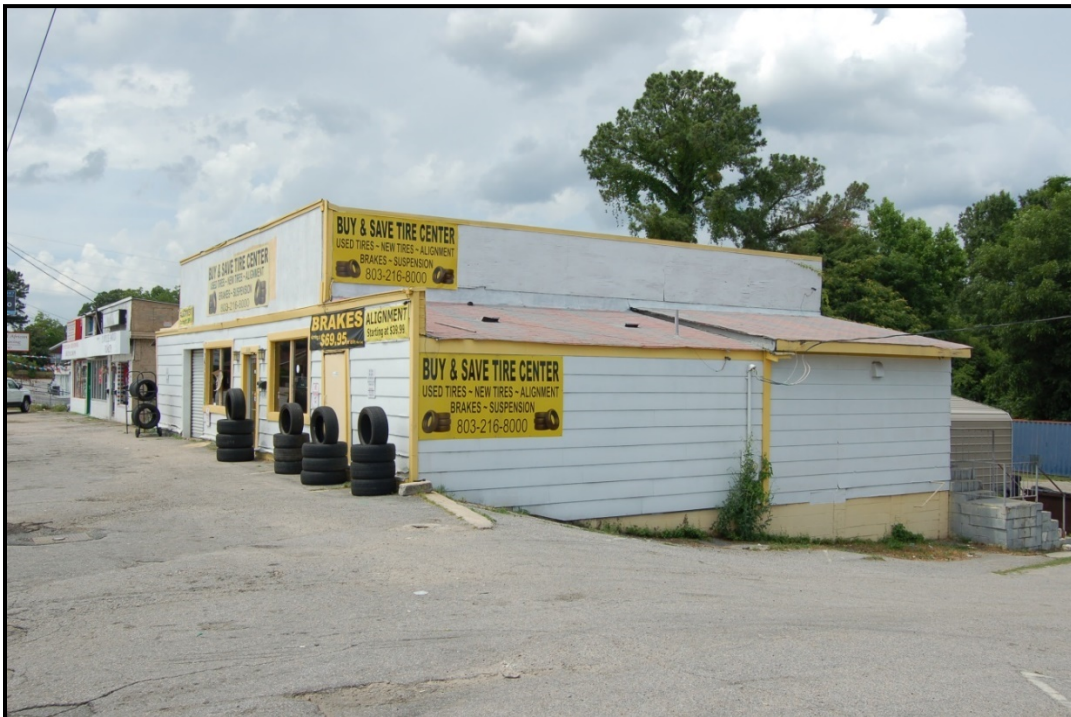
**Figure 5.81: Resource 106-6406 (2420 Broad River Road) – Oblique view of the façade and south side elevation, facing northeast.**

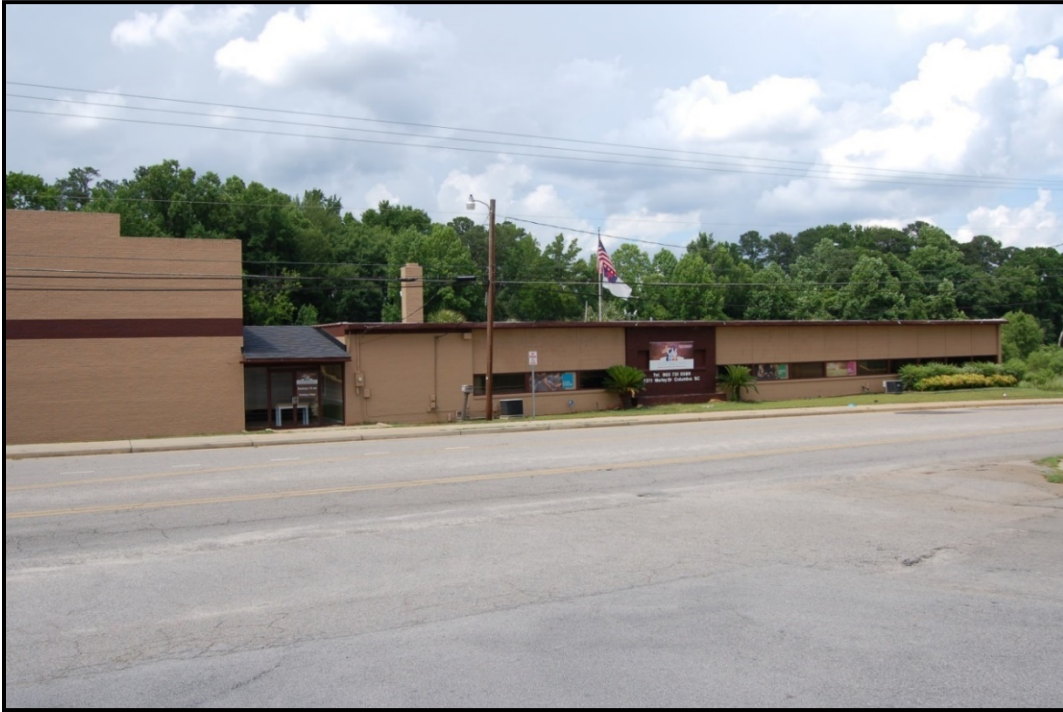
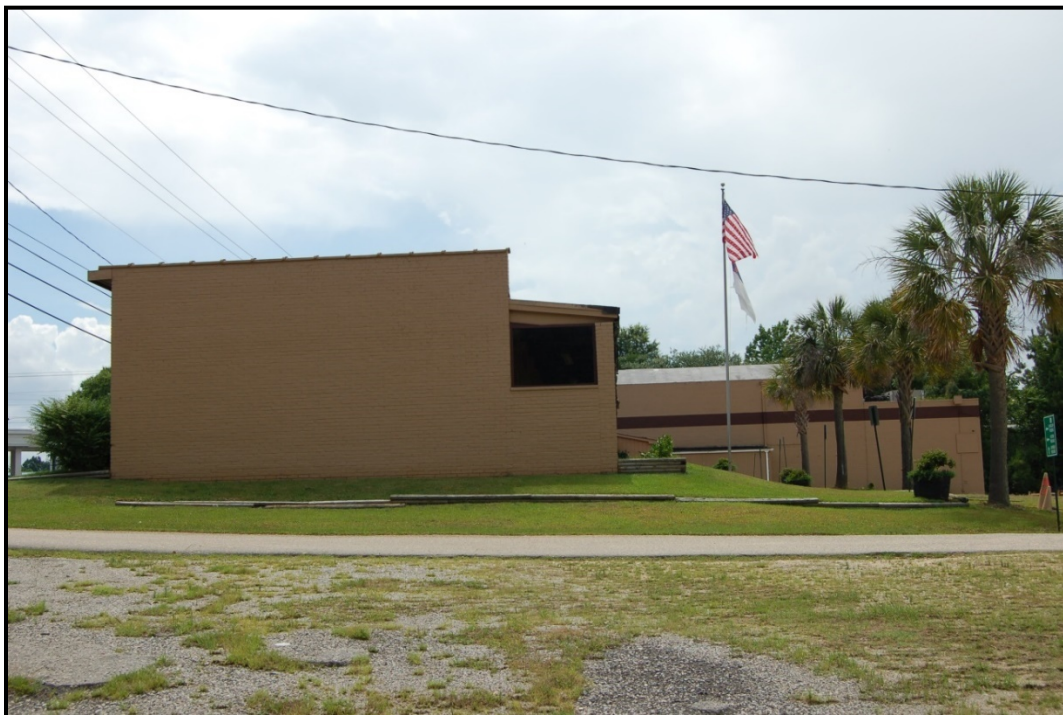
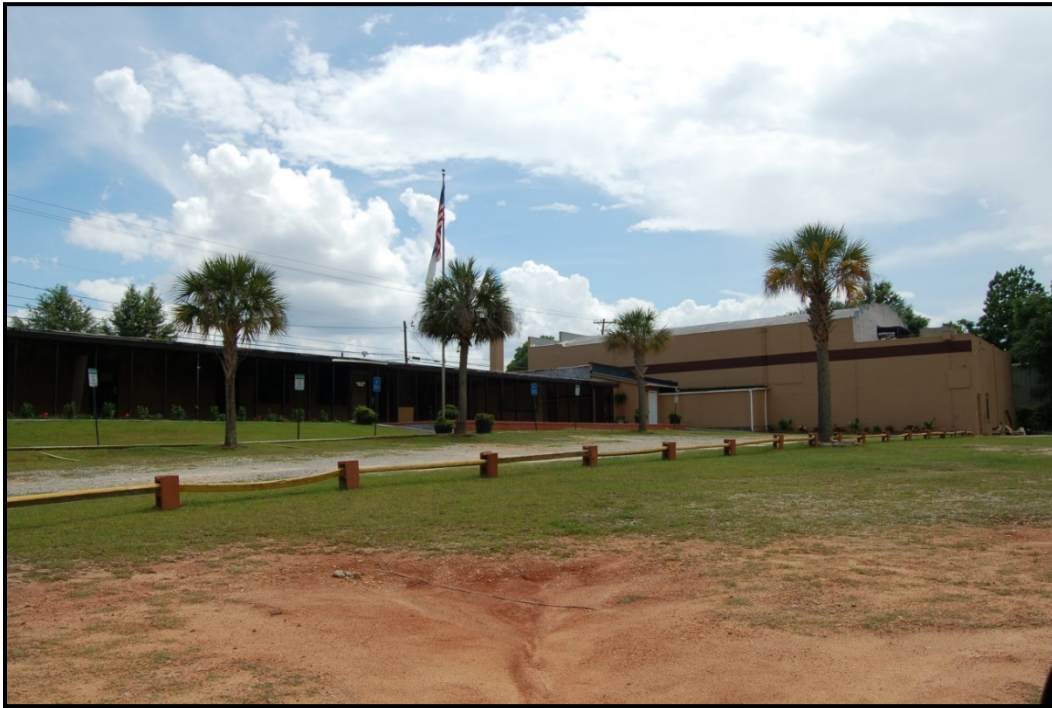
Figure 5.82: Resource 106-6407 (1311 Marley Drive) – View of the façade, facing north.

Figure 5.83: Resource 106-6407 (1311 Marley Drive) – View of the east side elevation, facing west.

**Figure 5.84: Resource 106-6407 (1311 Marley Drive) – Oblique view of the rear elevation, facing southwest.**

The resource is not known to be associated with a significant activity or event and there is not a known connection between the resource and any individual whose activities or achievements are historically significant. The resource was a parochial school. It was not a Richland County public and it was not an Equalization School. Therefore, there was no basis for evaluating the resource under Criterion A or B. Also, there are no indications that the resource is likely to yield information on important research questions in history or prehistory. The resource does not appear to have the potential to be the principal source of important information. Therefore, there was no basis for evaluating the resource under Criterion D. The integrity of the resource has been diminished in the areas of design, materials, workmanship and feeling. The size of the original window openings on the façade has been significantly reduced by the installation of masonry on the upper third of the original window openings and the connecting hallway between the original separate buildings and the full-width addition on the rear elevation have been constructed with materials that are incompatible with the original masonry. Because of the diminished integrity in the areas of design, materials, workmanship, and feeling the resource cannot convey significance in the area of architecture. Therefore, Resource 106-6407 is recommended Not Eligible for listing in the NRHP under Criterion C in the area of architecture.
