## 3. Existing Conditions and Environmental Consequences

### 3.10 Cultural Resources

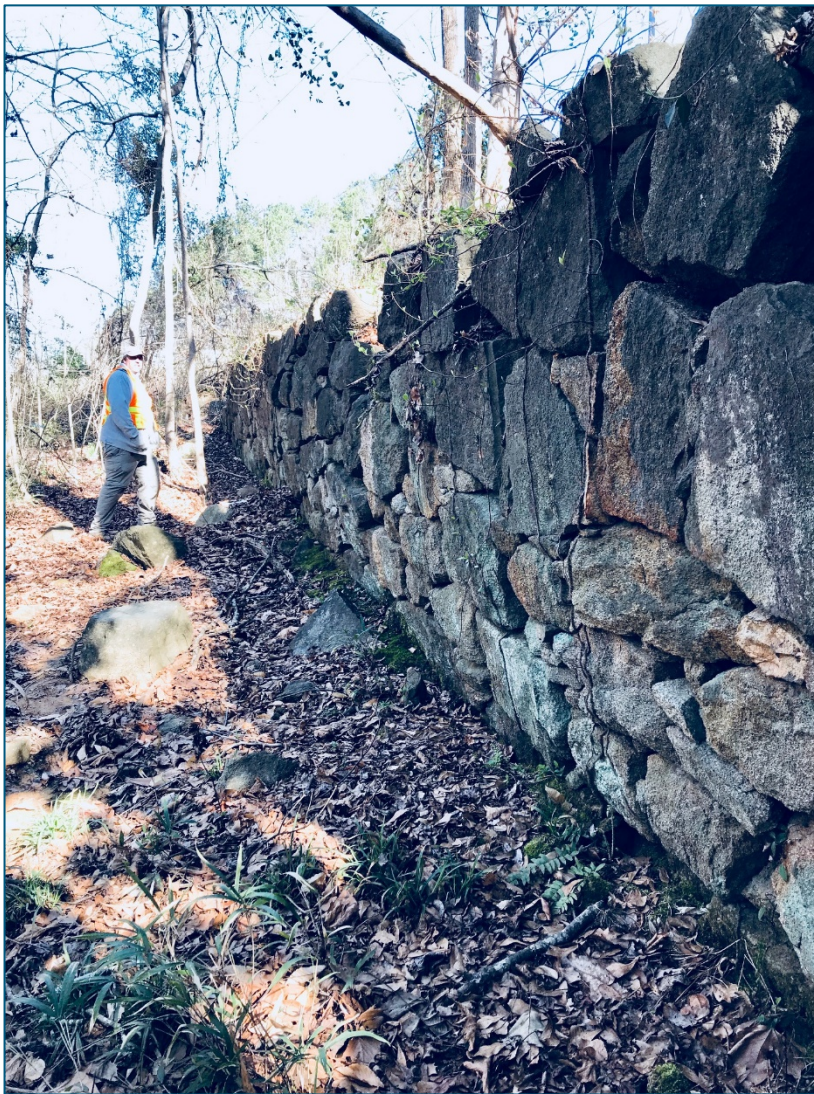
The newly documented canal segments within the project area are similar in appearance to the segments documented in 1972 by Ryan within the Columbia Zoological Park, but in general somewhat narrow and deeper, averaging around five meters (16.4 feet) wide and one or one and a half meters (3.28 or 4.92 feet) deep. In the northwestern portion of the canal, which was excavated through a granite outcropping, sheared or cleaved stone is found in many sections of the canal walls. Some of these rocks retain the remnants of the small circular holes drilled in the stones to fracture or dislodge them through the use of chisels or explosives. Much of the canal in the project area also serves as a creek bed at this time, as water flows from a drainage pipe into the canal near its northwestern end, eventually emptying into the Saluda River through a blowout in the canal wall. The only substantive feature noted within the present project area was a stone wall stretching for approximately 46

**Figure 3.10-1 Typical view of the Saluda Canal, facing west**

meters (150 feet) parallel to and in between the canal bed and the river, immediately adjacent to the Three Rivers Greenway. The function of this wall and its exact relation to the canal is unclear, but it may have been a “guard wall” designed to protect the head of the canal from washout during flood events. Figures 3.10-1 and 3.10-2 present views of the Saluda Canal.

Although the canal has been impacted by the development of the railroad and highway systems of Columbia, it is still a recognizable landscape feature associated with the Saluda Canal system. As such, the resource was recorded as a revisit to Site 38RD59, the boundaries of which were amended to include the newly observed sections of the Saluda Canal and its presumed location in areas that have been subjected to modern disturbance. The canal was also evaluated for NRHP inclusion. The Cultural Resources Survey Report (Appendix M) provides a complete NRHP evaluation of the resource. The Saluda Canal is recommended eligible for inclusion in the NRHP under Criteria A, C, and D in the areas of commerce, engineering, and

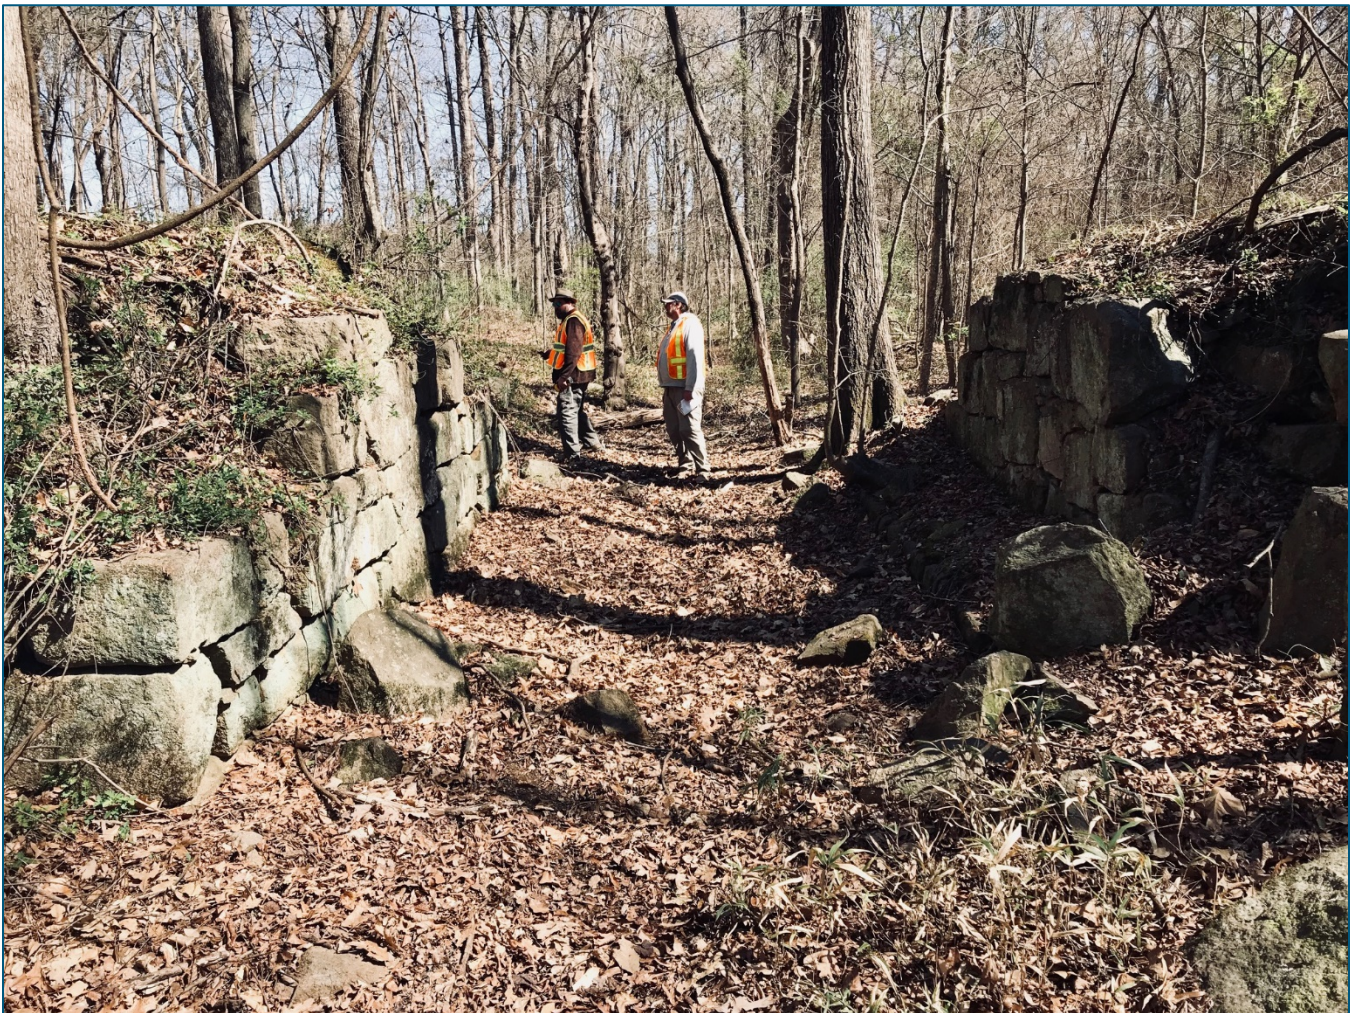
Figure 3.10-2 Typical view of the Saluda Canal, facing east.

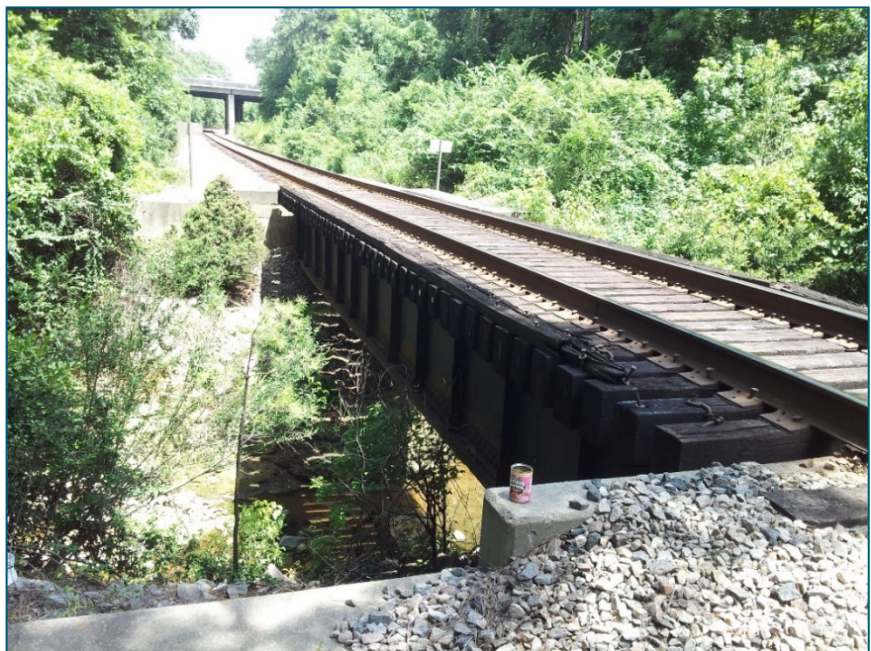
**Site 38RD277** consists of a railroad trestle that was recorded over an unnamed tributary of the Saluda River just north of the I-26 Bridge over the Saluda River. Because it was originally recorded as an archaeological site it was addressed during the archaeological portion of this investigation. The trestle was recorded in 1982, but no formal NRHP evaluation was given for the structure.<sup>23</sup> As a result of the revisit during the present investigation, it is clear that the trestle recorded as 38RD277 is no longer present at this location. The resource was described as a substantial brick structure built

Figure 3.10-3 View of Site 38RD277, facing east

over the unnamed creek.<sup>24</sup> Currently, the trestle at this location is made of a steel span with a wood plank floor atop a poured concrete frame. Based on this, it is clear that the resource originally recorded as 38RD277 has been destroyed and no further archaeological or historic architectural documentation is necessary. Figure 3.10-3 presents a view of Site 38RD277.
