Natural Resources Technical Report

Carolina Crossroads

I-20/I-26/I-126 Corridor Improvements

Final (Revised) May 2019

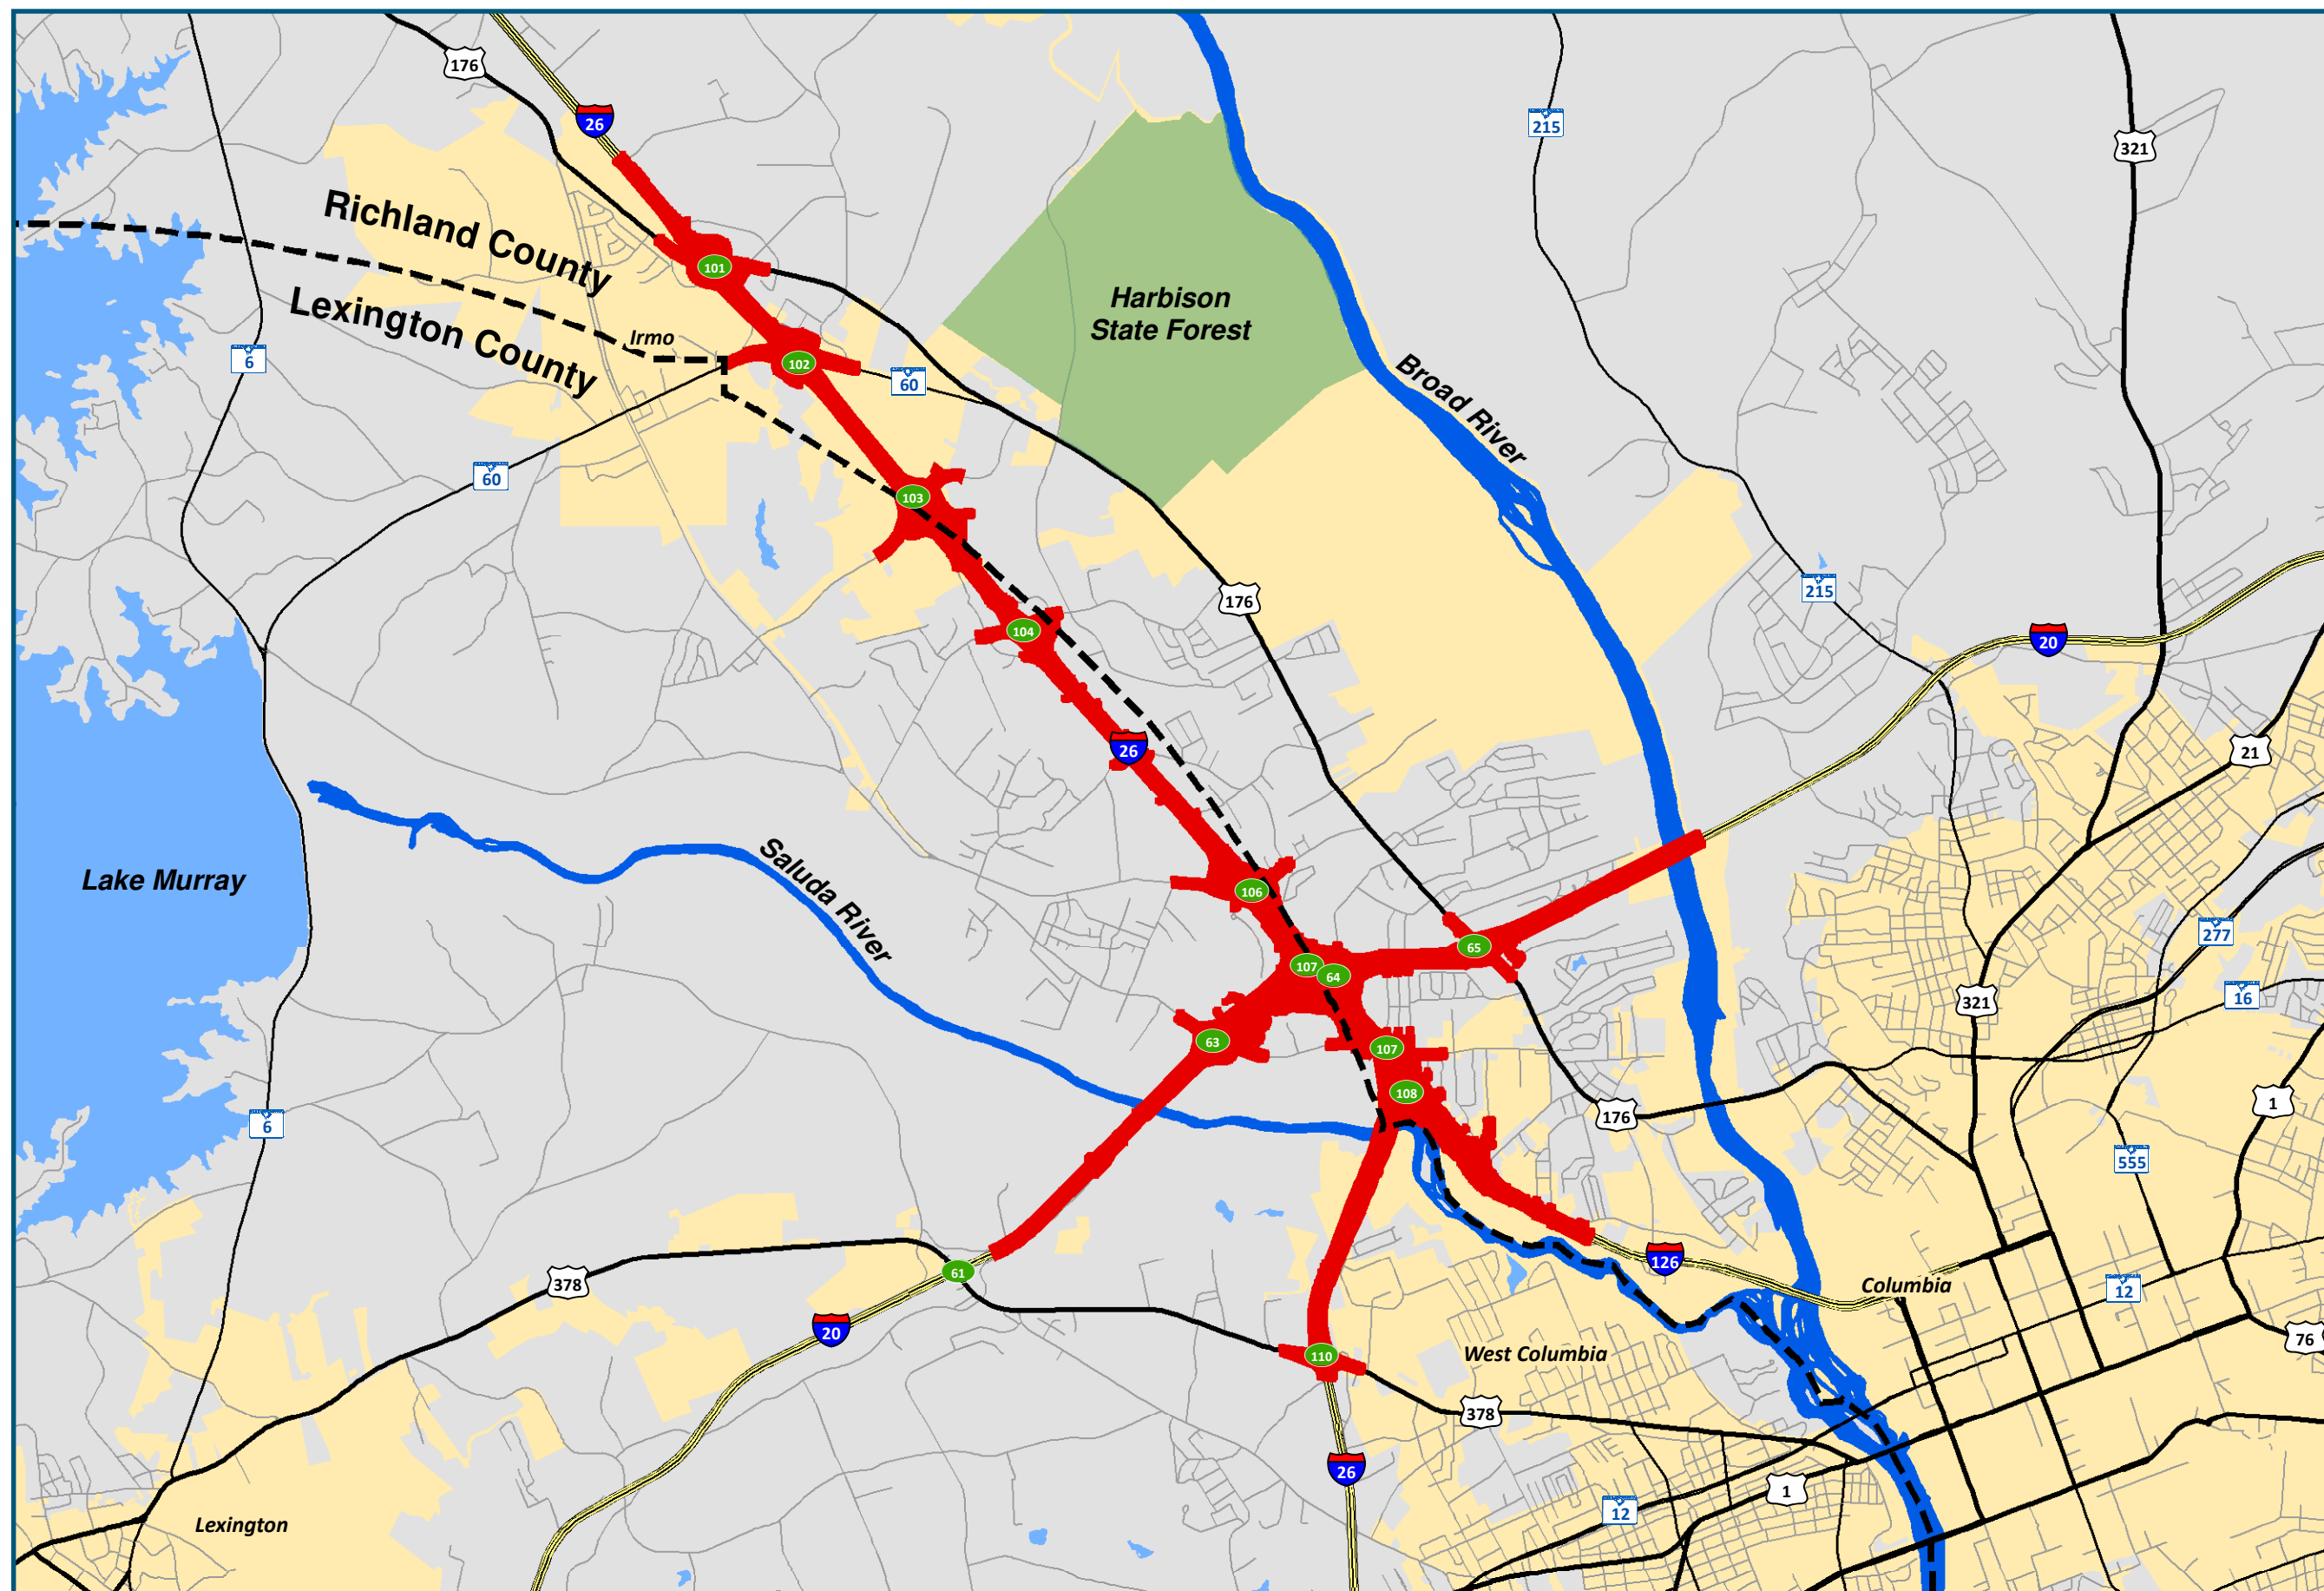
Figure 1
Site Location Map

The proposed project is a transportation corridor improvement located in Lexington and Richland Counties, South Carolina. To date, the project study area (PSA) has been defined as a mainline corridor including I-20 from US 378 (Sunset Boulevard) to the Broad River, I-26 from US 176 (Broad River Road) to Sunset Boulevard, and I-126 from I-26 to Stone Ridge Drive. Furthermore, the PSA extends approximately 100-150 feet beyond the existing SCDOT right-of-way limits within the mainline corridor for a total of approximately 1,482 acres; please see **Appendix A, Figure 1** for a Site Location Map.

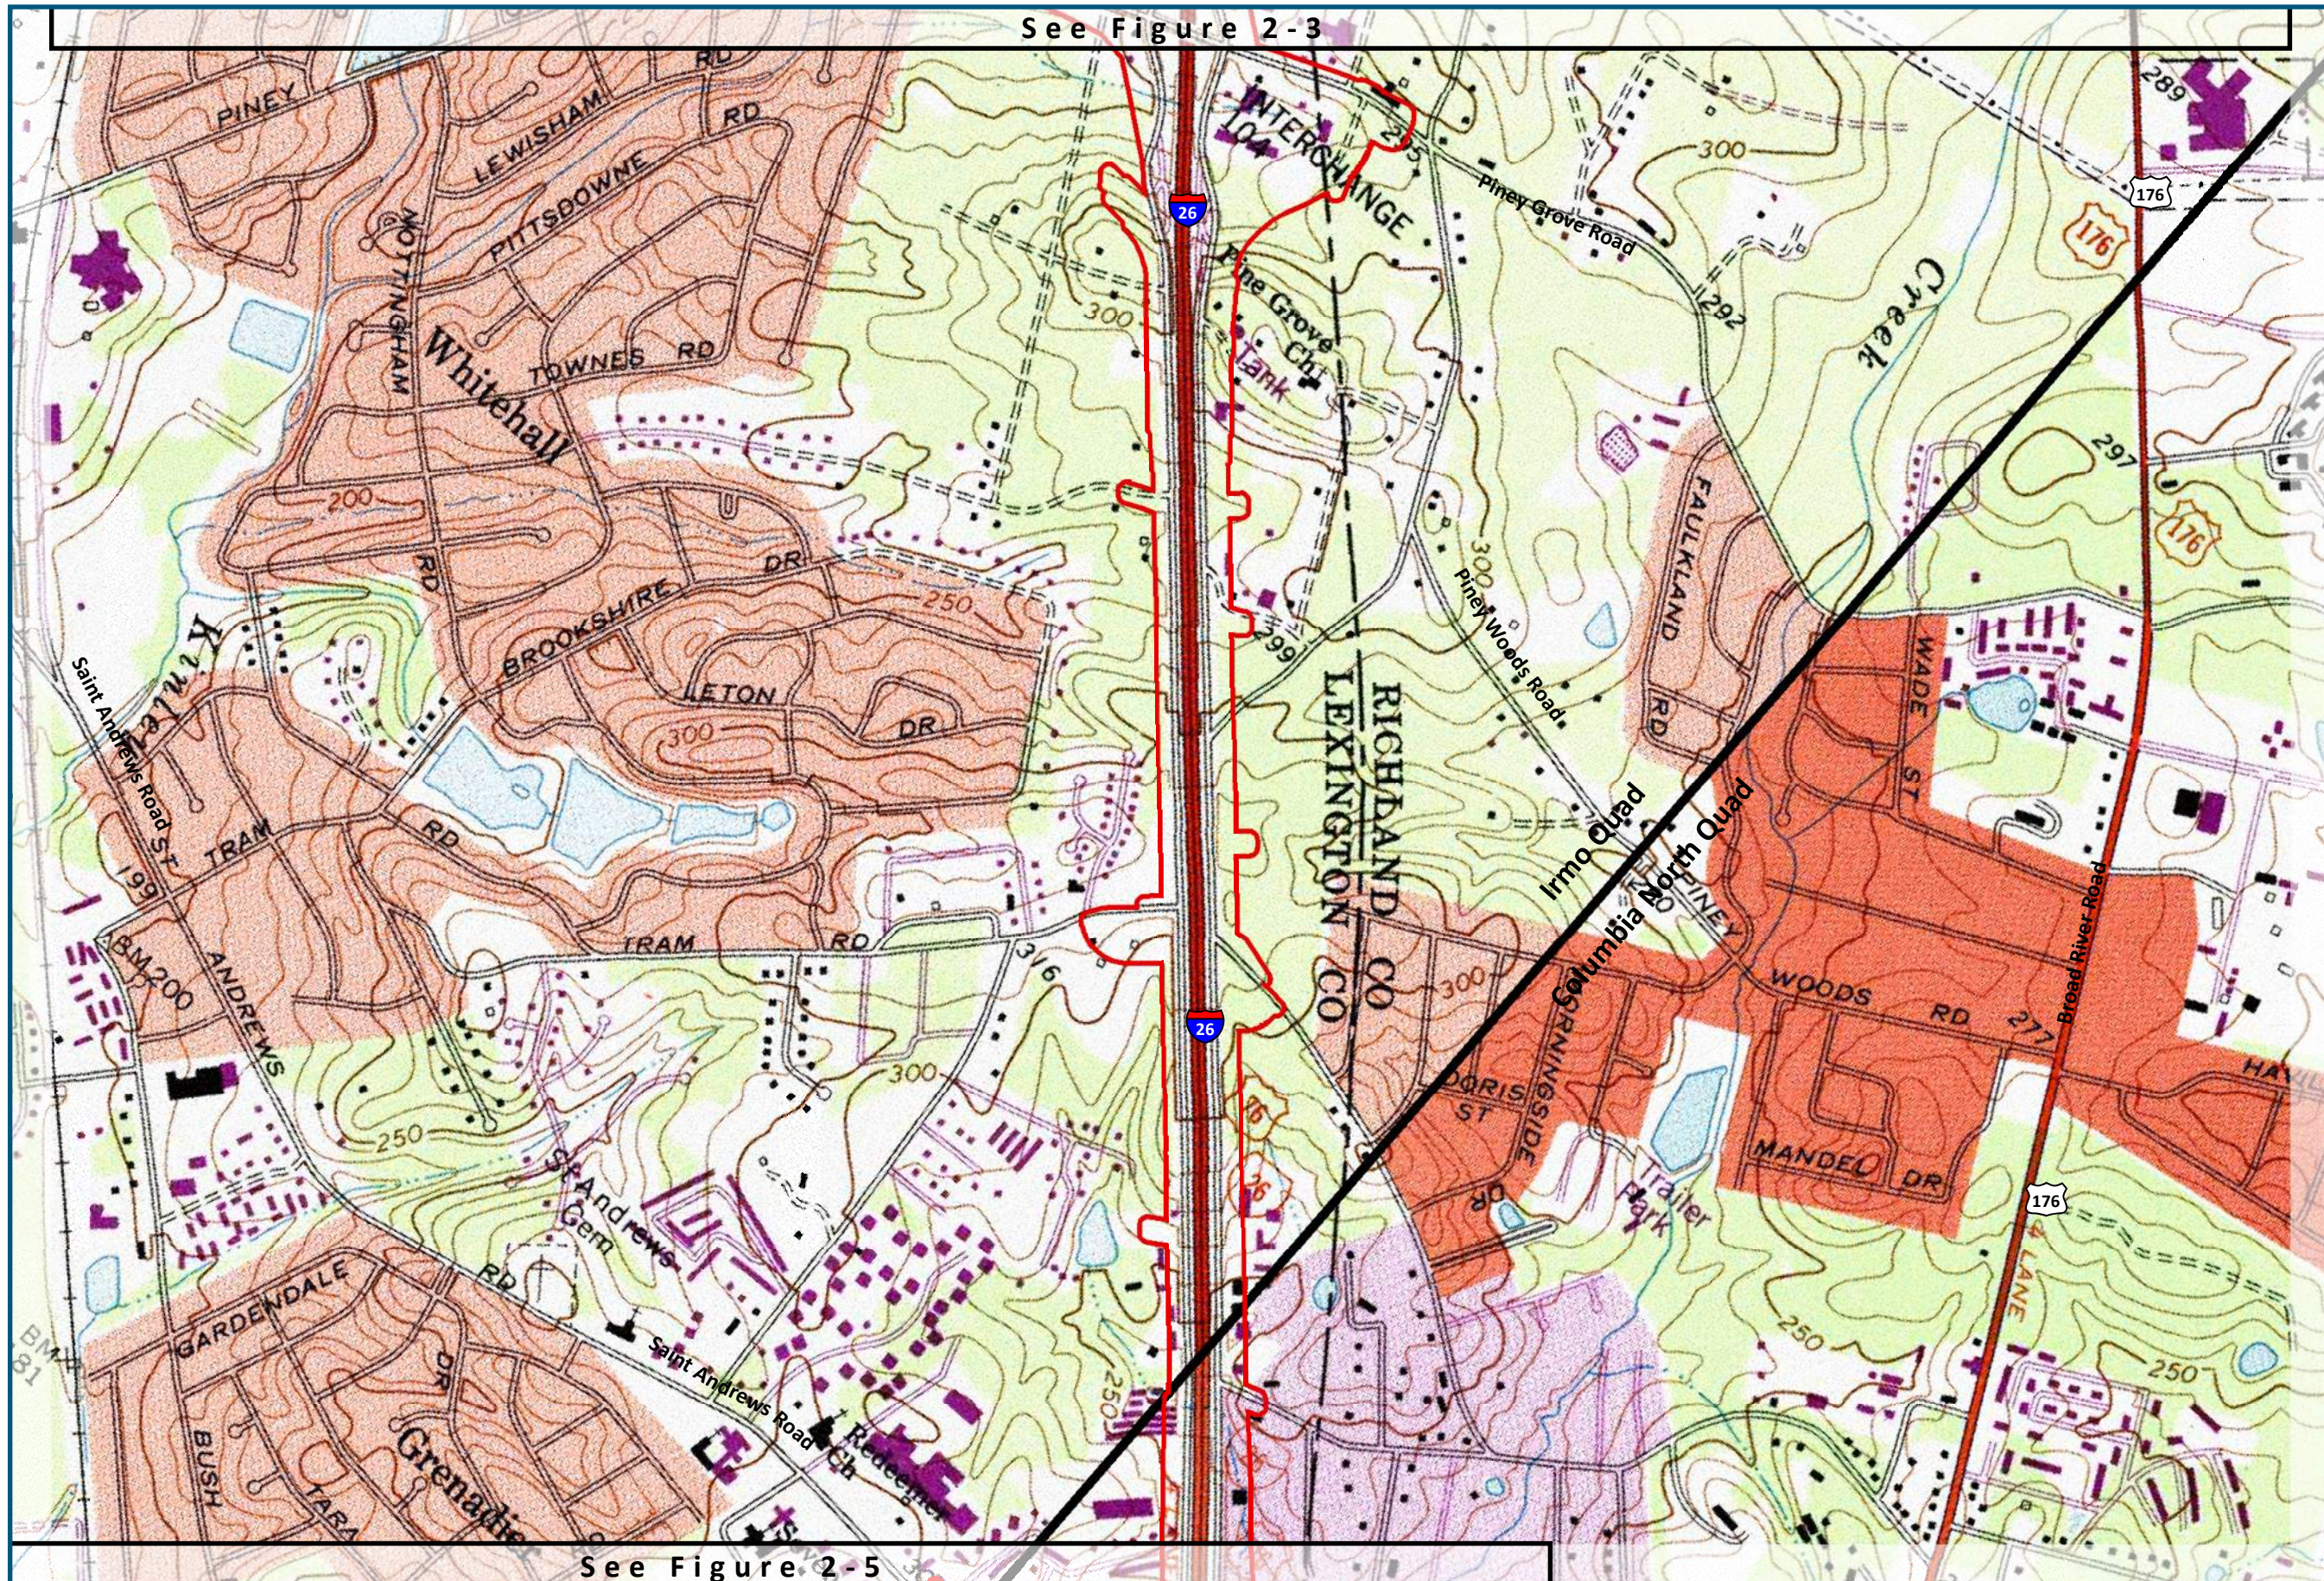
Figure 2-4
USGS Topography Map

- Legend**
- Project Study Area (1,482 acres)
 - USGS Quad Index

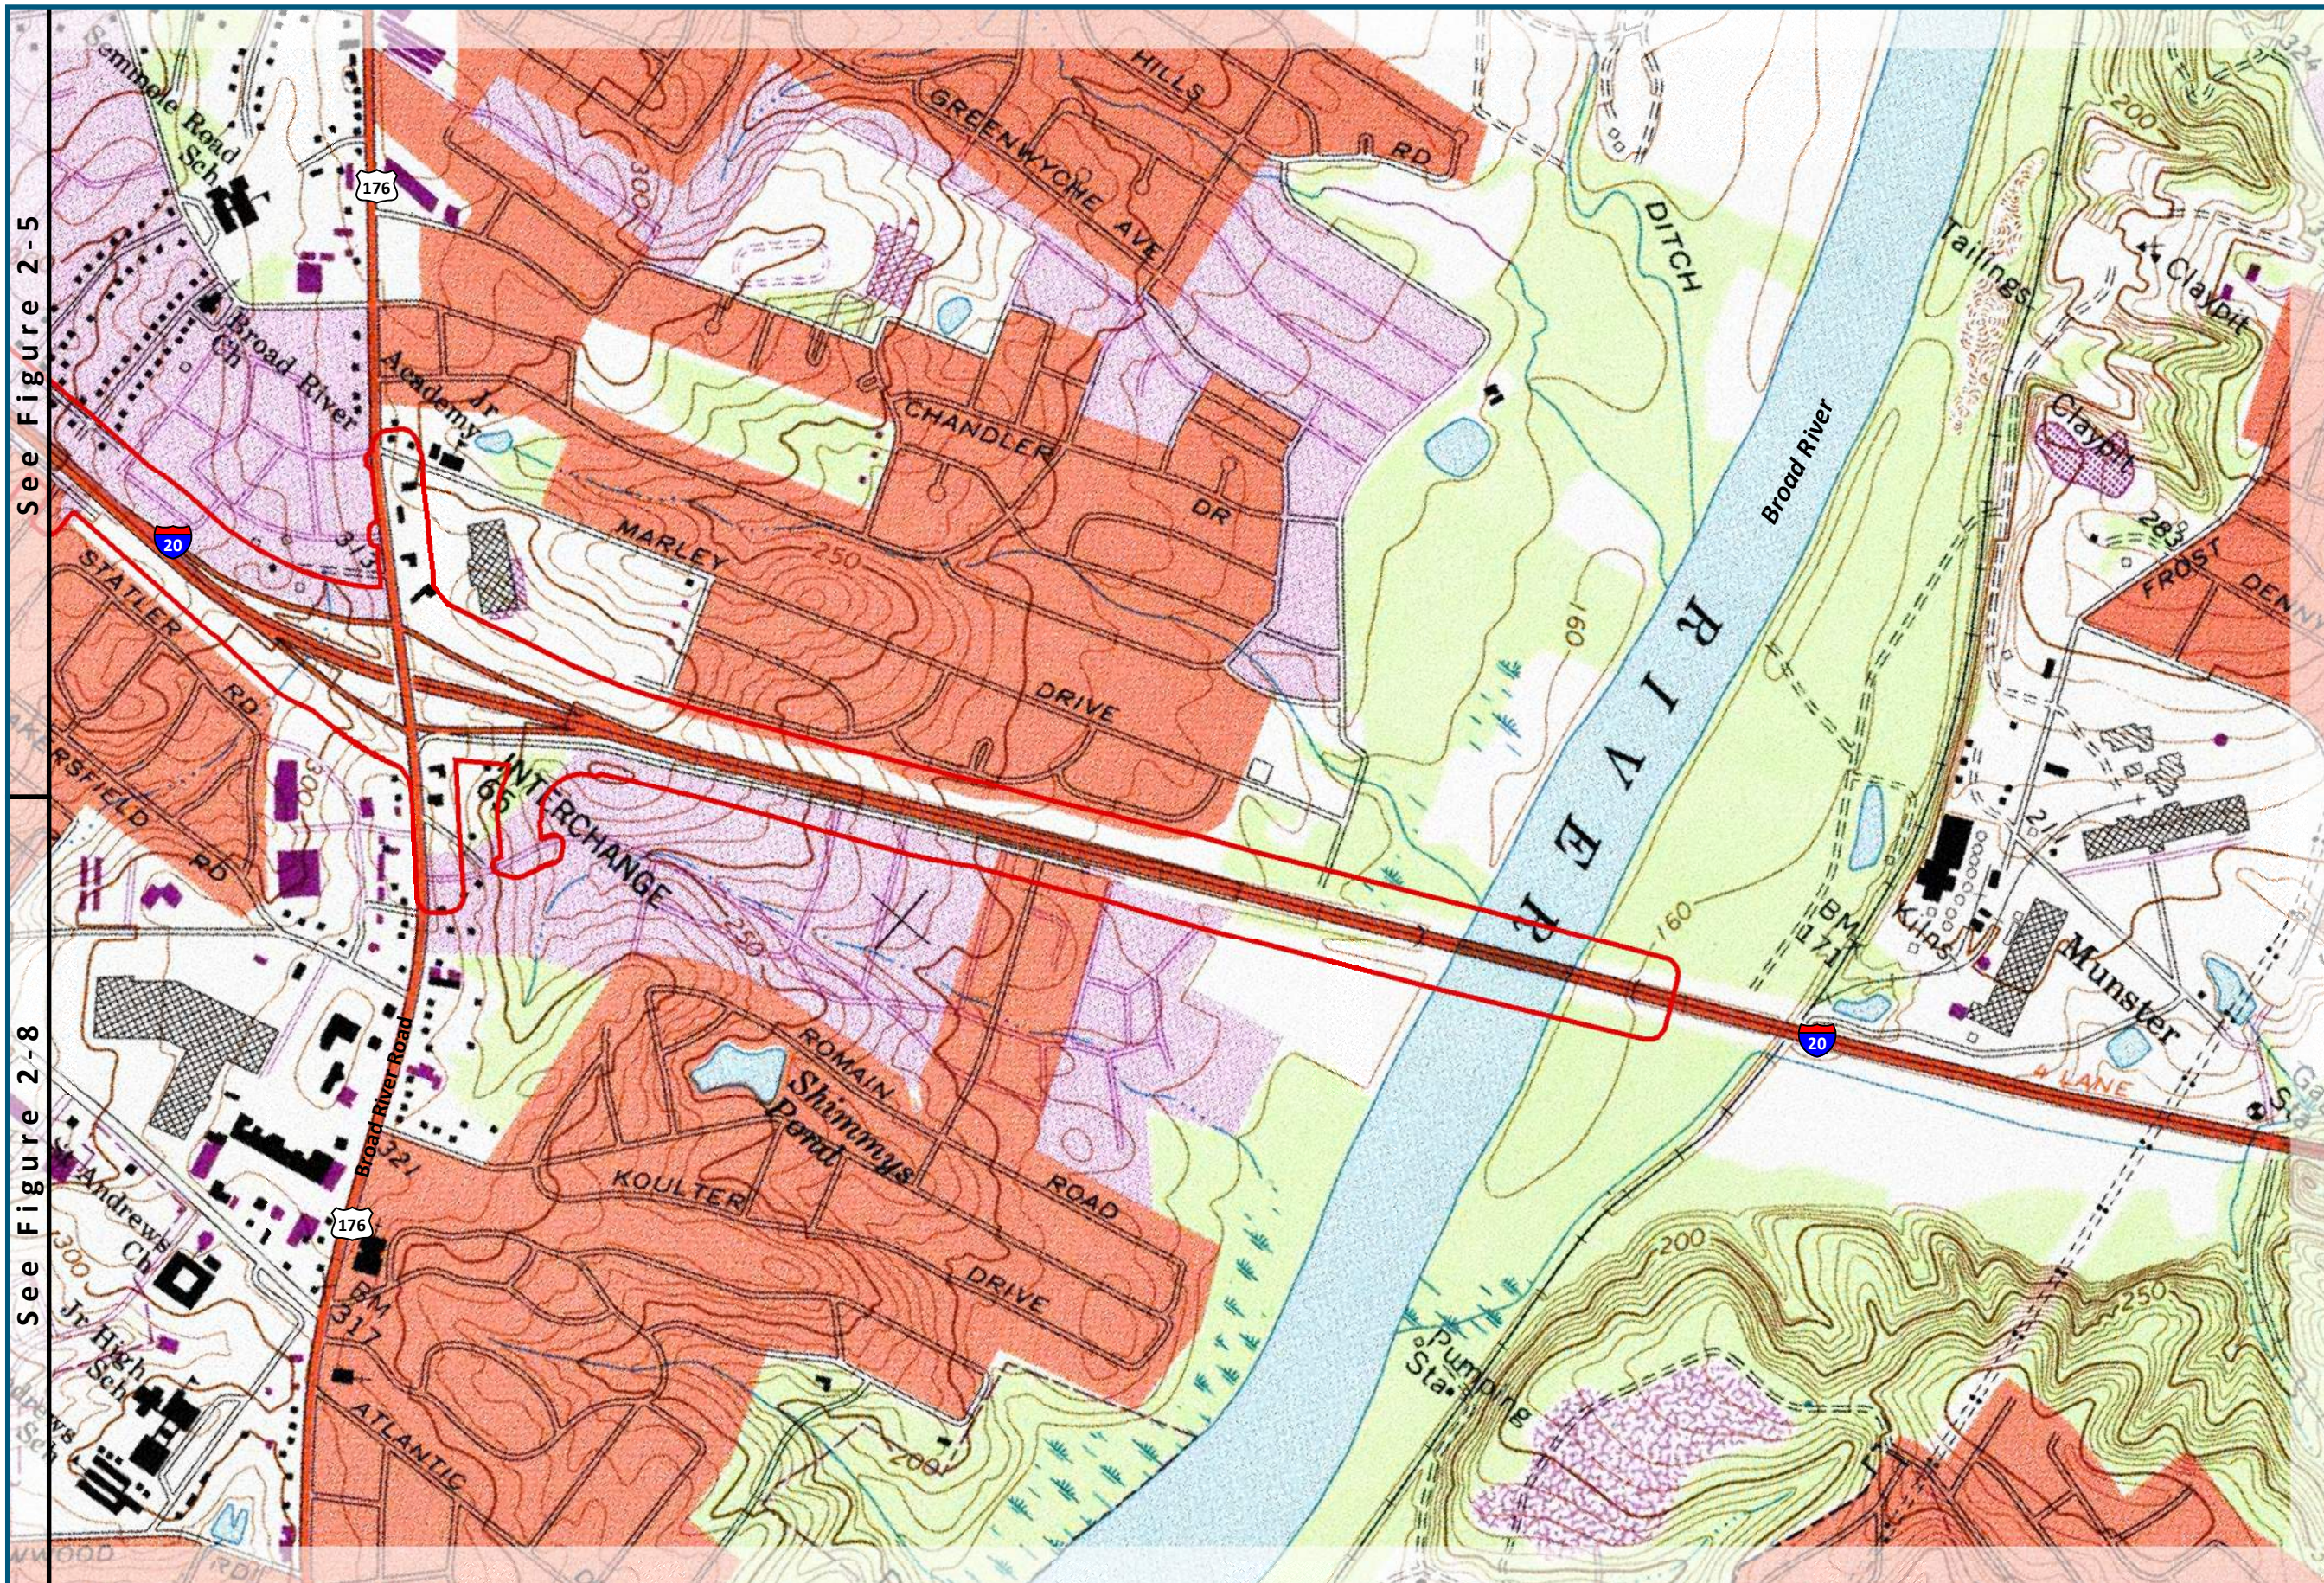
Figure 2-7
USGS Topography Map

- Legend**
- Project Study Area (1,482 acres)
 - USGS Quad Index

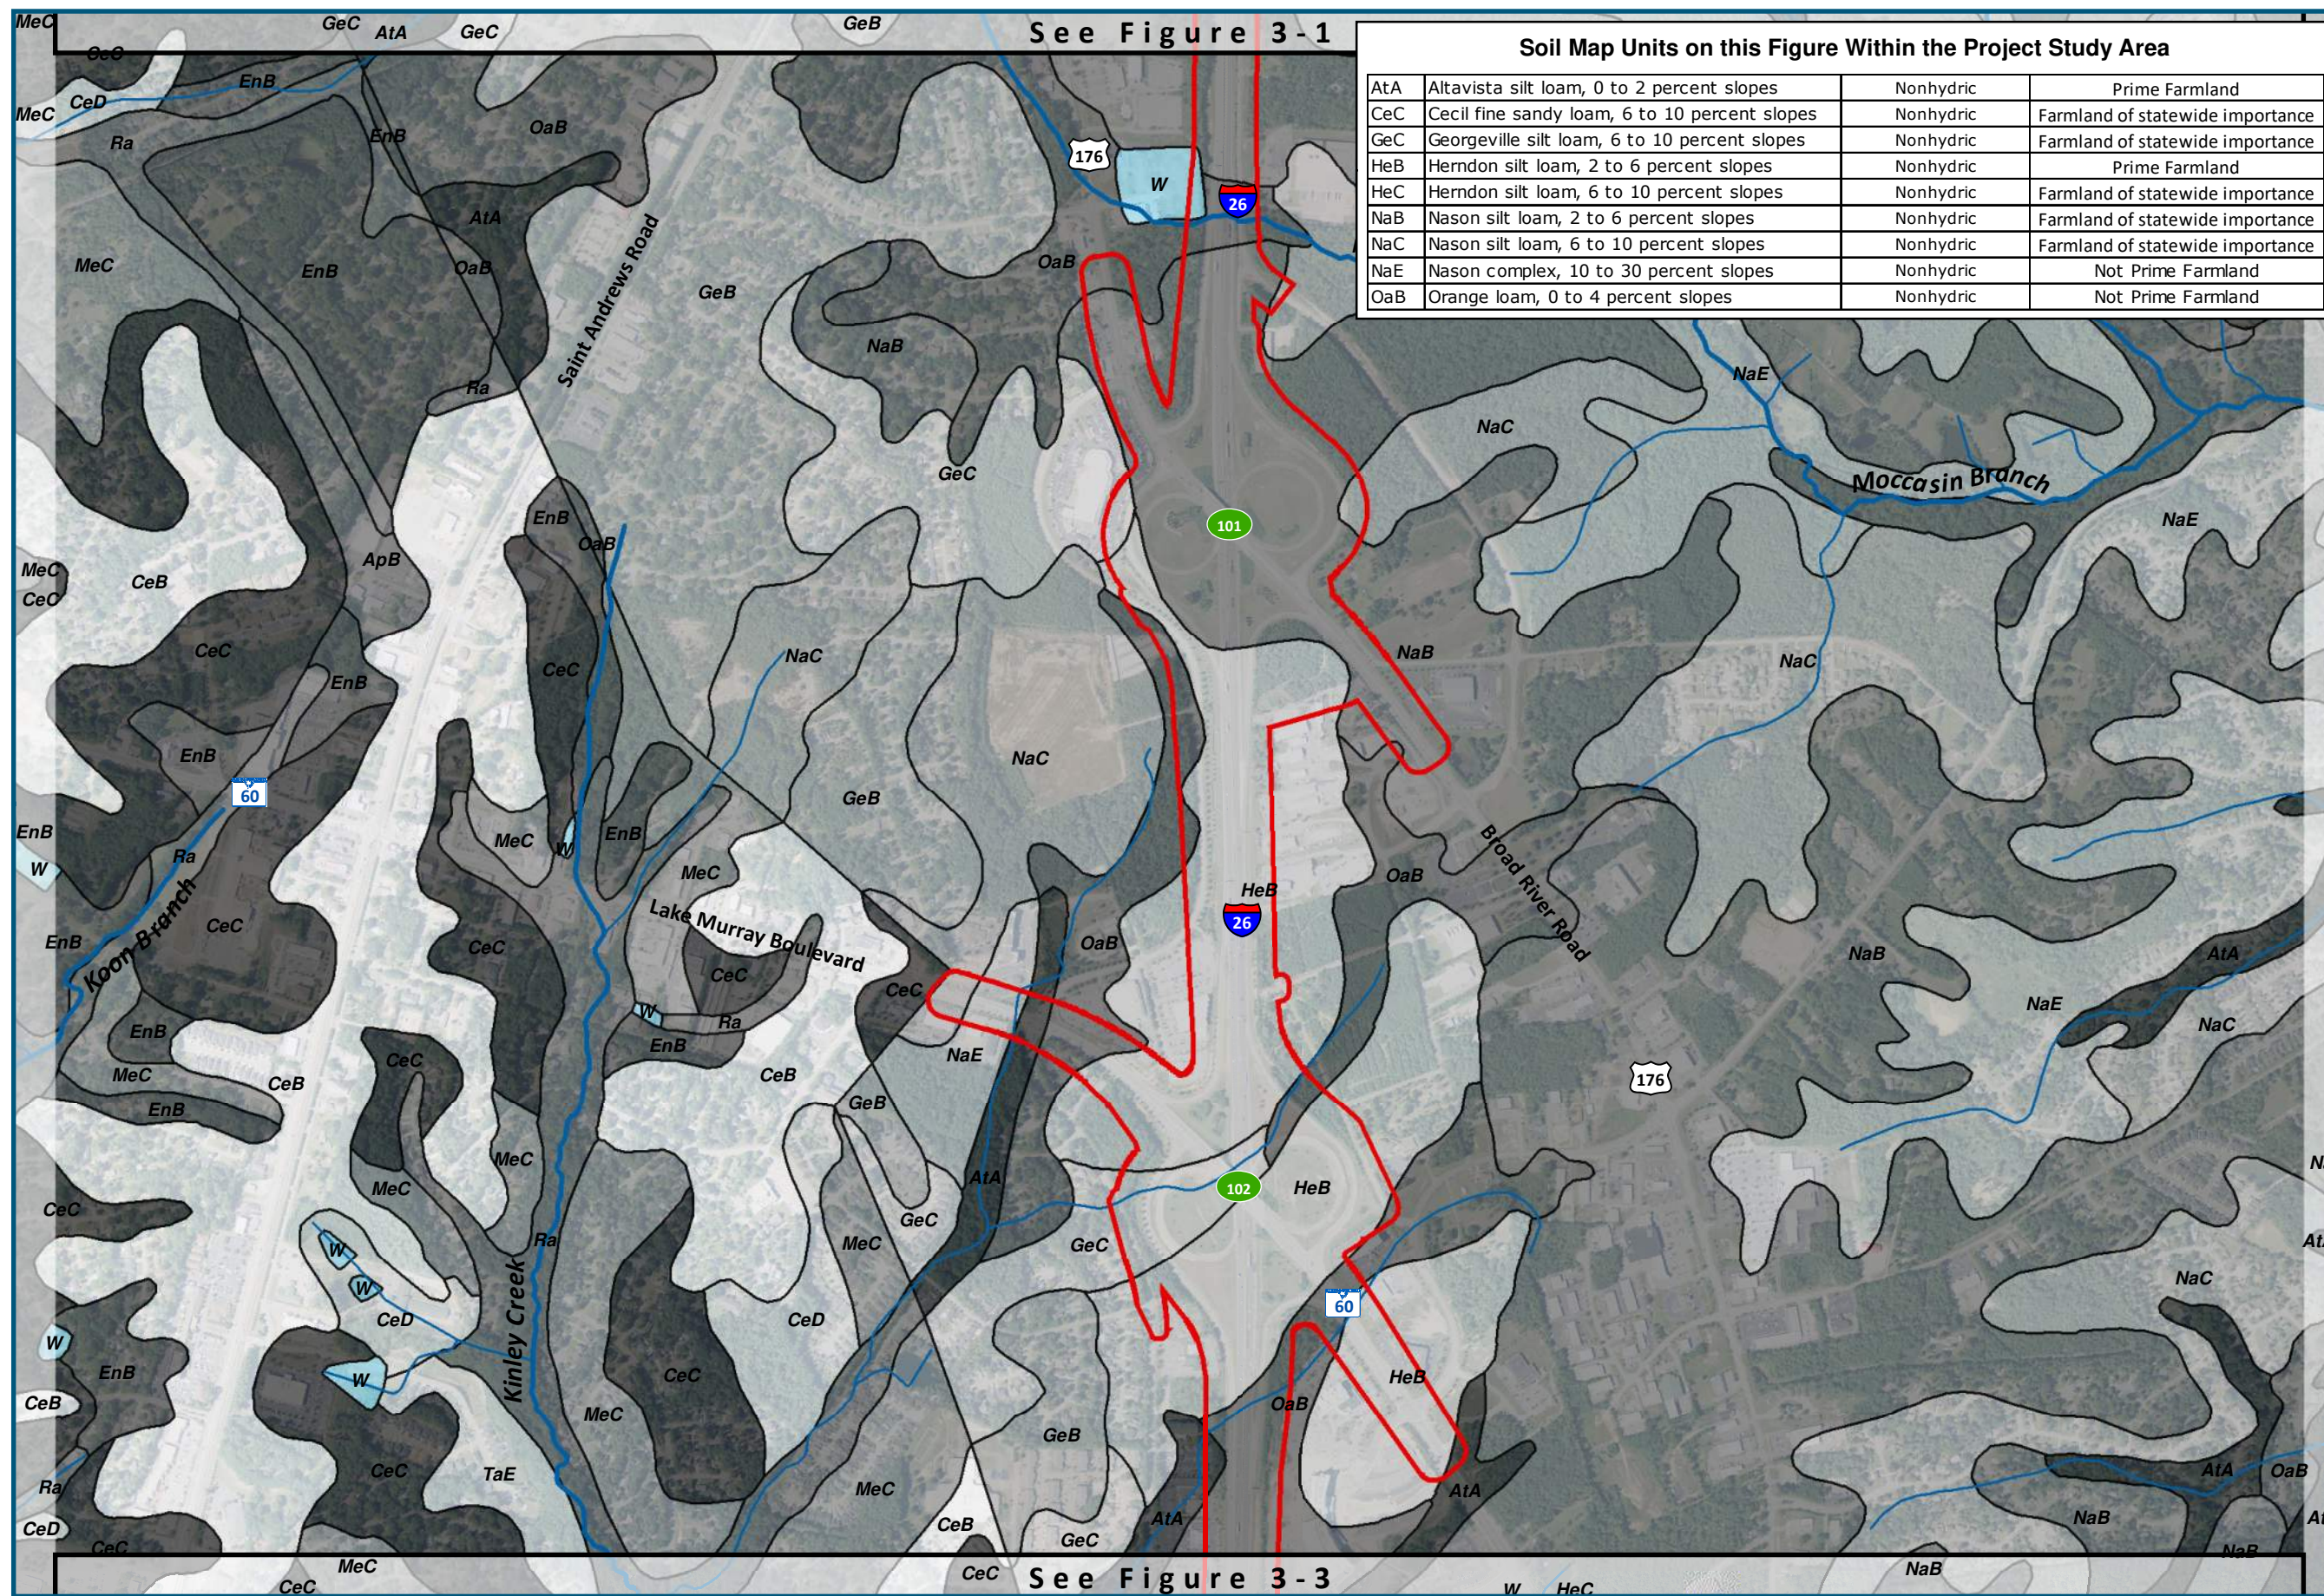
Figure 3-2
NRCS Soil Map Unit
Map

Soil Map Units on this Figure Within the Project Study Area			
AtA	Altavista silt loam, 0 to 2 percent slopes	Nonhydic	Prime Farmland
CeC	Cecil fine sandy loam, 6 to 10 percent slopes	Nonhydic	Farmland of statewide importance
GeC	Georgeville silt loam, 6 to 10 percent slopes	Nonhydic	Farmland of statewide importance
HeB	Herndon silt loam, 2 to 6 percent slopes	Nonhydic	Prime Farmland
HeC	Herndon silt loam, 6 to 10 percent slopes	Nonhydic	Farmland of statewide importance
NaB	Nason silt loam, 2 to 6 percent slopes	Nonhydic	Farmland of statewide importance
NaC	Nason silt loam, 6 to 10 percent slopes	Nonhydic	Farmland of statewide importance
NaE	Nason complex, 10 to 30 percent slopes	Nonhydic	Not Prime Farmland
OaB	Orange loam, 0 to 4 percent slopes	Nonhydic	Not Prime Farmland

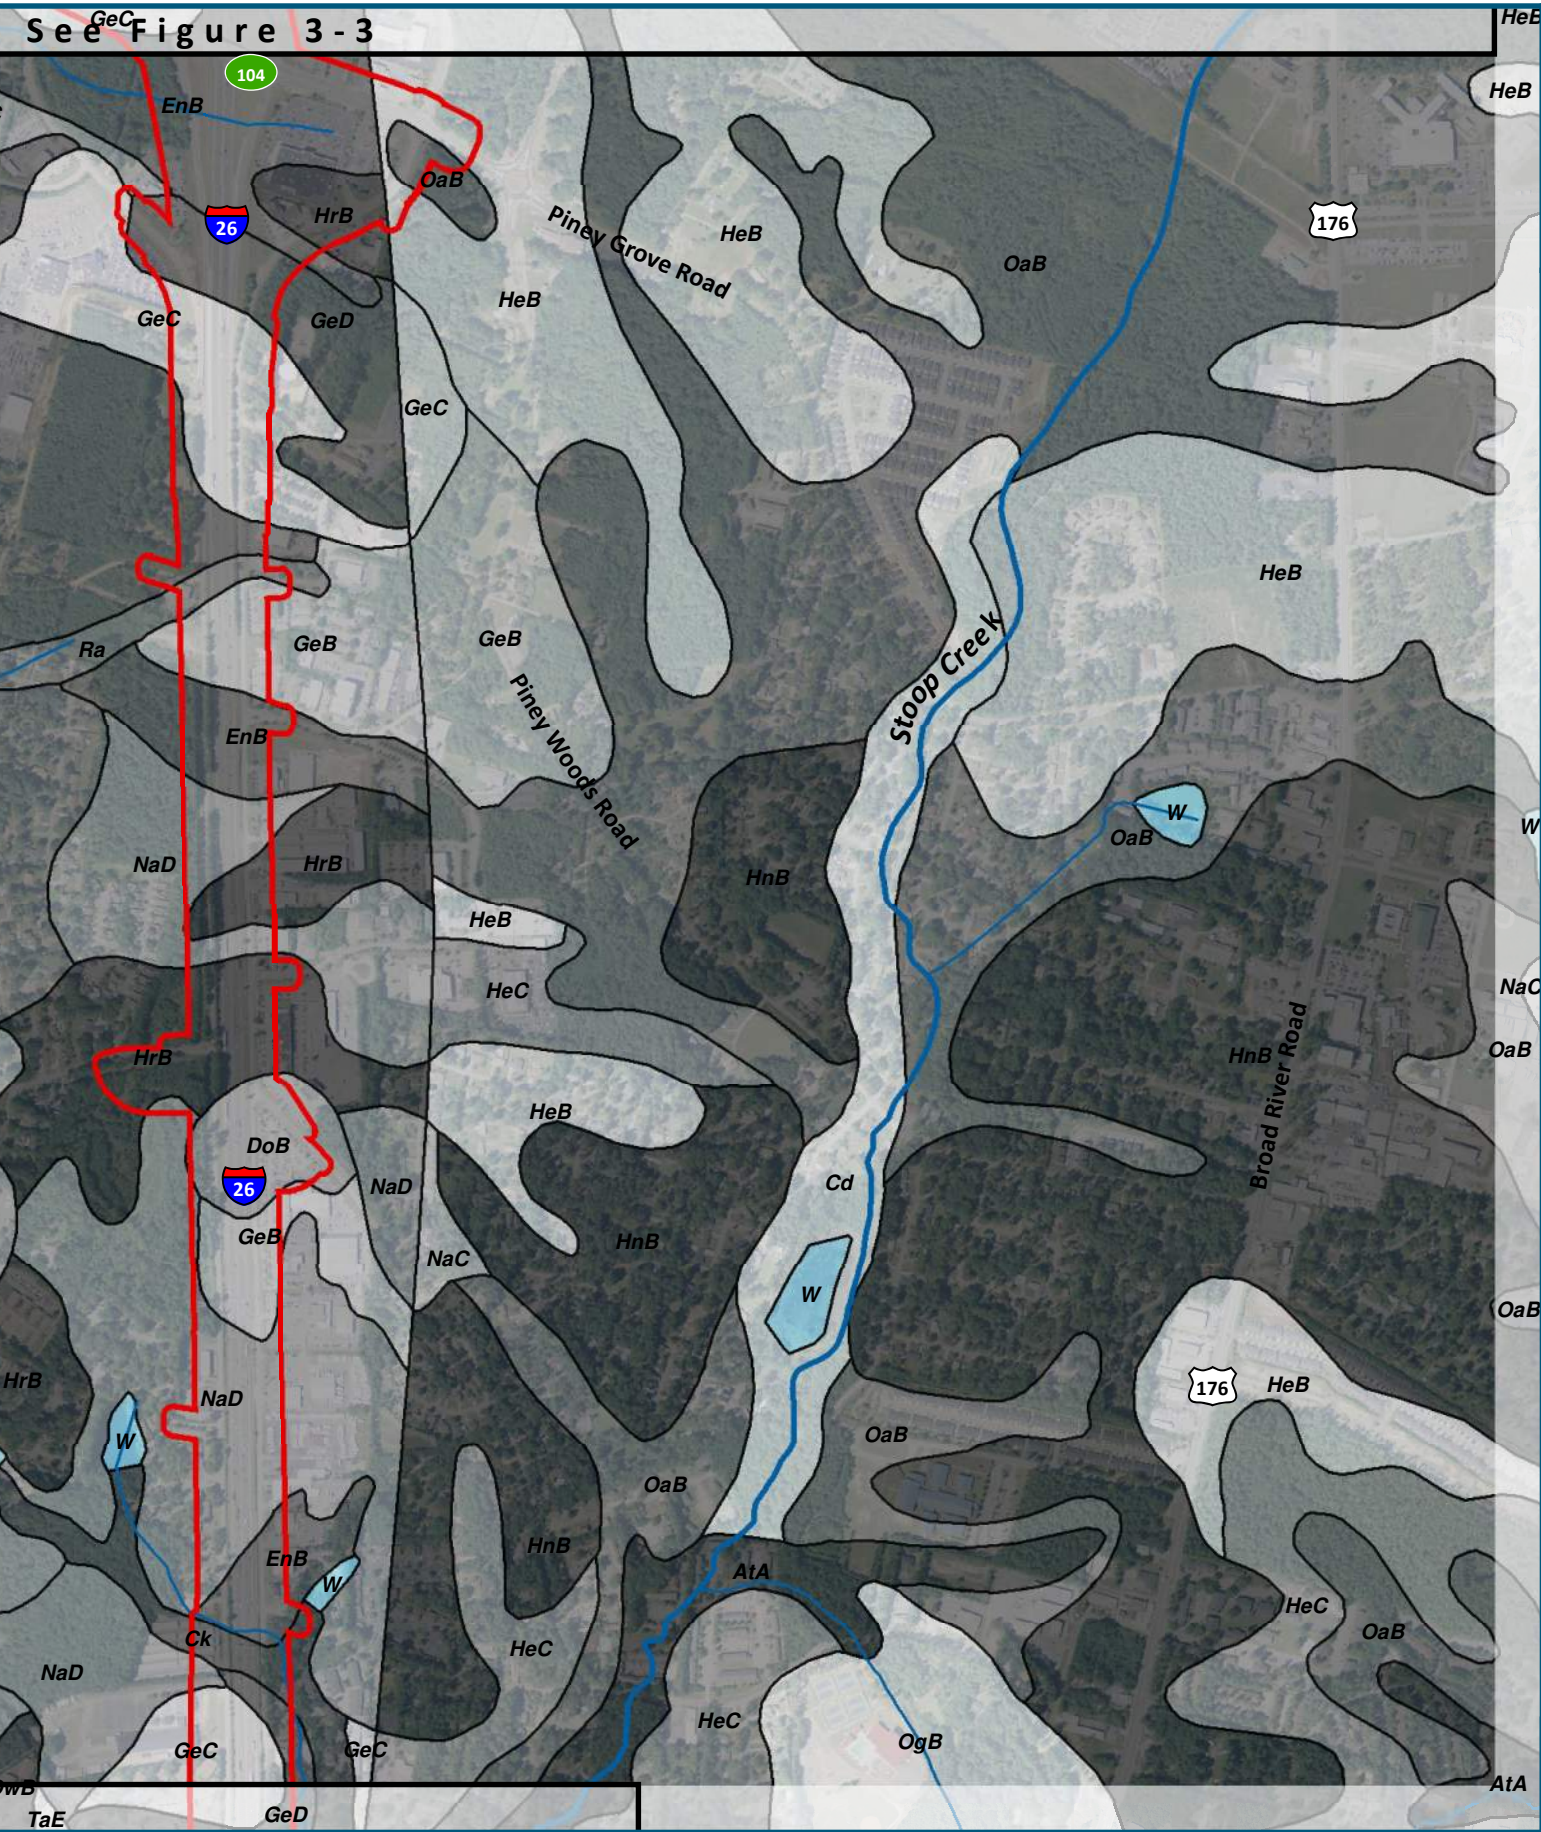
**Figure 3-4
NRCS Soil Map Unit
Map**

Soil Map Units on this Figure Within the Project Study Area			
Ck	Chenneby soils	Predominantly nonhydic	Prime farmland*
DoB	Dothan loamy sand, 2 to 6 percent slopes	Nonhydic	Prime farmland
EnB	Enon silt loam, 2 to 6 percent slopes	Nonhydic	Farmland of statewide importance
GeB	Georgeville silt loam, 2 to 6 percent slopes	Nonhydic	Prime farmland
GeC	Georgeville silt loam, 6 to 10 percent slopes	Nonhydic	Farmland of statewide importance
GeD	Georgeville very fine sandy loam, 10 to 15 percent slopes	Nonhydic	Not prime farmland
HeB	Herndon silt loam, 2 to 6 percent slopes	Nonhydic	Prime farmland
HrB	Herndon silt loam, 2 to 6 percent slopes	Nonhydic	Prime farmland
MeC	Mecklenburg silt loam, 6 to 10 percent slopes	Nonhydic	Farmland of statewide importance
NaD	Nason silt loam, 6 to 15 percent slopes	Nonhydic	Not prime farmland
OaB	Orange loam, 0 to 4 percent slopes	Nonhydic	Not prime farmland
Ra	Rains sandy loam	Hydic	Farmland of statewide importance

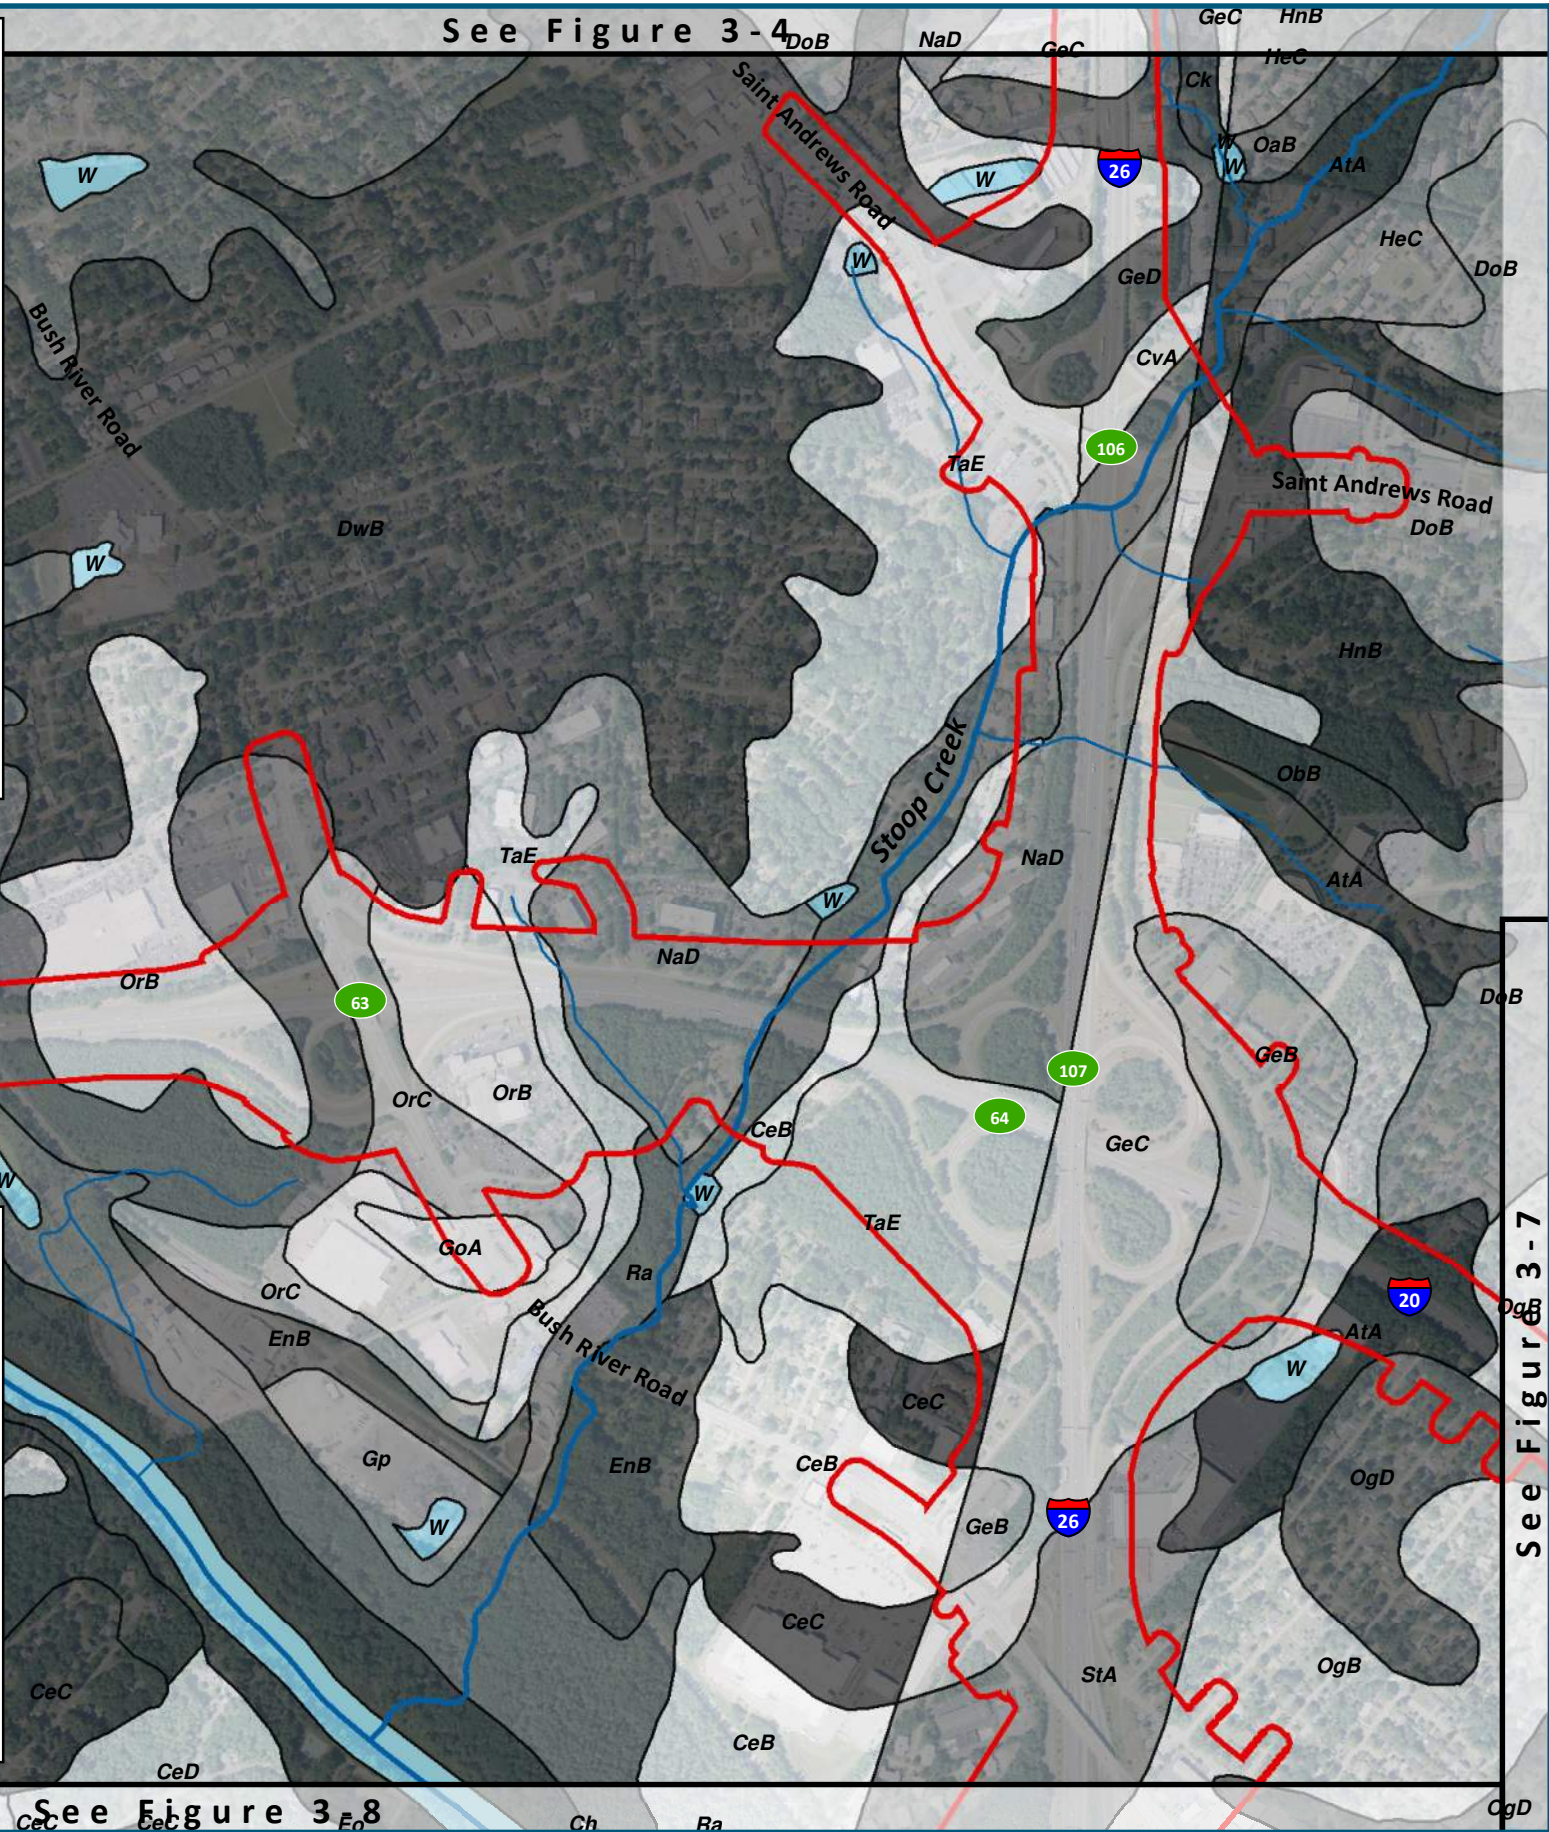
Figure 3-5
NRCS Soil Map Unit
Map
01/17/2019 Sheet 5 of 8

Soil Map Units on this Figure Within the Project Study Area (Cont.)			
HnB	Herndon-Urban land complex, 2 to 6 percent slopes	Nonhydic	Not prime farmland
NaD	Nason silt loam, 6 to 15 percent slopes	Nonhydic	Not prime farmland
OgB	Orangeburg-Urban land complex, 2 to 6 percent slopes	Nonhydic	Not prime farmland
OgD	Orangeburg-Urban land complex, 6 to 15 percent slopes	Nonhydic	Not prime farmland
OrB	Orangeburg loamy sand, 2 to 6 percent slopes	Nonhydic	Prime farmland
OrC	Orangeburg loamy sand, 6 to 10 percent slopes	Nonhydic	Farmland of statewide importance
Ra	Rains sandy loam	Hydic	Farmland of statewide importance
StA	State sandy loam, 0 to 2 percent slopes	Nonhydic	Prime farmland
TaE	Tatum silt loam, 15 to 25 percent slopes	Nonhydic	Not prime farmland
W	Water	Nonhydic	Not prime farmland
