Natural Resources Technical Report

Carolina Crossroads

I-20/I-26/I-126 Corridor Improvements

Final (Revised) May 2019

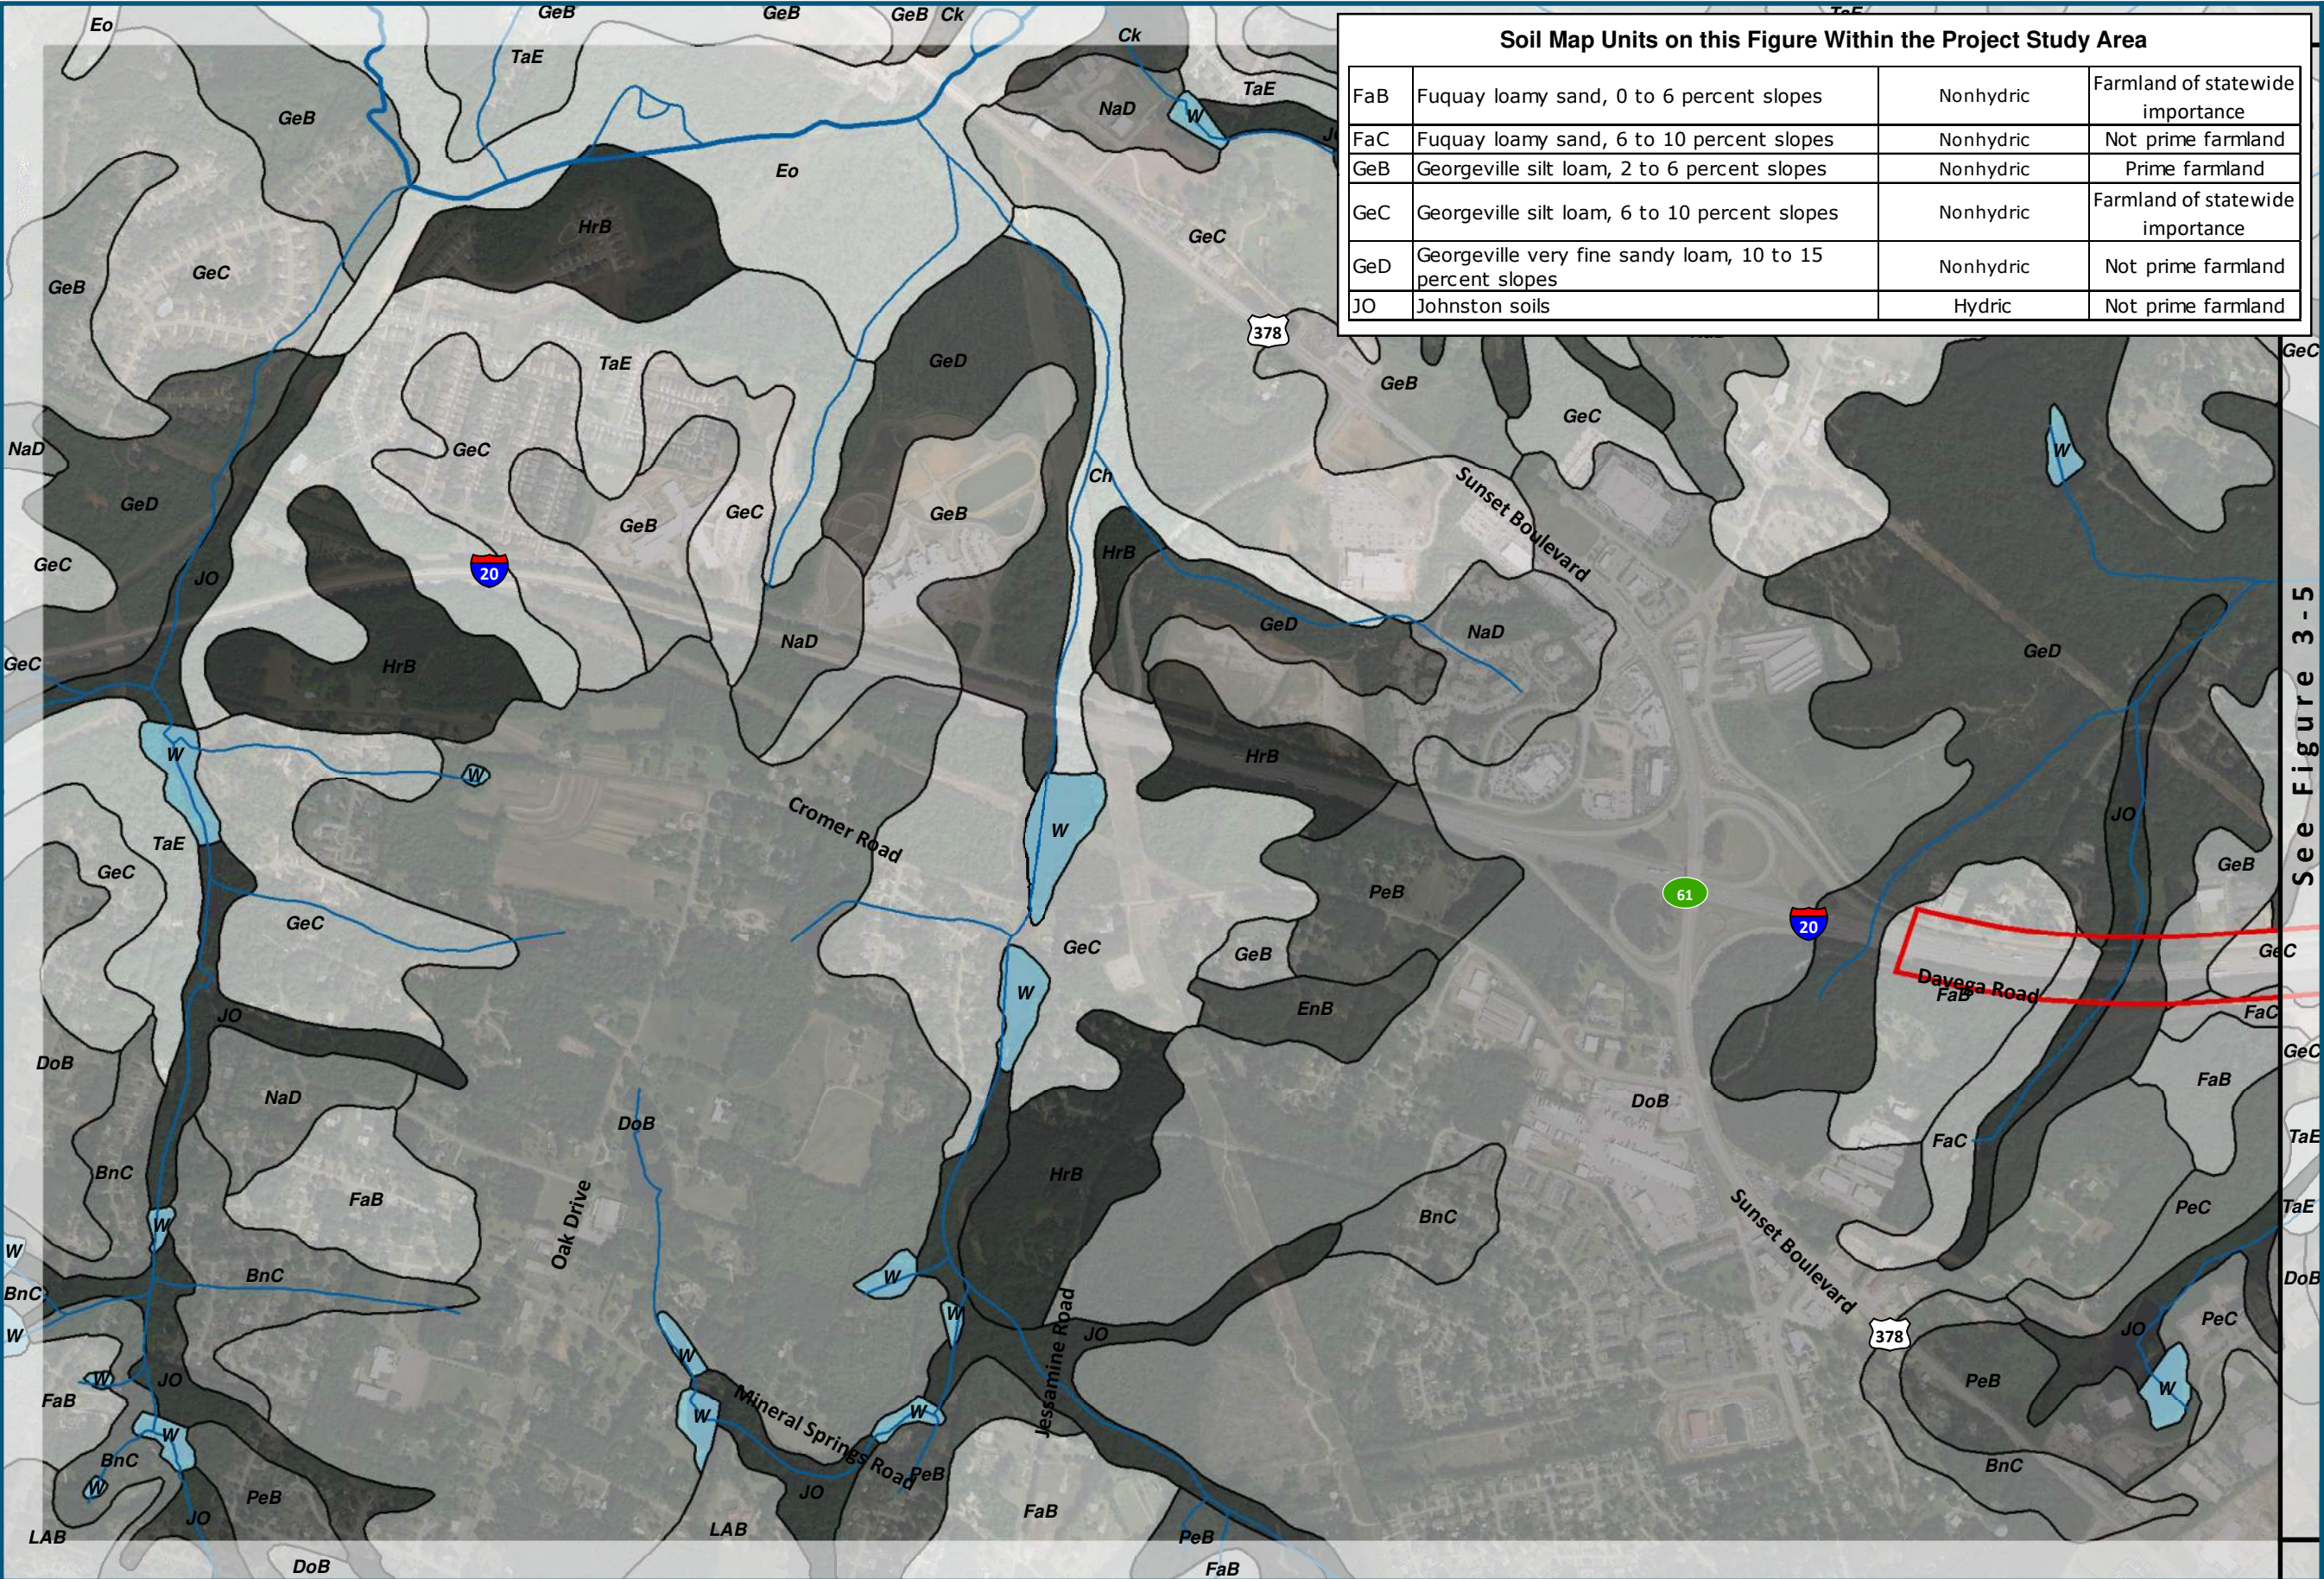
Figure 3-6
NRCS Soil Map Unit
Map

Soil Map Units on this Figure Within the Project Study Area			
FaB	Fuquay loamy sand, 0 to 6 percent slopes	Nonhydic	Farmland of statewide importance
FaC	Fuquay loamy sand, 6 to 10 percent slopes	Nonhydic	Not prime farmland
GeB	Georgeville silt loam, 2 to 6 percent slopes	Nonhydic	Prime farmland
GeC	Georgeville silt loam, 6 to 10 percent slopes	Nonhydic	Farmland of statewide importance
GeD	Georgeville very fine sandy loam, 10 to 15 percent slopes	Nonhydic	Not prime farmland
JO	Johnston soils	Hydic	Not prime farmland

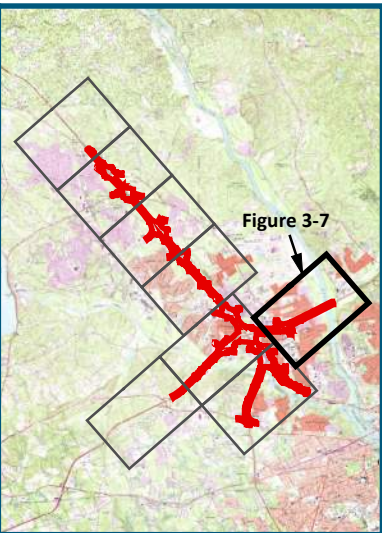
Figure 3-7
NRCS Soil Map Unit
Map

Soil Map Units on this Figure Within the Project Study Area			
AtA	Altavista silt loam, 0 to 2 percent slopes	Nonhydryc	Prime farmland
Co	Congaree loam	Predominantly nonhydryc	Prime farmland*
HnB	Herndon-Urban land complex, 2 to 6 percent slopes	Nonhydryc	Not prime farmland
OgB	Orangeburg-Urban land complex, 2 to 6 percent slopes	Nonhydryc	Not prime farmland
OgD	Orangeburg-Urban land complex, 6 to 15 percent slopes	Nonhydryc	Not prime farmland
StA	State sandy loam, 0 to 2 percent slopes	Nonhydryc	Prime farmland
* if drained and either protected from flooding or not frequently flooded during the growing season

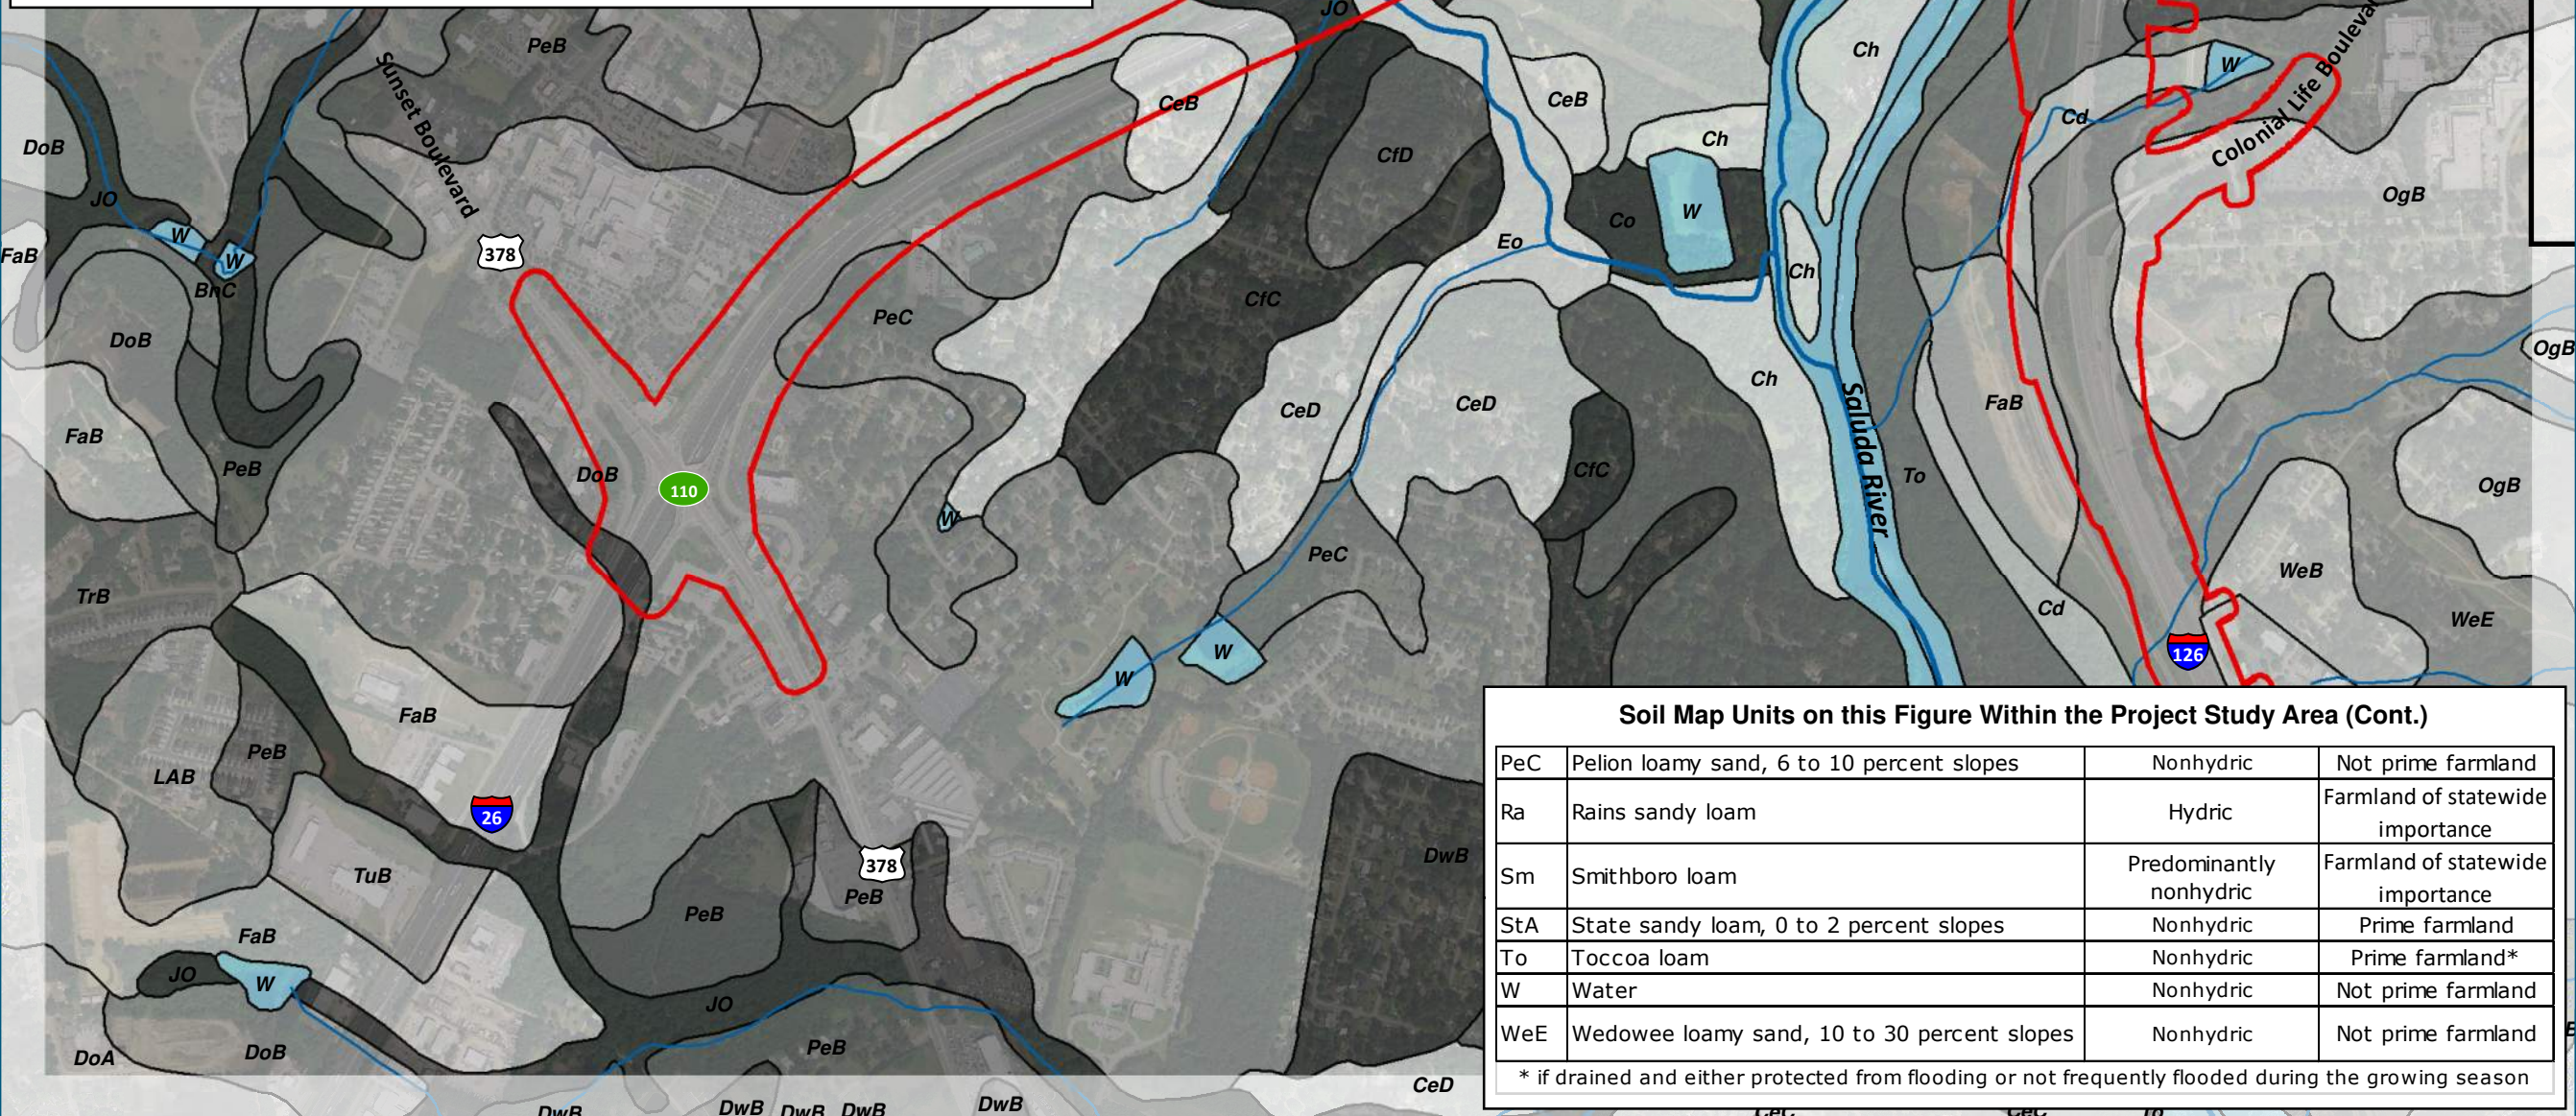
Figure 3-8

Soil Map Units on this Figure Within the Project Study Area			
Cd	Chastain silty clay loam	Hydric	Not prime farmland
CeB	Cecil fine sandy loam, 2 to 6 percent slopes	Nonhydric	Prime farmland
CeC	Cecil fine sandy loam, 6 to 10 percent slopes	Nonhydric	Farmland of statewide importance
CeD	Cecil fine sandy loam, 10 to 15 percent slopes	Nonhydric	Not prime farmland
Ch	Chenneby silty clay loam	Predominantly nonhydric	Prime farmland*
Co	Congaree loam	Predominantly nonhydric	Prime farmland*
DoB	Dothan loamy sand, 2 to 6 percent slopes	Nonhydric	Prime farmland
Eo	Enoree silt loam, 0 to 2 percent slopes, frequently flooded	Hydric	Not prime farmland
FaB	Faceville sandy loam, 2 to 6 percent slopes	Nonhydric	Prime farmland
JO	Johnston soils	Hydric	Not prime farmland
OgB	Orangeburg-Urban land complex, 2 to 6 percent slopes	Nonhydric	Not prime farmland
OgD	Orangeburg-Urban land complex, 6 to 15 percent slopes	Nonhydric	Not prime farmland

Soil Map Units on this Figure Within the Project Study Area (Cont.)			
PeC	Pelion loamy sand, 6 to 10 percent slopes	Nonhydric	Not prime farmland
Ra	Rains sandy loam	Hydric	Farmland of statewide importance
Sm	Smithboro loam	Predominantly nonhydric	Farmland of statewide importance
StA	State sandy loam, 0 to 2 percent slopes	Nonhydric	Prime farmland
To	Toccoa loam	Nonhydric	Prime farmland*
W	Water	Nonhydric	Not prime farmland
WeE	Wedowee loamy sand, 10 to 30 percent slopes	Nonhydric	Not prime farmland

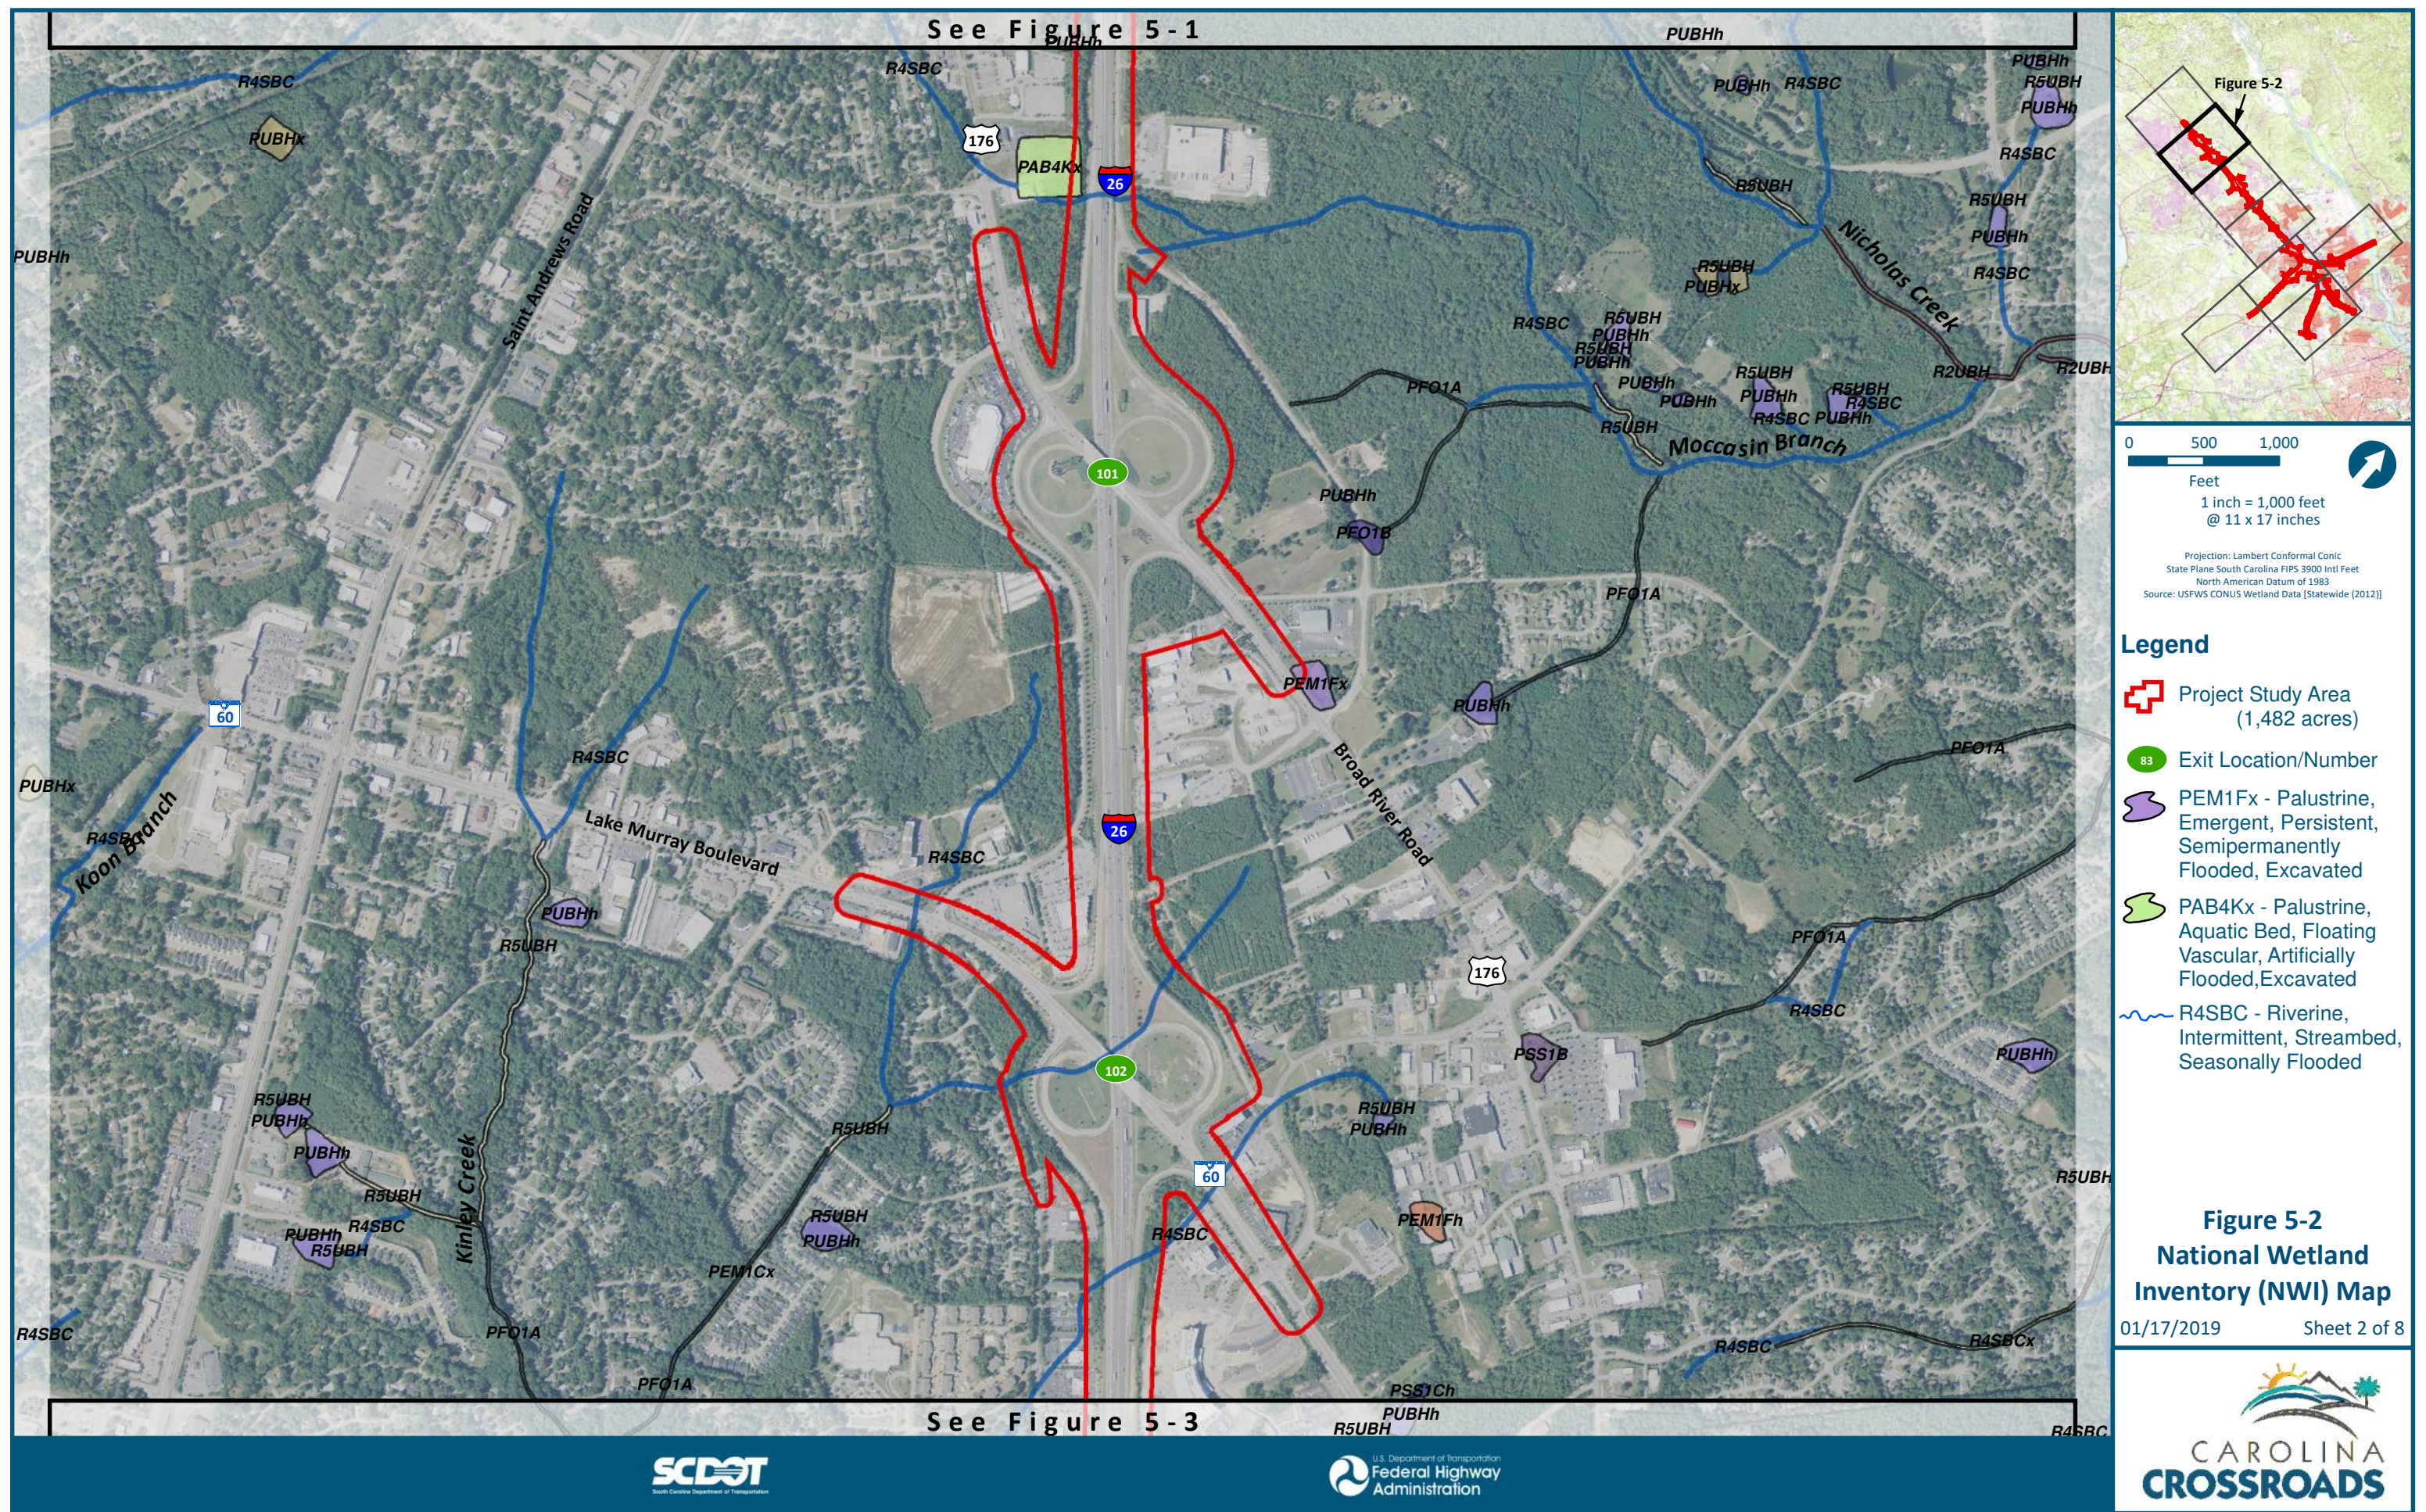
**Figure 5-2
National Wetland
Inventory (NWI) Map**
01/17/2019 Sheet 2 of 8

- Legend**
- Project Study Area (1,482 acres)
 - Exit Location/Number
 - PEM1Fx - Palustrine, Emergent, Persistent, Semipermanently Flooded, Excavated
 - PAB4Kx - Palustrine, Aquatic Bed, Floating Vascular, Artificially Flooded, Excavated
 - R4SBC - Riverine, Intermittent, Streambed, Seasonally Flooded

Prior to conducting fieldwork, Mead & Hunt reviewed National Wetlands Inventory (NWI) maps on the U.S. Fish and Wildlife Service (USFWS) NWI Wetlands Mapper via the internet (USFWS, 2017). Sixteen (16) wetland communities were depicted within the PSA on the NWI Wetlands Mapper within the PSA, and were mapped as two (2) Riverine systems (R2UBH), one (1) lake (L1UBHh), eight (8) freshwater ponds (PUBHh, PUBHx, and PUSCx), one (1) freshwater emergent wetland (PEM1Fx), and four (4) freshwater forested/shrub wetlands (PFO1A, PSS1A, and PFO1A). Please see **Appendix A, Figures 5-1 through 5-8** for the location and extent of NWI elements within the PSA.

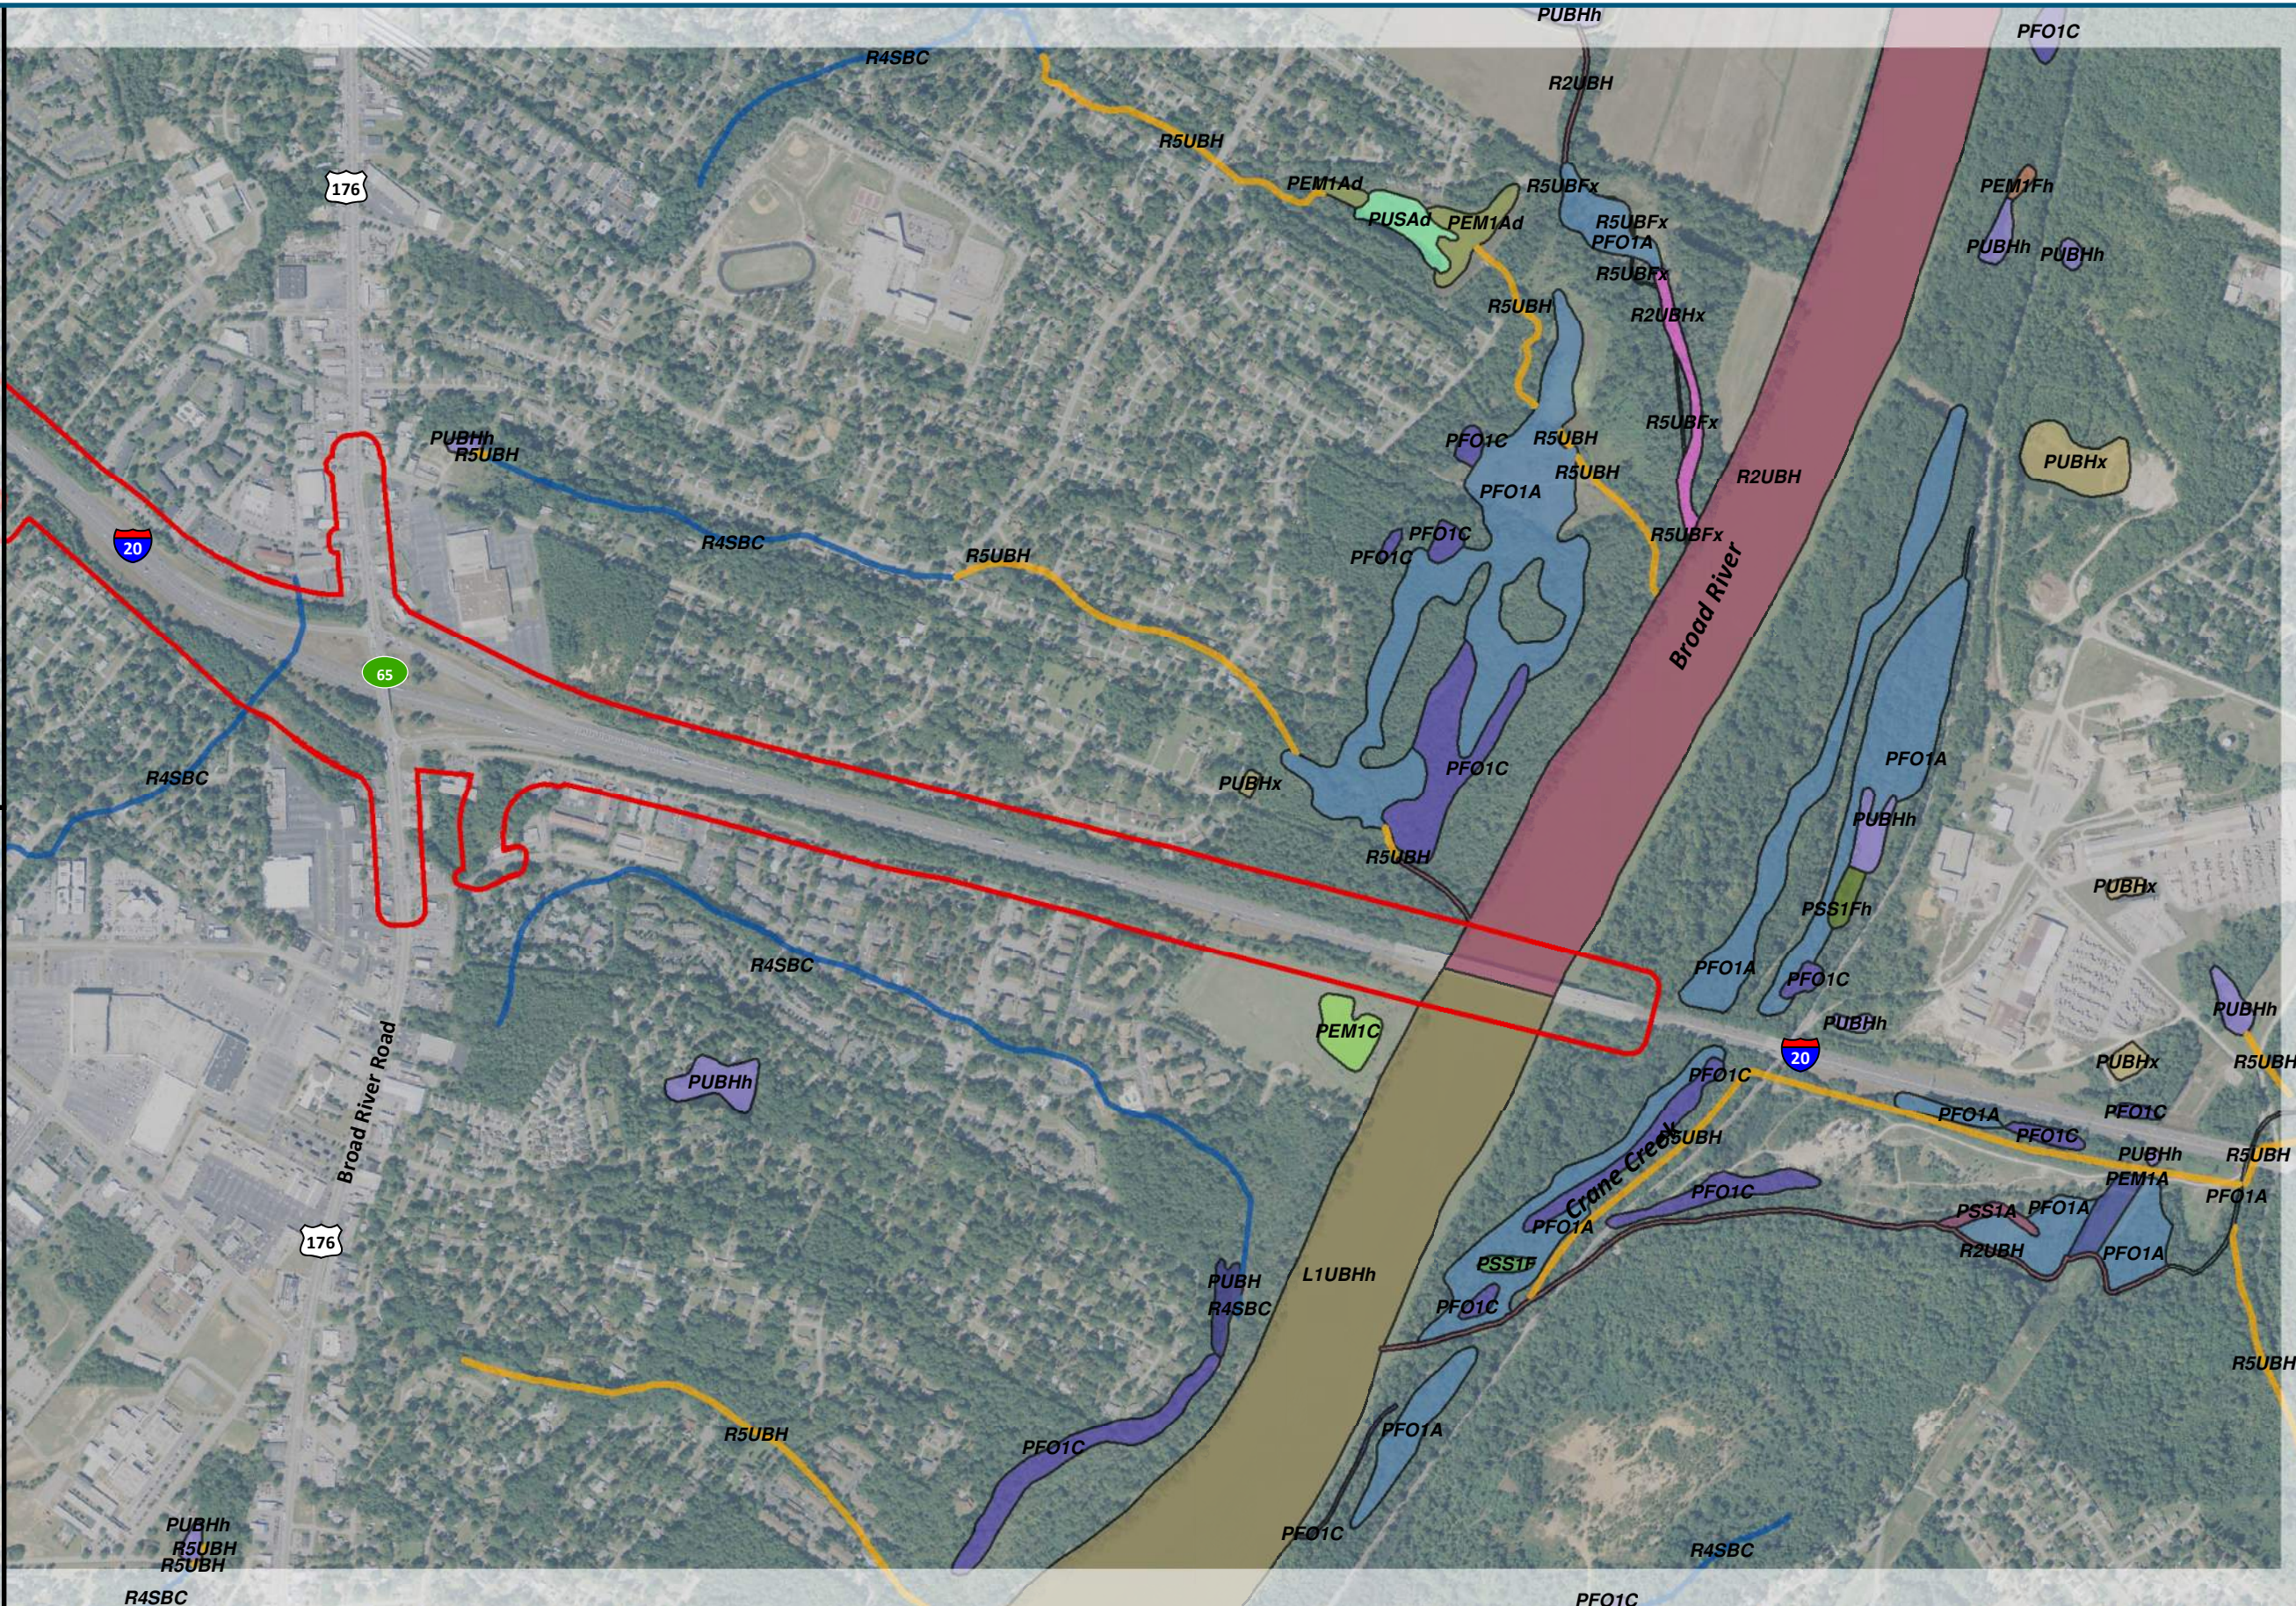
Figure 5-7
National Wetland Inventory (NWI) Map
01/17/2019 Sheet 7 of 8

- Legend**
- Project Study Area (1,482 acres)
 - Exit Location/Number
 - L1UBHh - Lacustrine Limnetic, Unconsolidated Bottom, Permanently Flooded, Diked/Impounded
 - R2UBH - Riverine, Lower Perennial, Unconsolidated Bottom, Permanently Flooded
 - R4SBC - Riverine, Intermittent, Streambed, Seasonally Flooded

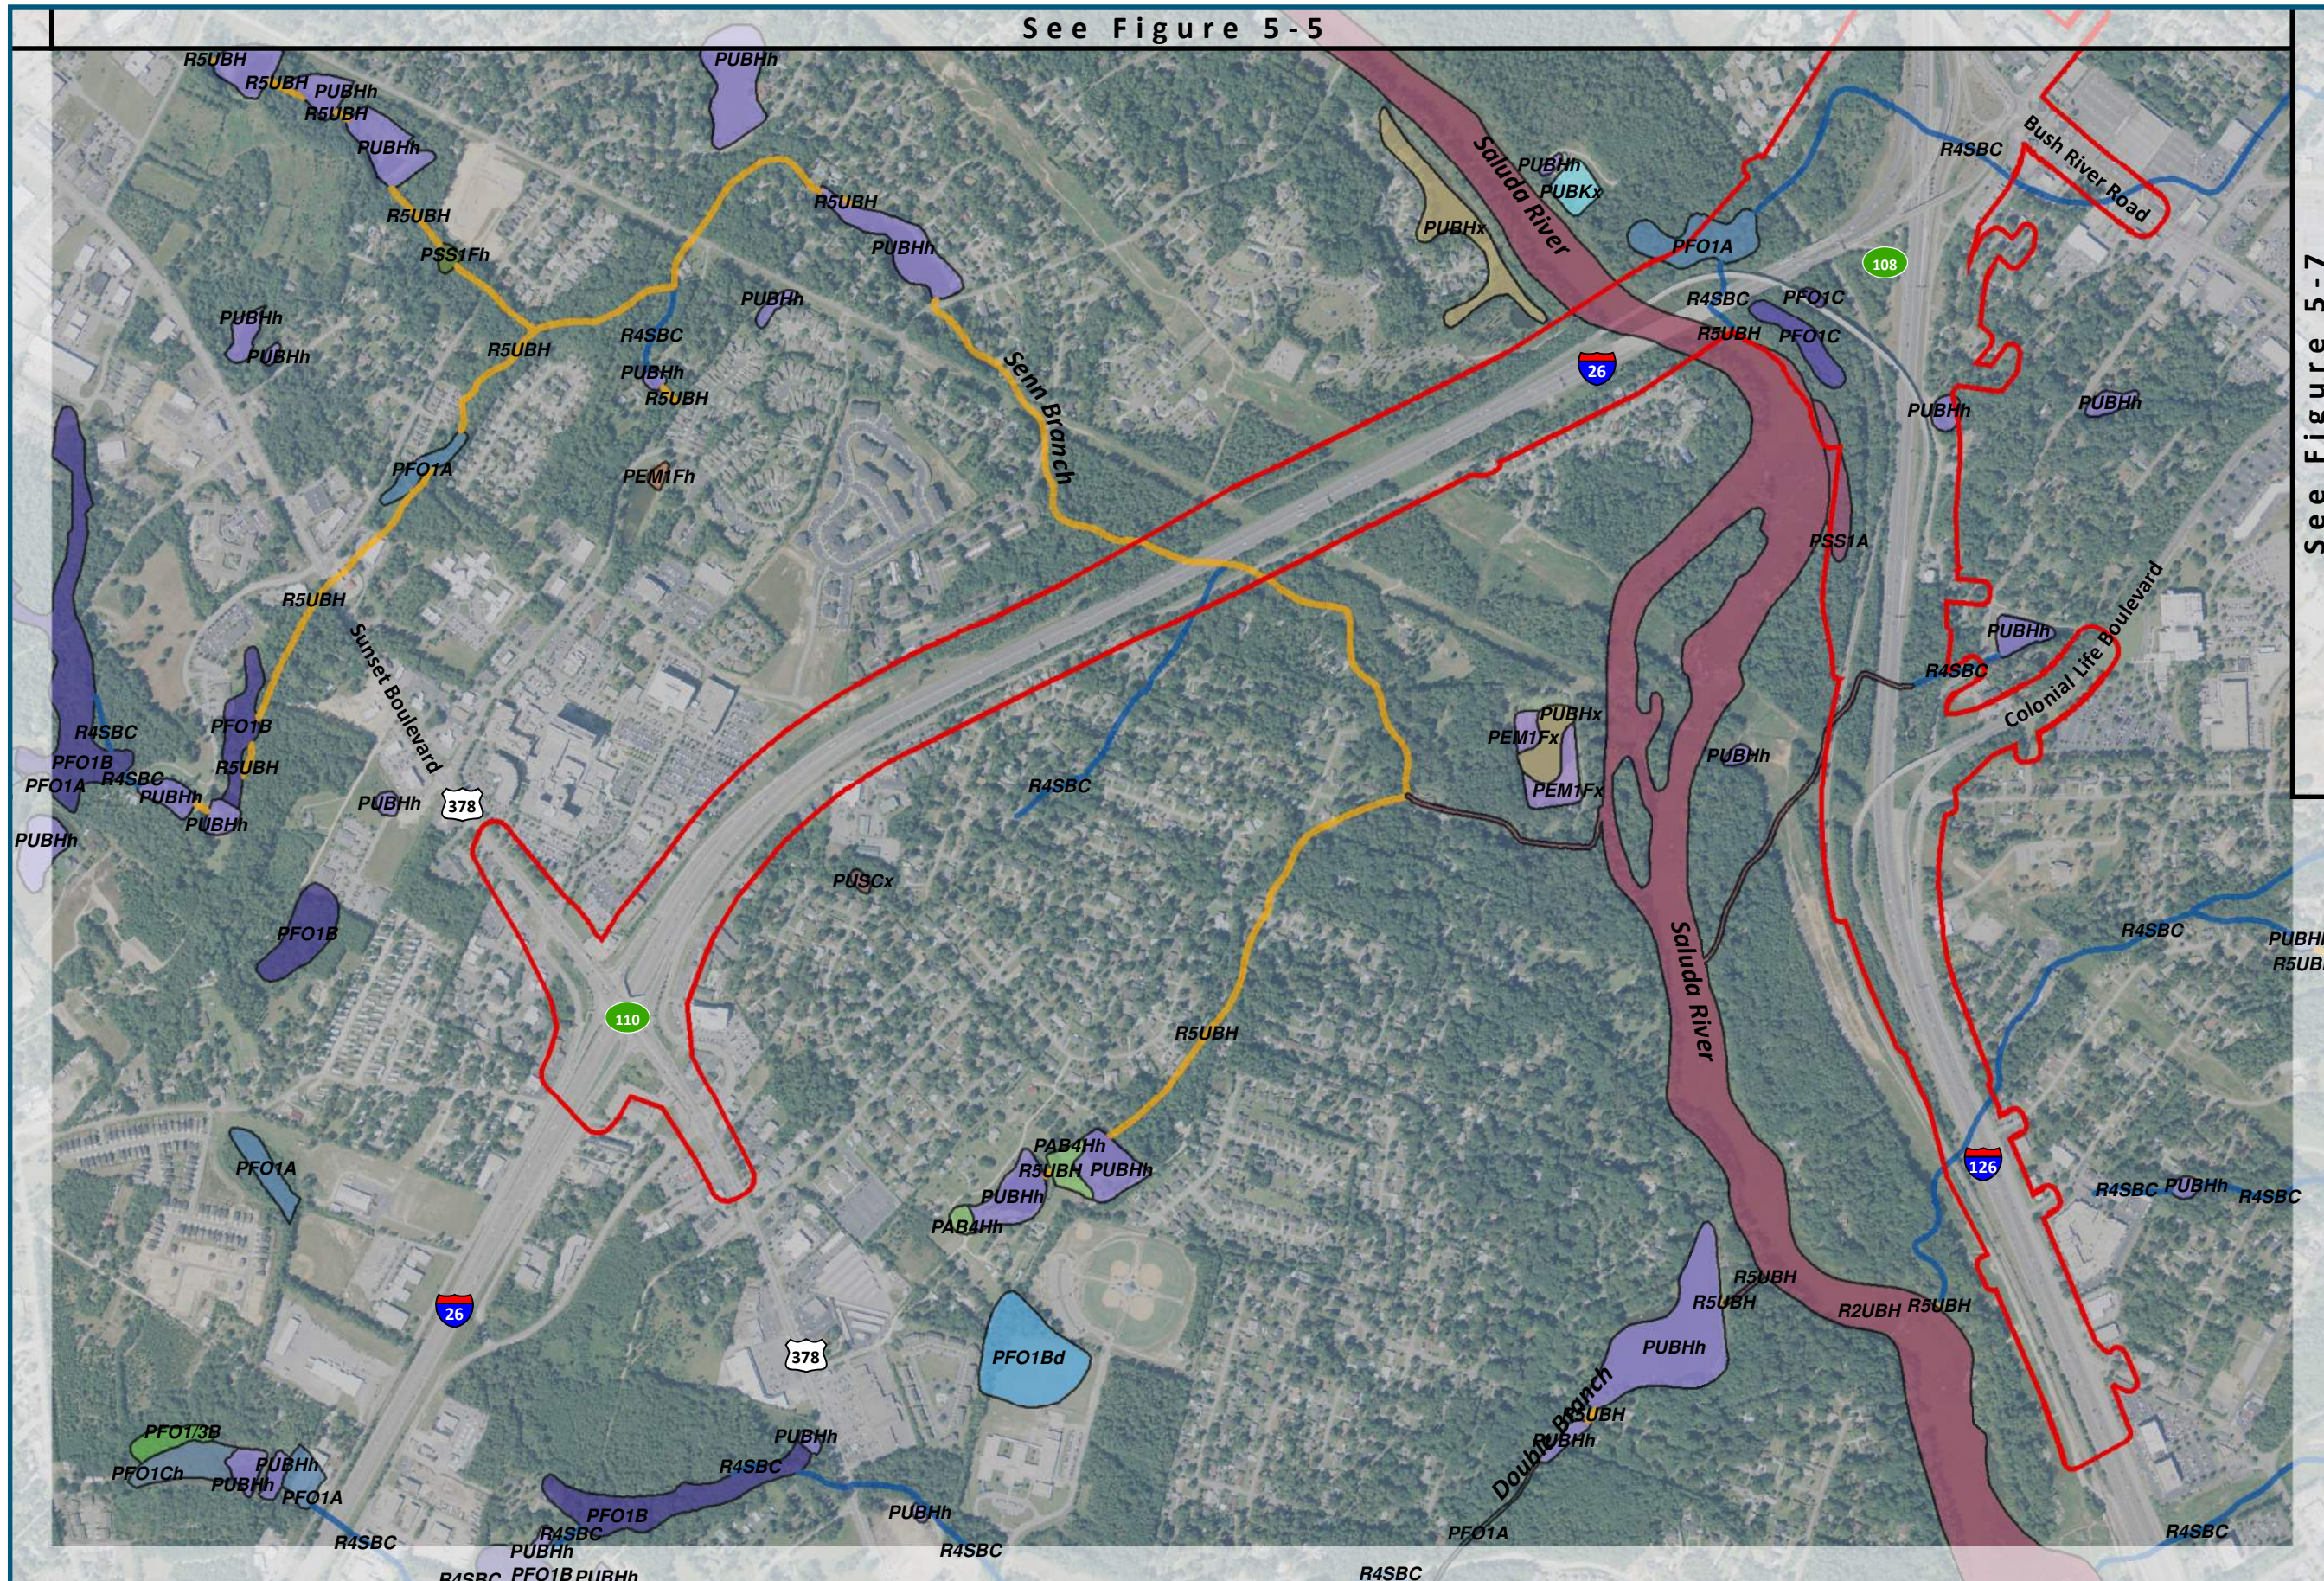
Figure 5-8
National Wetland
Inventory (NWI) Map

- Project Study Area (1,482 acres)
- Exit Location/Number
- PUBHh - Palustrine, Unconsolidated Bottom, Permanently Flooded, Diked/Impounded
- PFO1A - Palustrine, Forested, Broad-Leaved Deciduous, Temporarily Flooded
- PFO1C - Palustrine, Forested, Broad-Leaved Deciduous, Seasonally Flooded
- R2UBH - Riverine, Lower Perennial, Unconsolidated Bottom, Permanently Flooded
- R5UBH - Riverine, Unknown Perennial, Unconsolidated Bottom, Permanently Flooded
- R4SBC - Riverine, Intermittent, Streambed, Seasonally Flooded

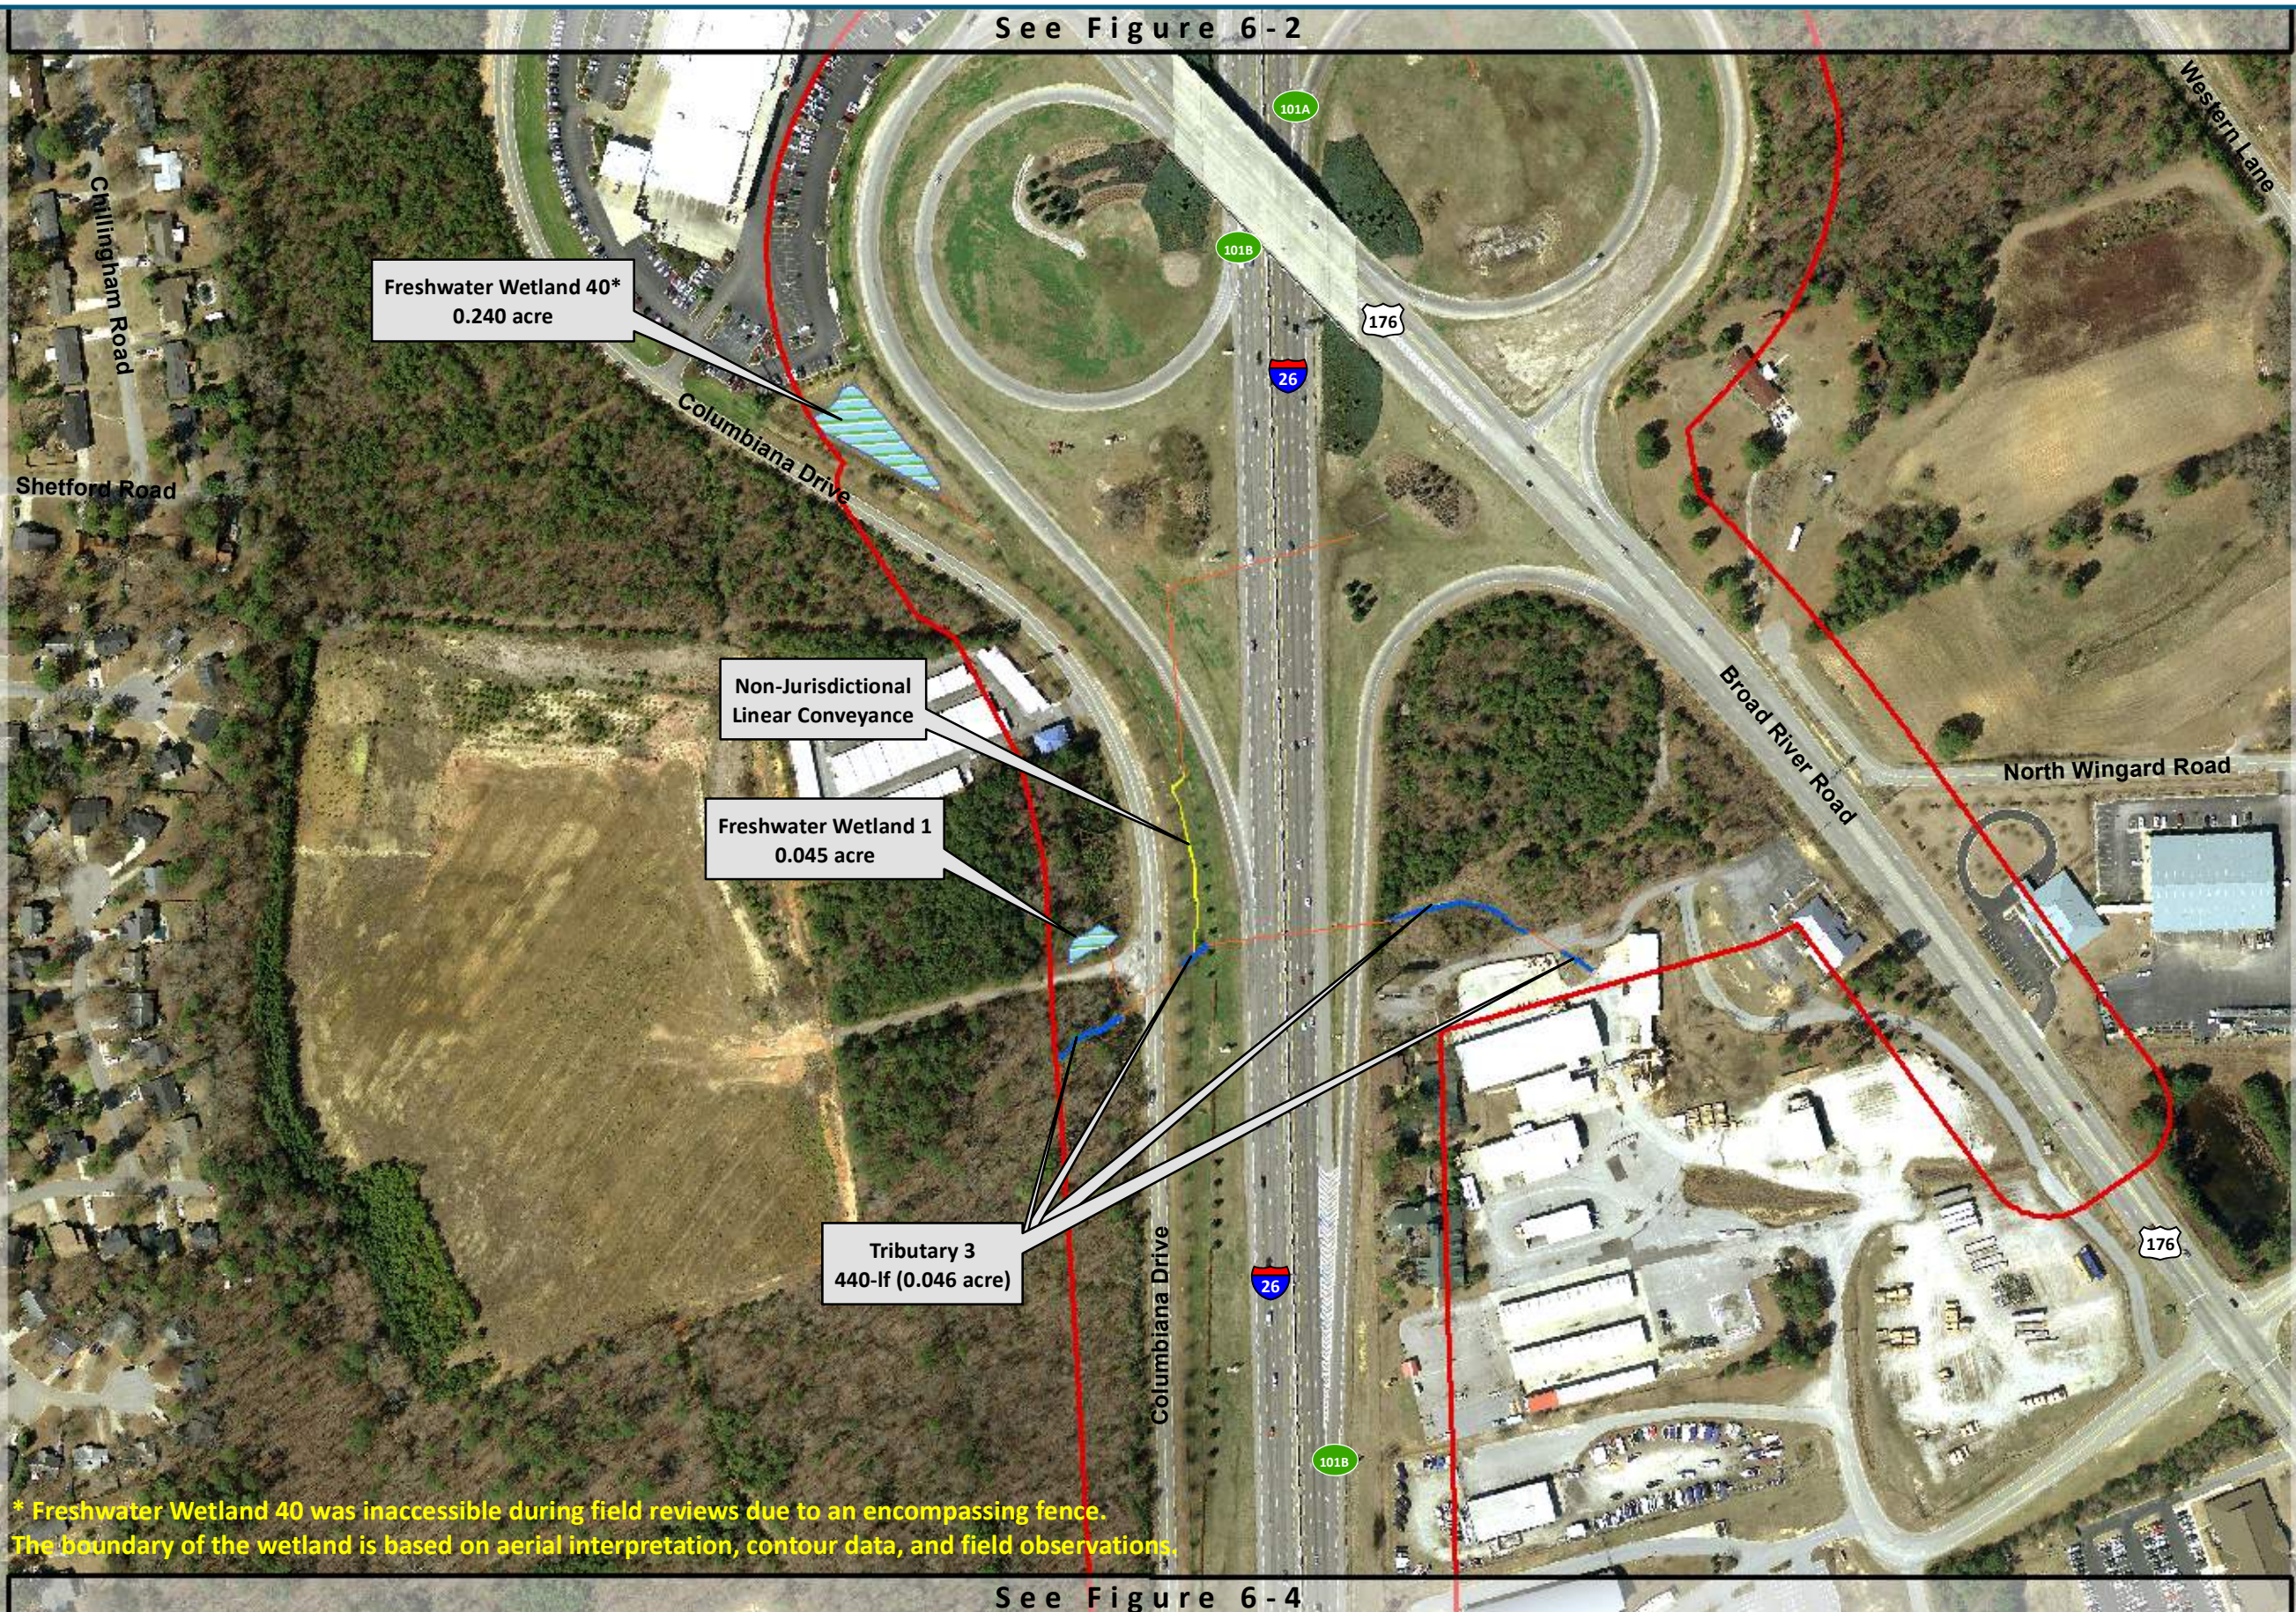
* Freshwater Wetland 40 was inaccessible during field reviews due to an encompassing fence. The boundary of the wetland is based on aerial interpretation, contour data, and field observations.
