Natural Resources Technical Report

Carolina Crossroads

I-20/I-26/I-126 Corridor Improvements

Final (Revised) May 2019

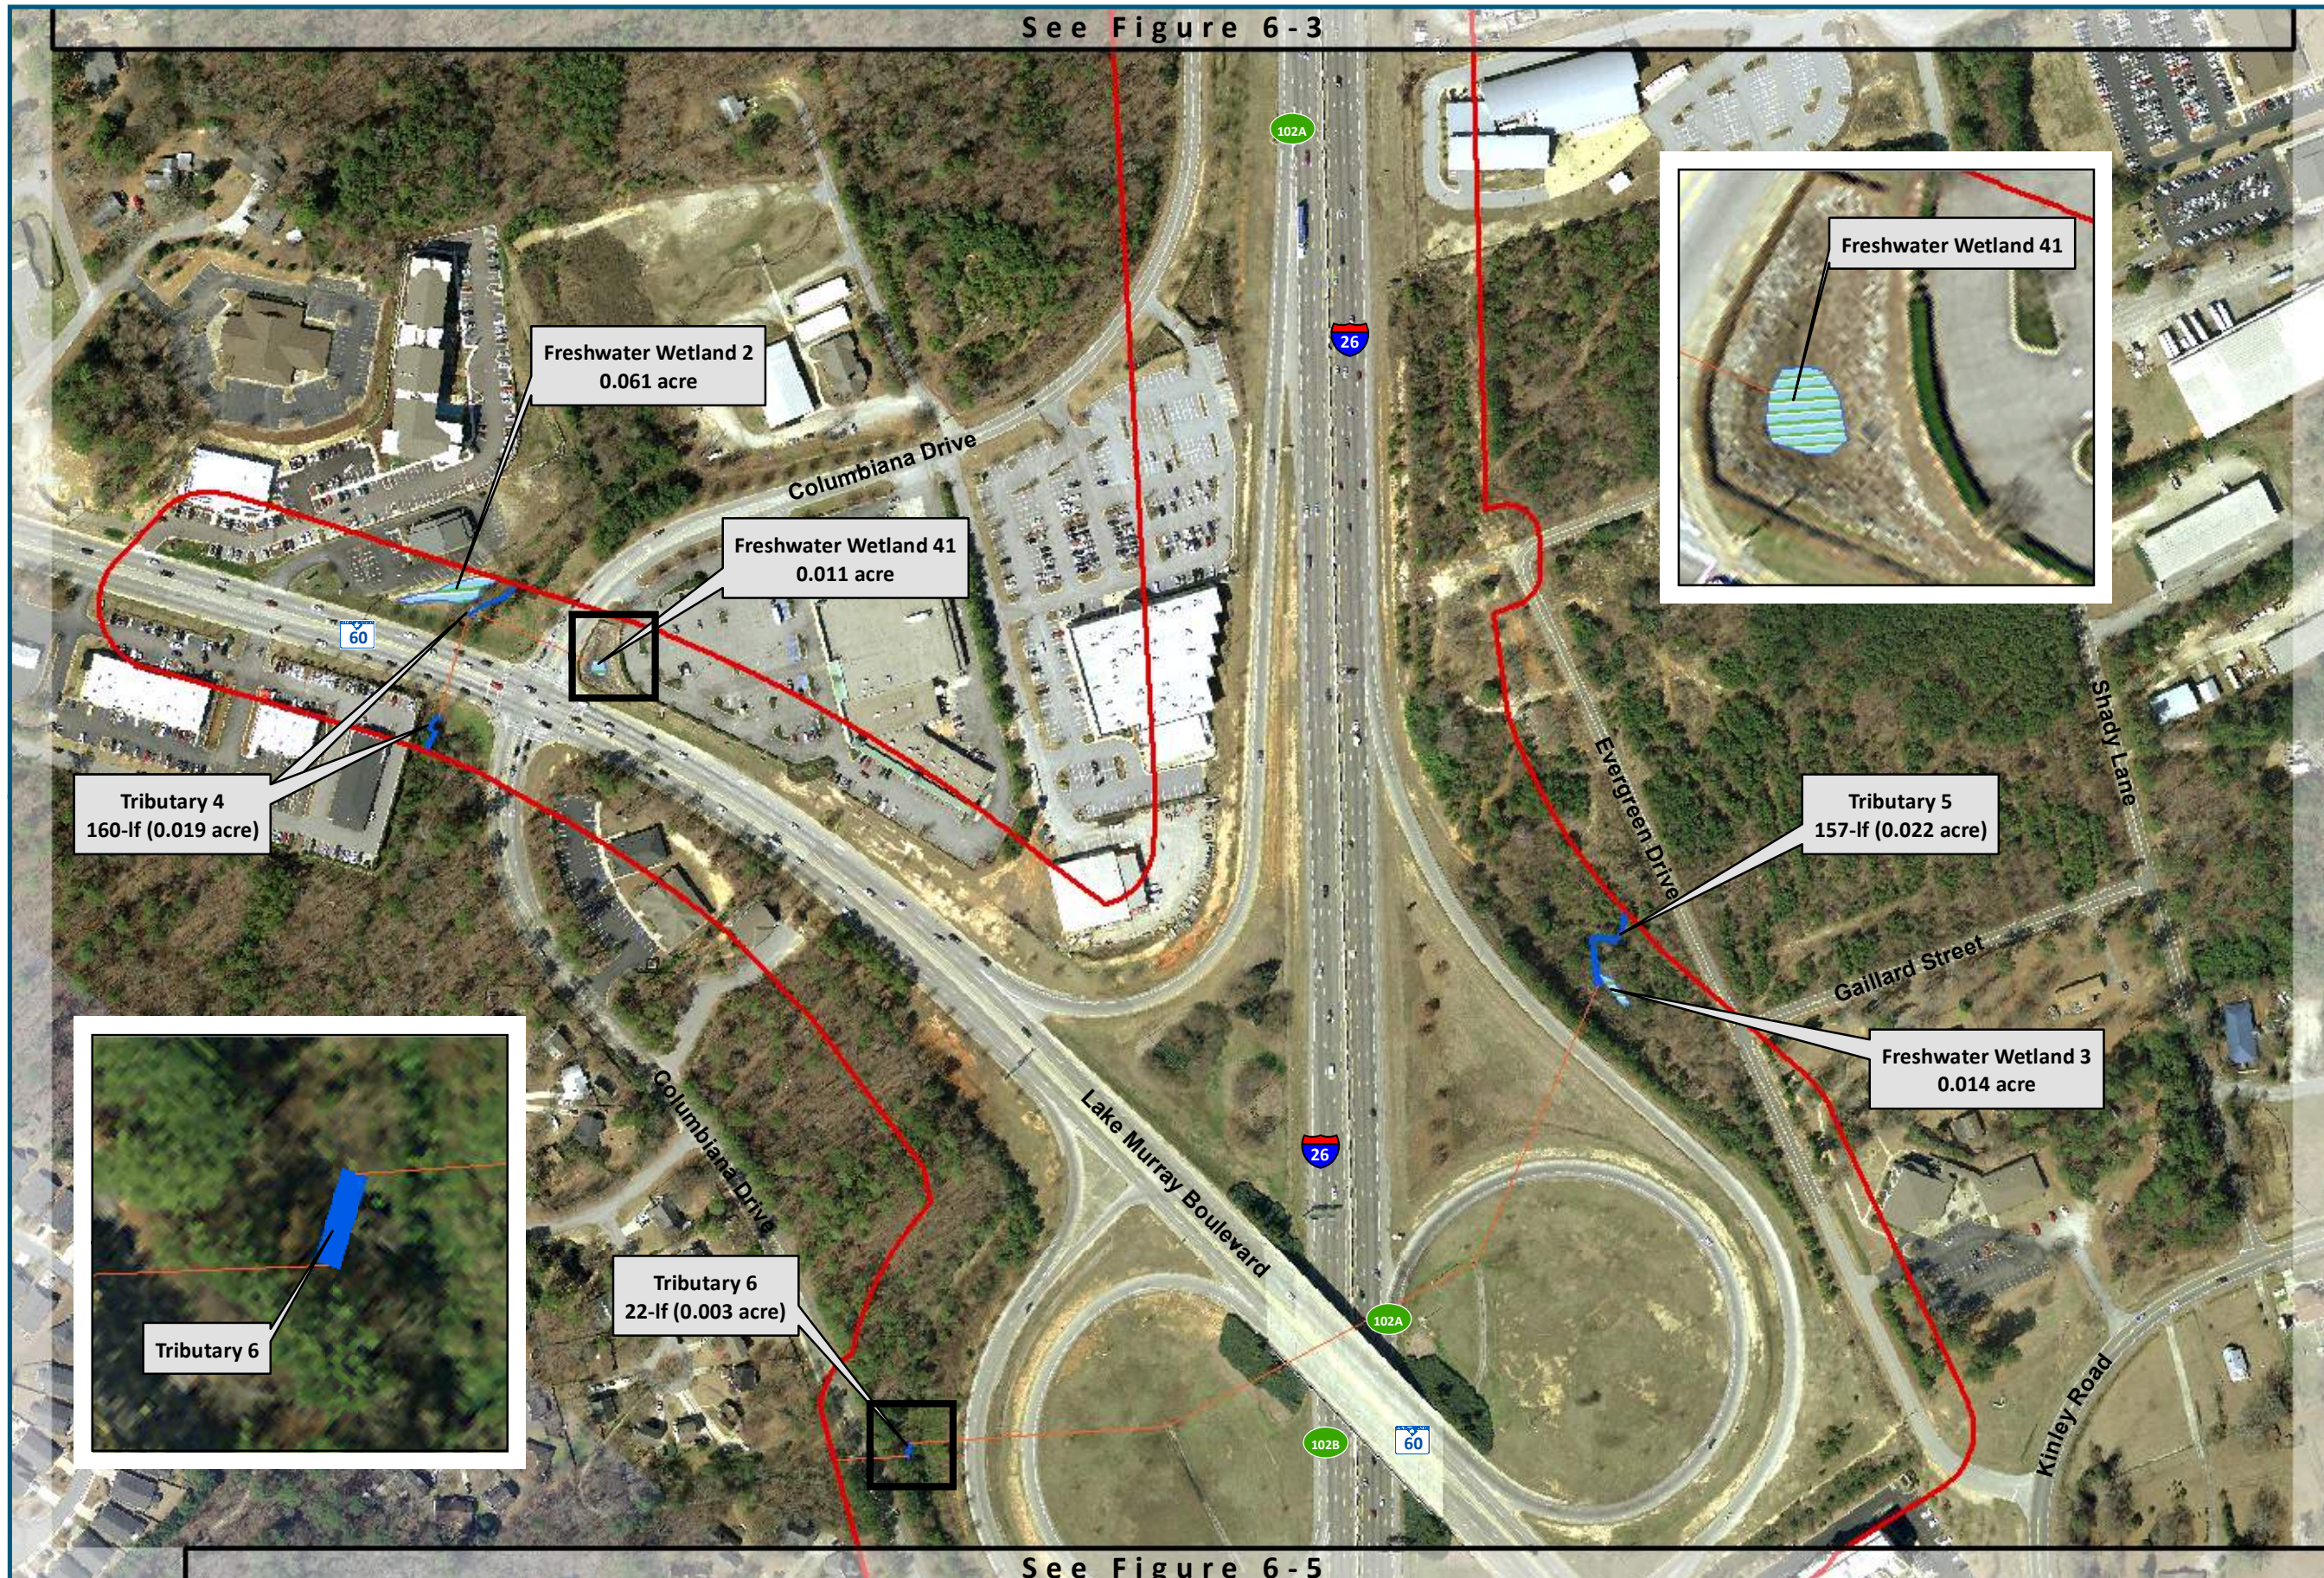
Figure 6-4
Delineated Waters of
the U.S.

- Legend**
- Project Study Area (1,482 acres)
 - Freshwater Wetland (0.086 acre)
 - Pond / Water
 - Tributary (339-lf / 0.044 acre)
 - Conveyance / Non-Water
 - Culvert / Pipe / Flume
 - Exit Location/Number

A total of 55 wetland communities were identified within the PSA during site reviews by the project team, as listed in Table 3. Please see **Appendix A, Figures 6-1 through 6-35** for the location and extent of delineated wetlands in the PSA.

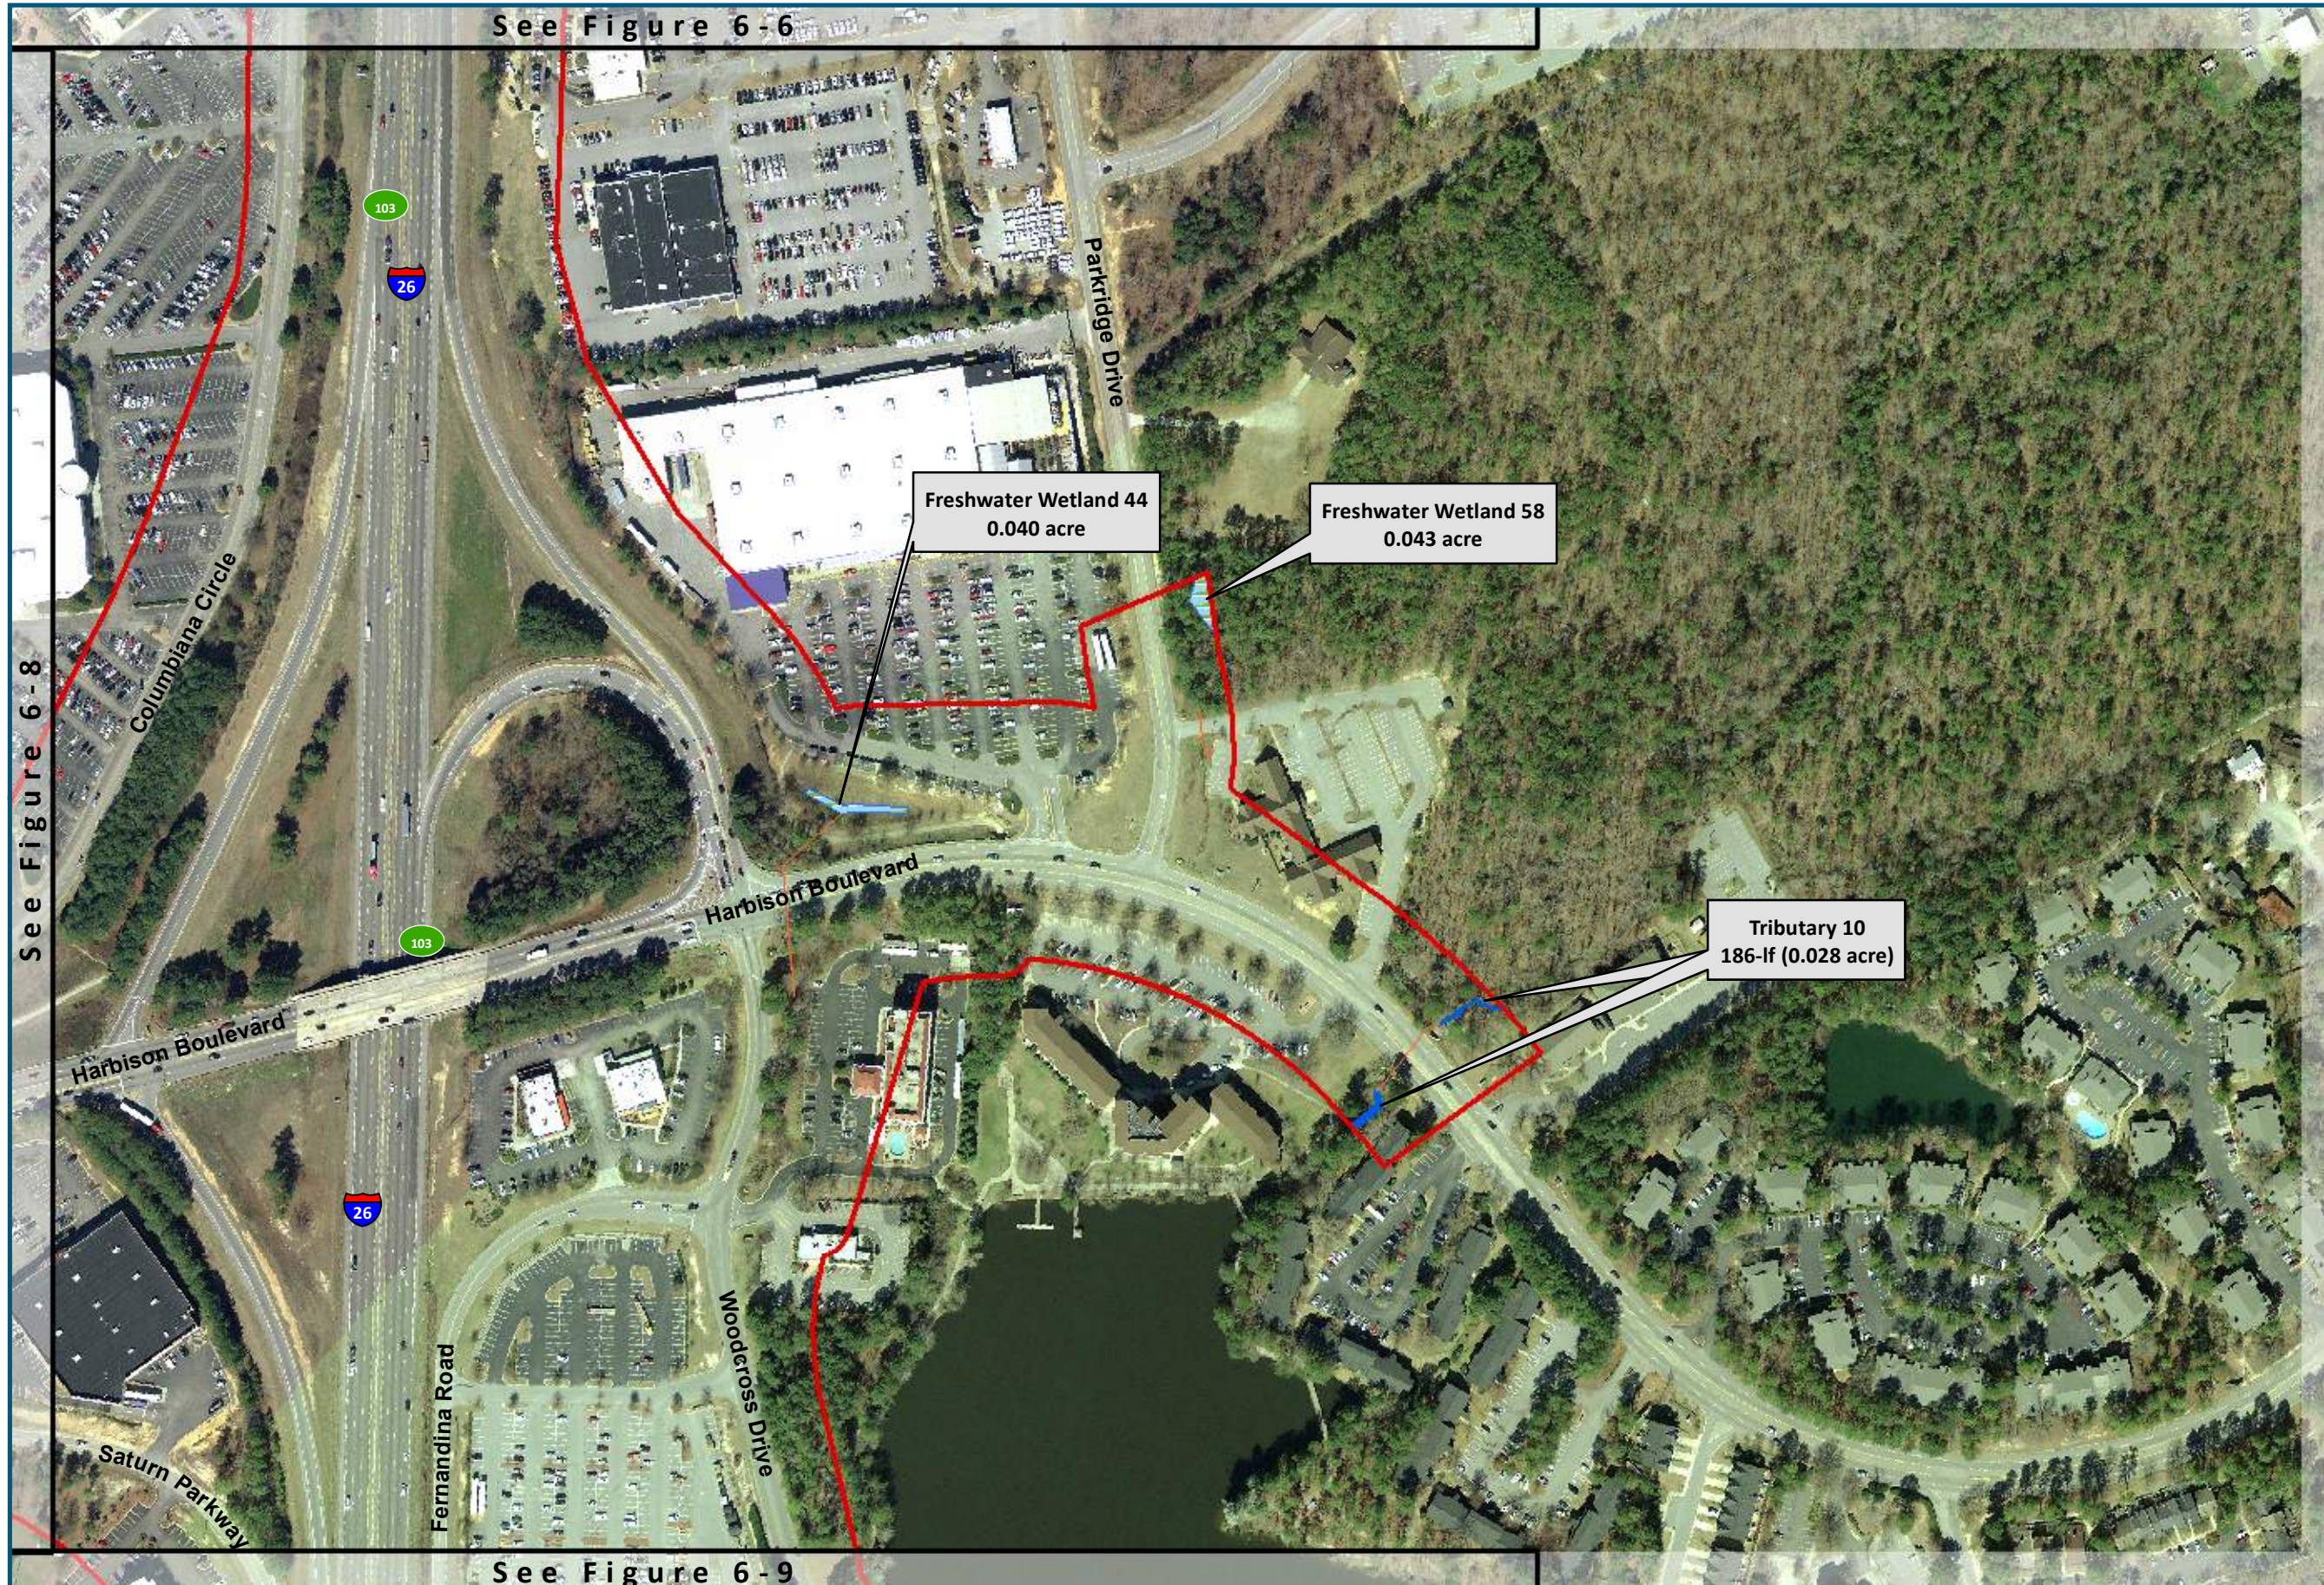
Figure 6-7
Delineated Waters of the U.S.

- Project Study Area (1,482 acres)
- Freshwater Wetland (0.083 acre)
- Pond / Water
- Tributary (186-lf / 0.028 acre)
- Conveyance / Non-Water
- Culvert / Pipe / Flume
- Exit Location/Number

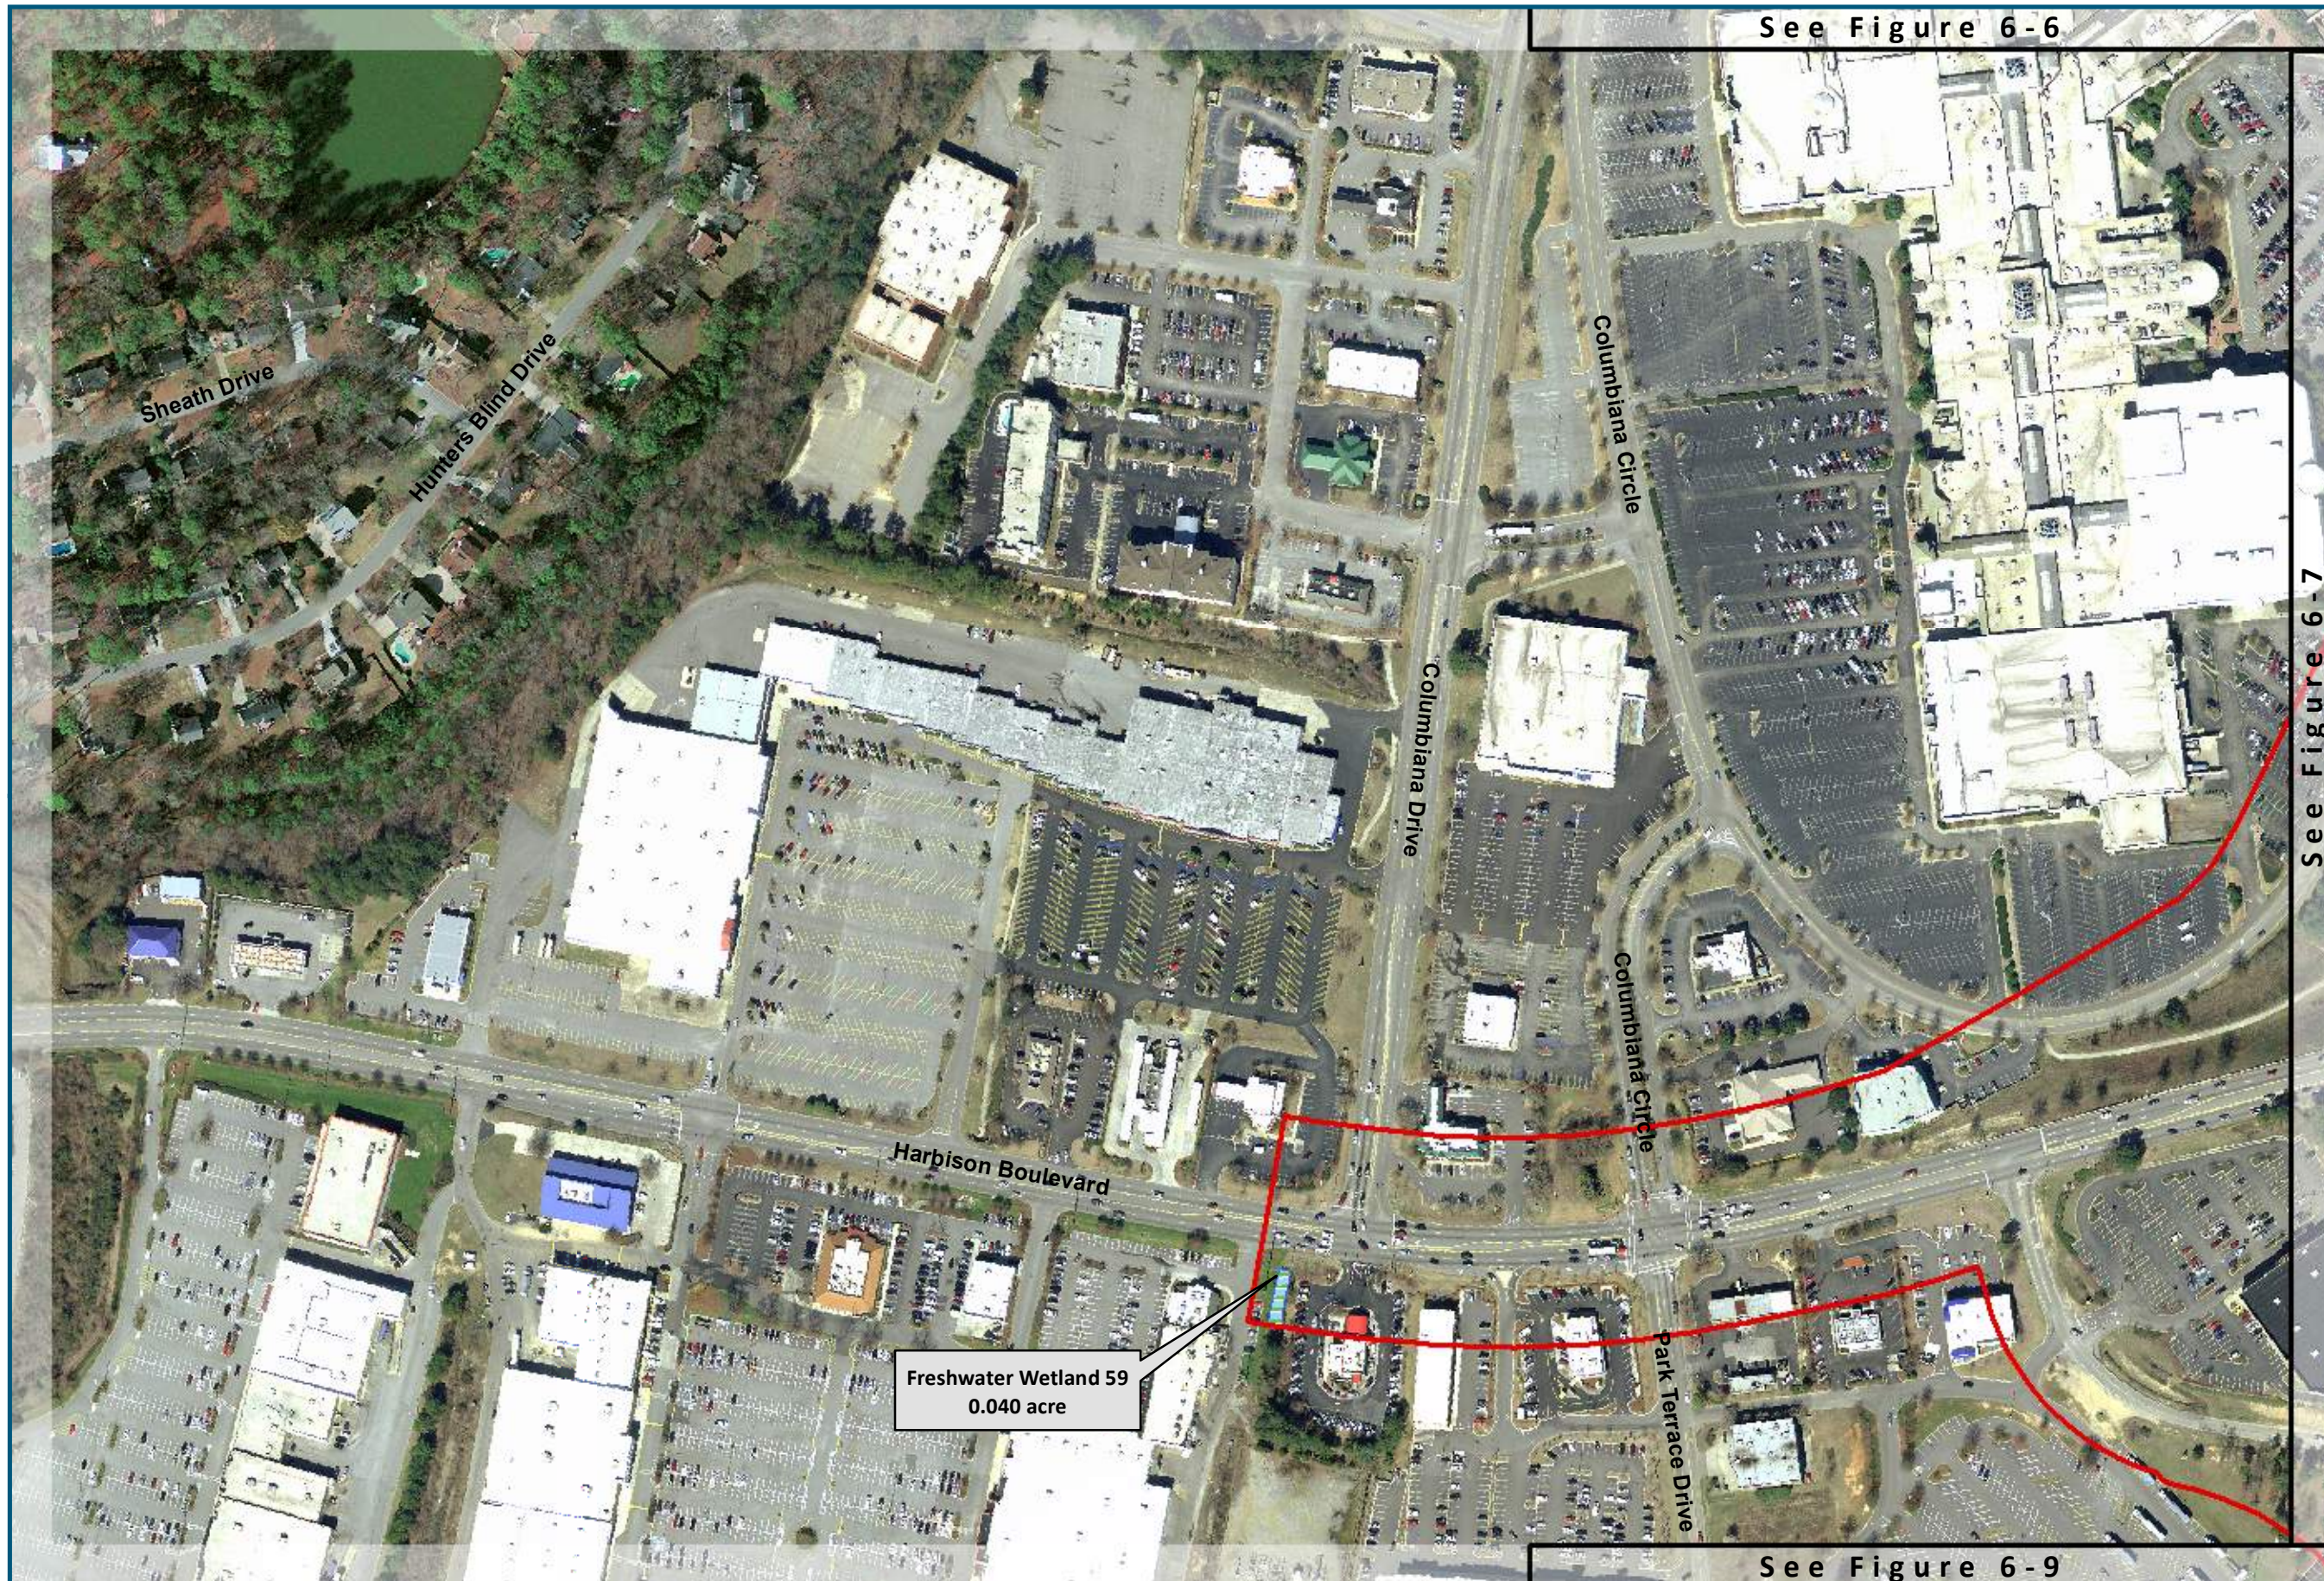
Figure 6-8
Delineated Waters of
the U.S.

- Legend**
- Project Study Area (1,482 acres)
 - Freshwater Wetland (0.040 acre)
 - Pond / Water
 - Tributary
 - Conveyance / Non-Water
 - Culvert / Pipe / Flume
 - Exit Location/Number

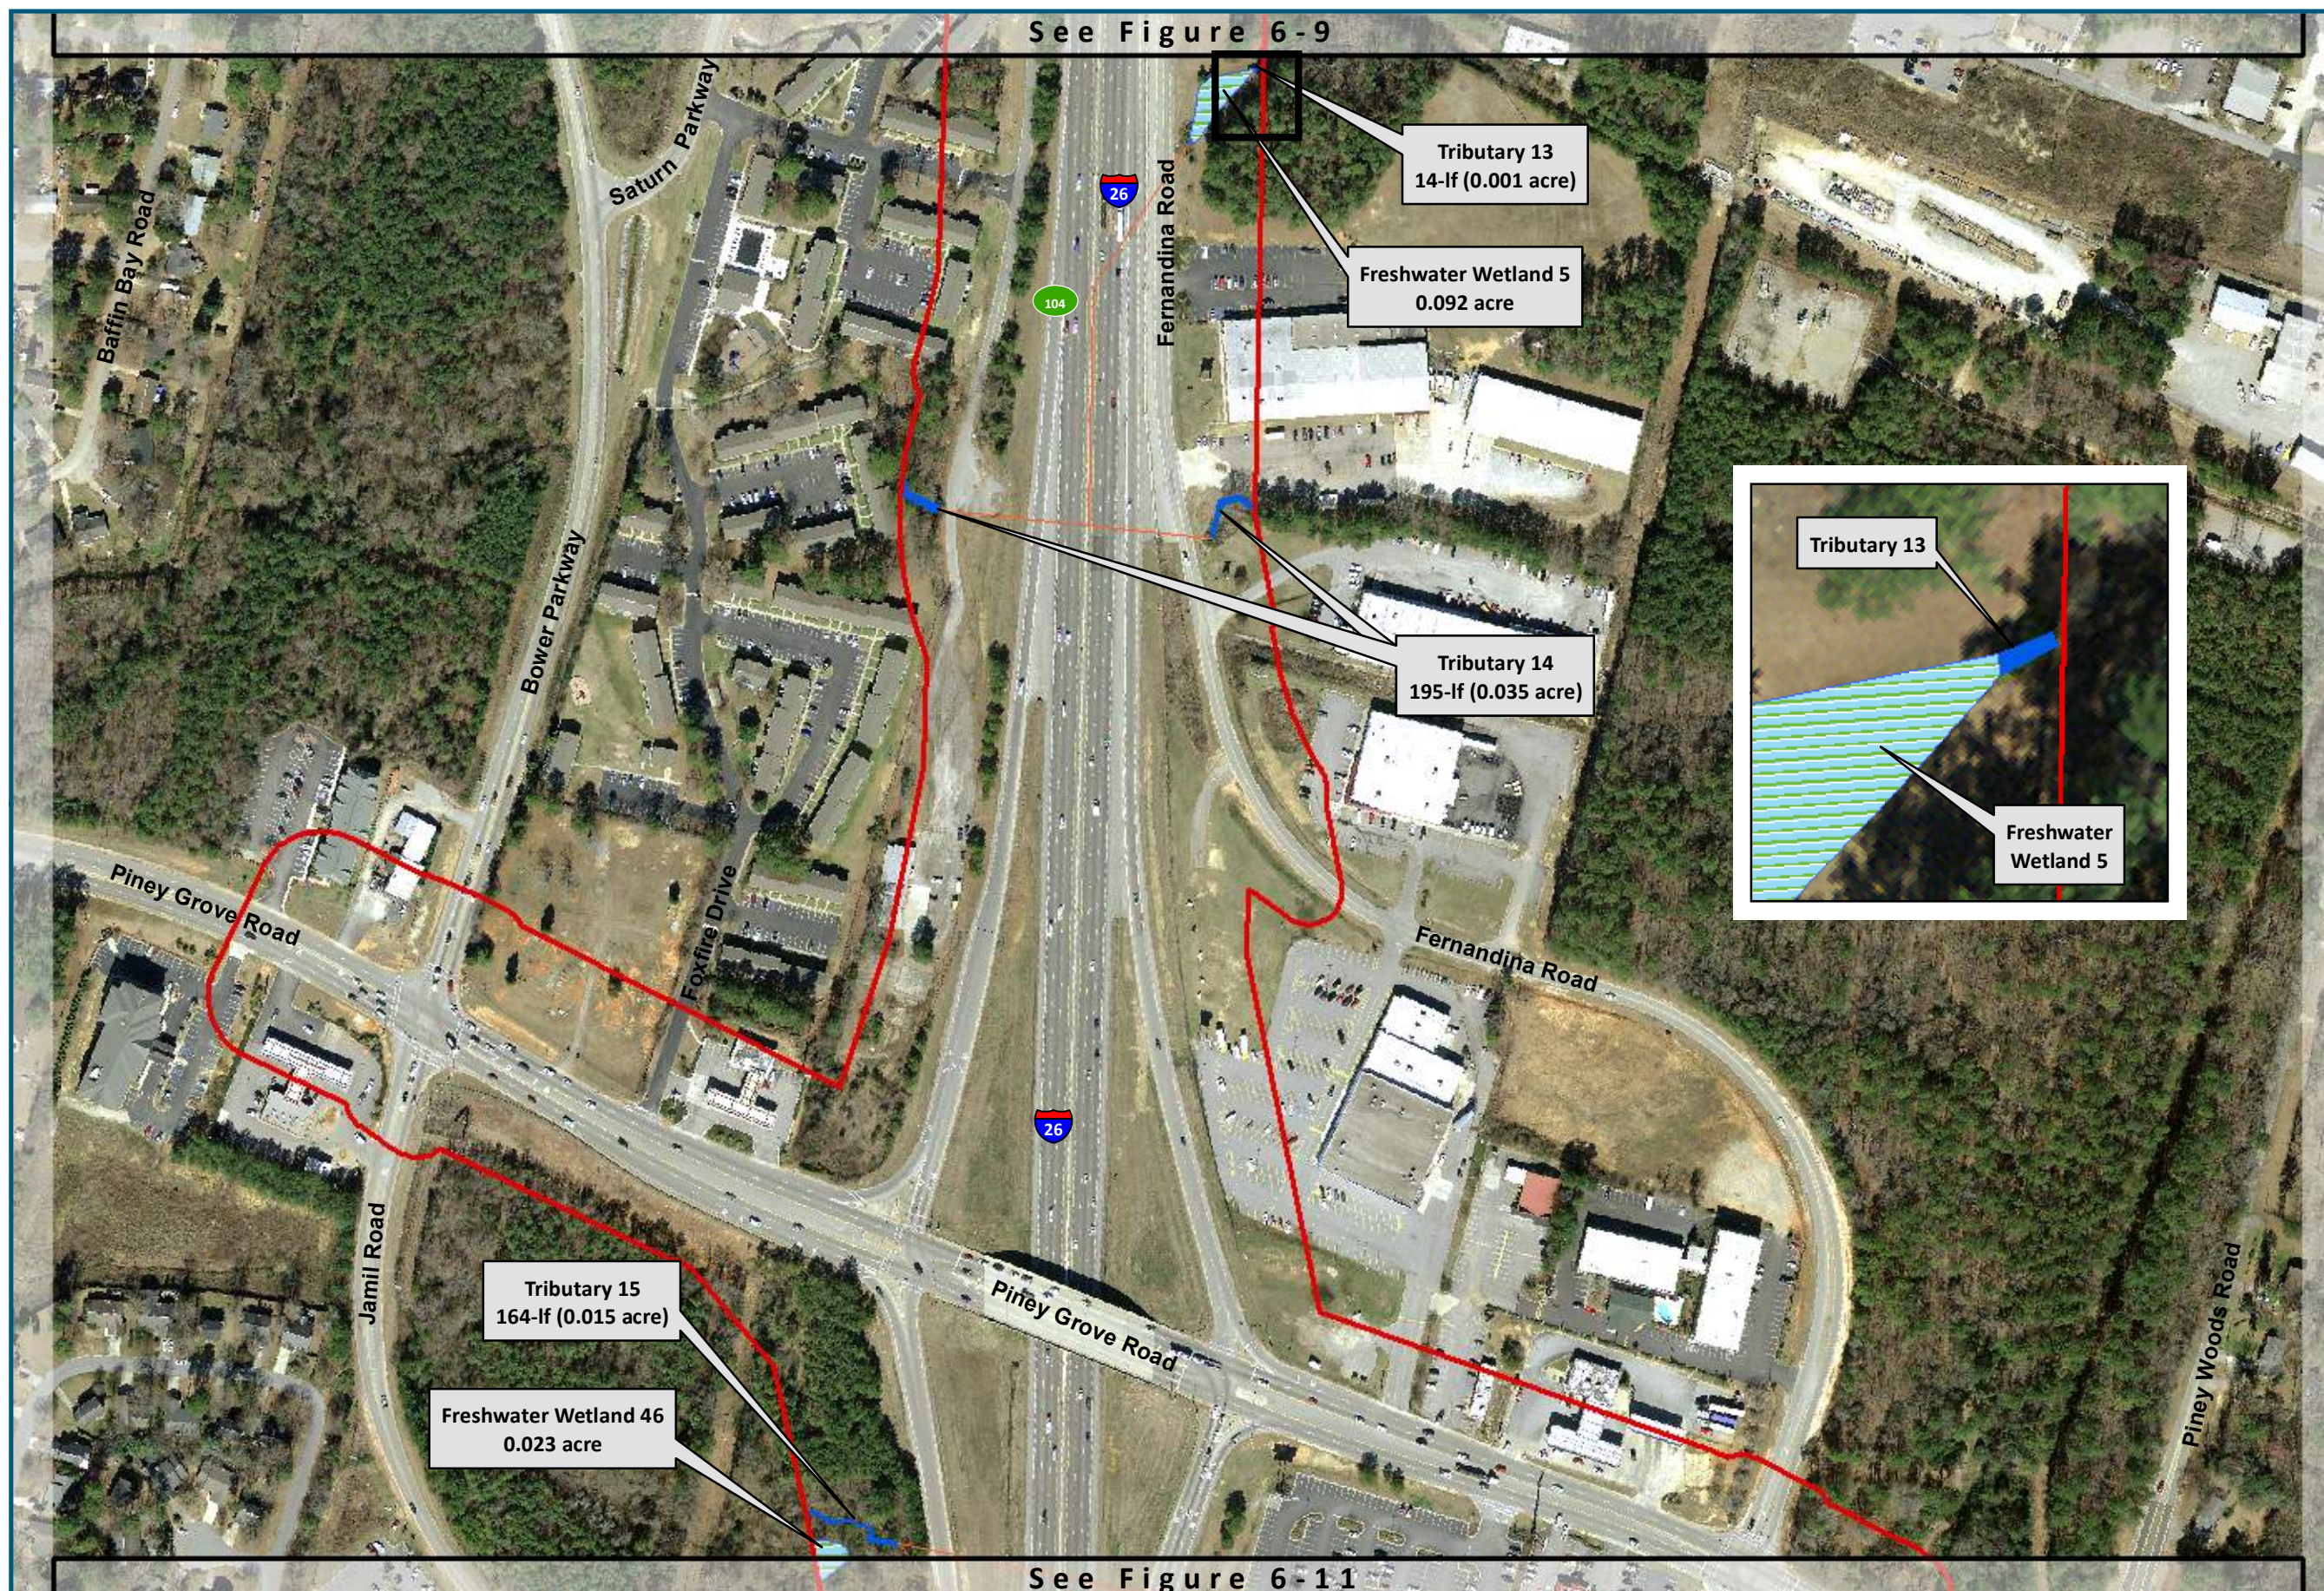
Figure 6-10
Delineated Waters of
the U.S.

- Legend**
- Project Study Area (1,482 acres)
 - Freshwater Wetland (0.115 acre)
 - Pond / Water
 - Tributary (373-lf / 0.051 acre)
 - Conveyance / Non-Water
 - Culvert / Pipe / Flume
 - Exit Location/Number

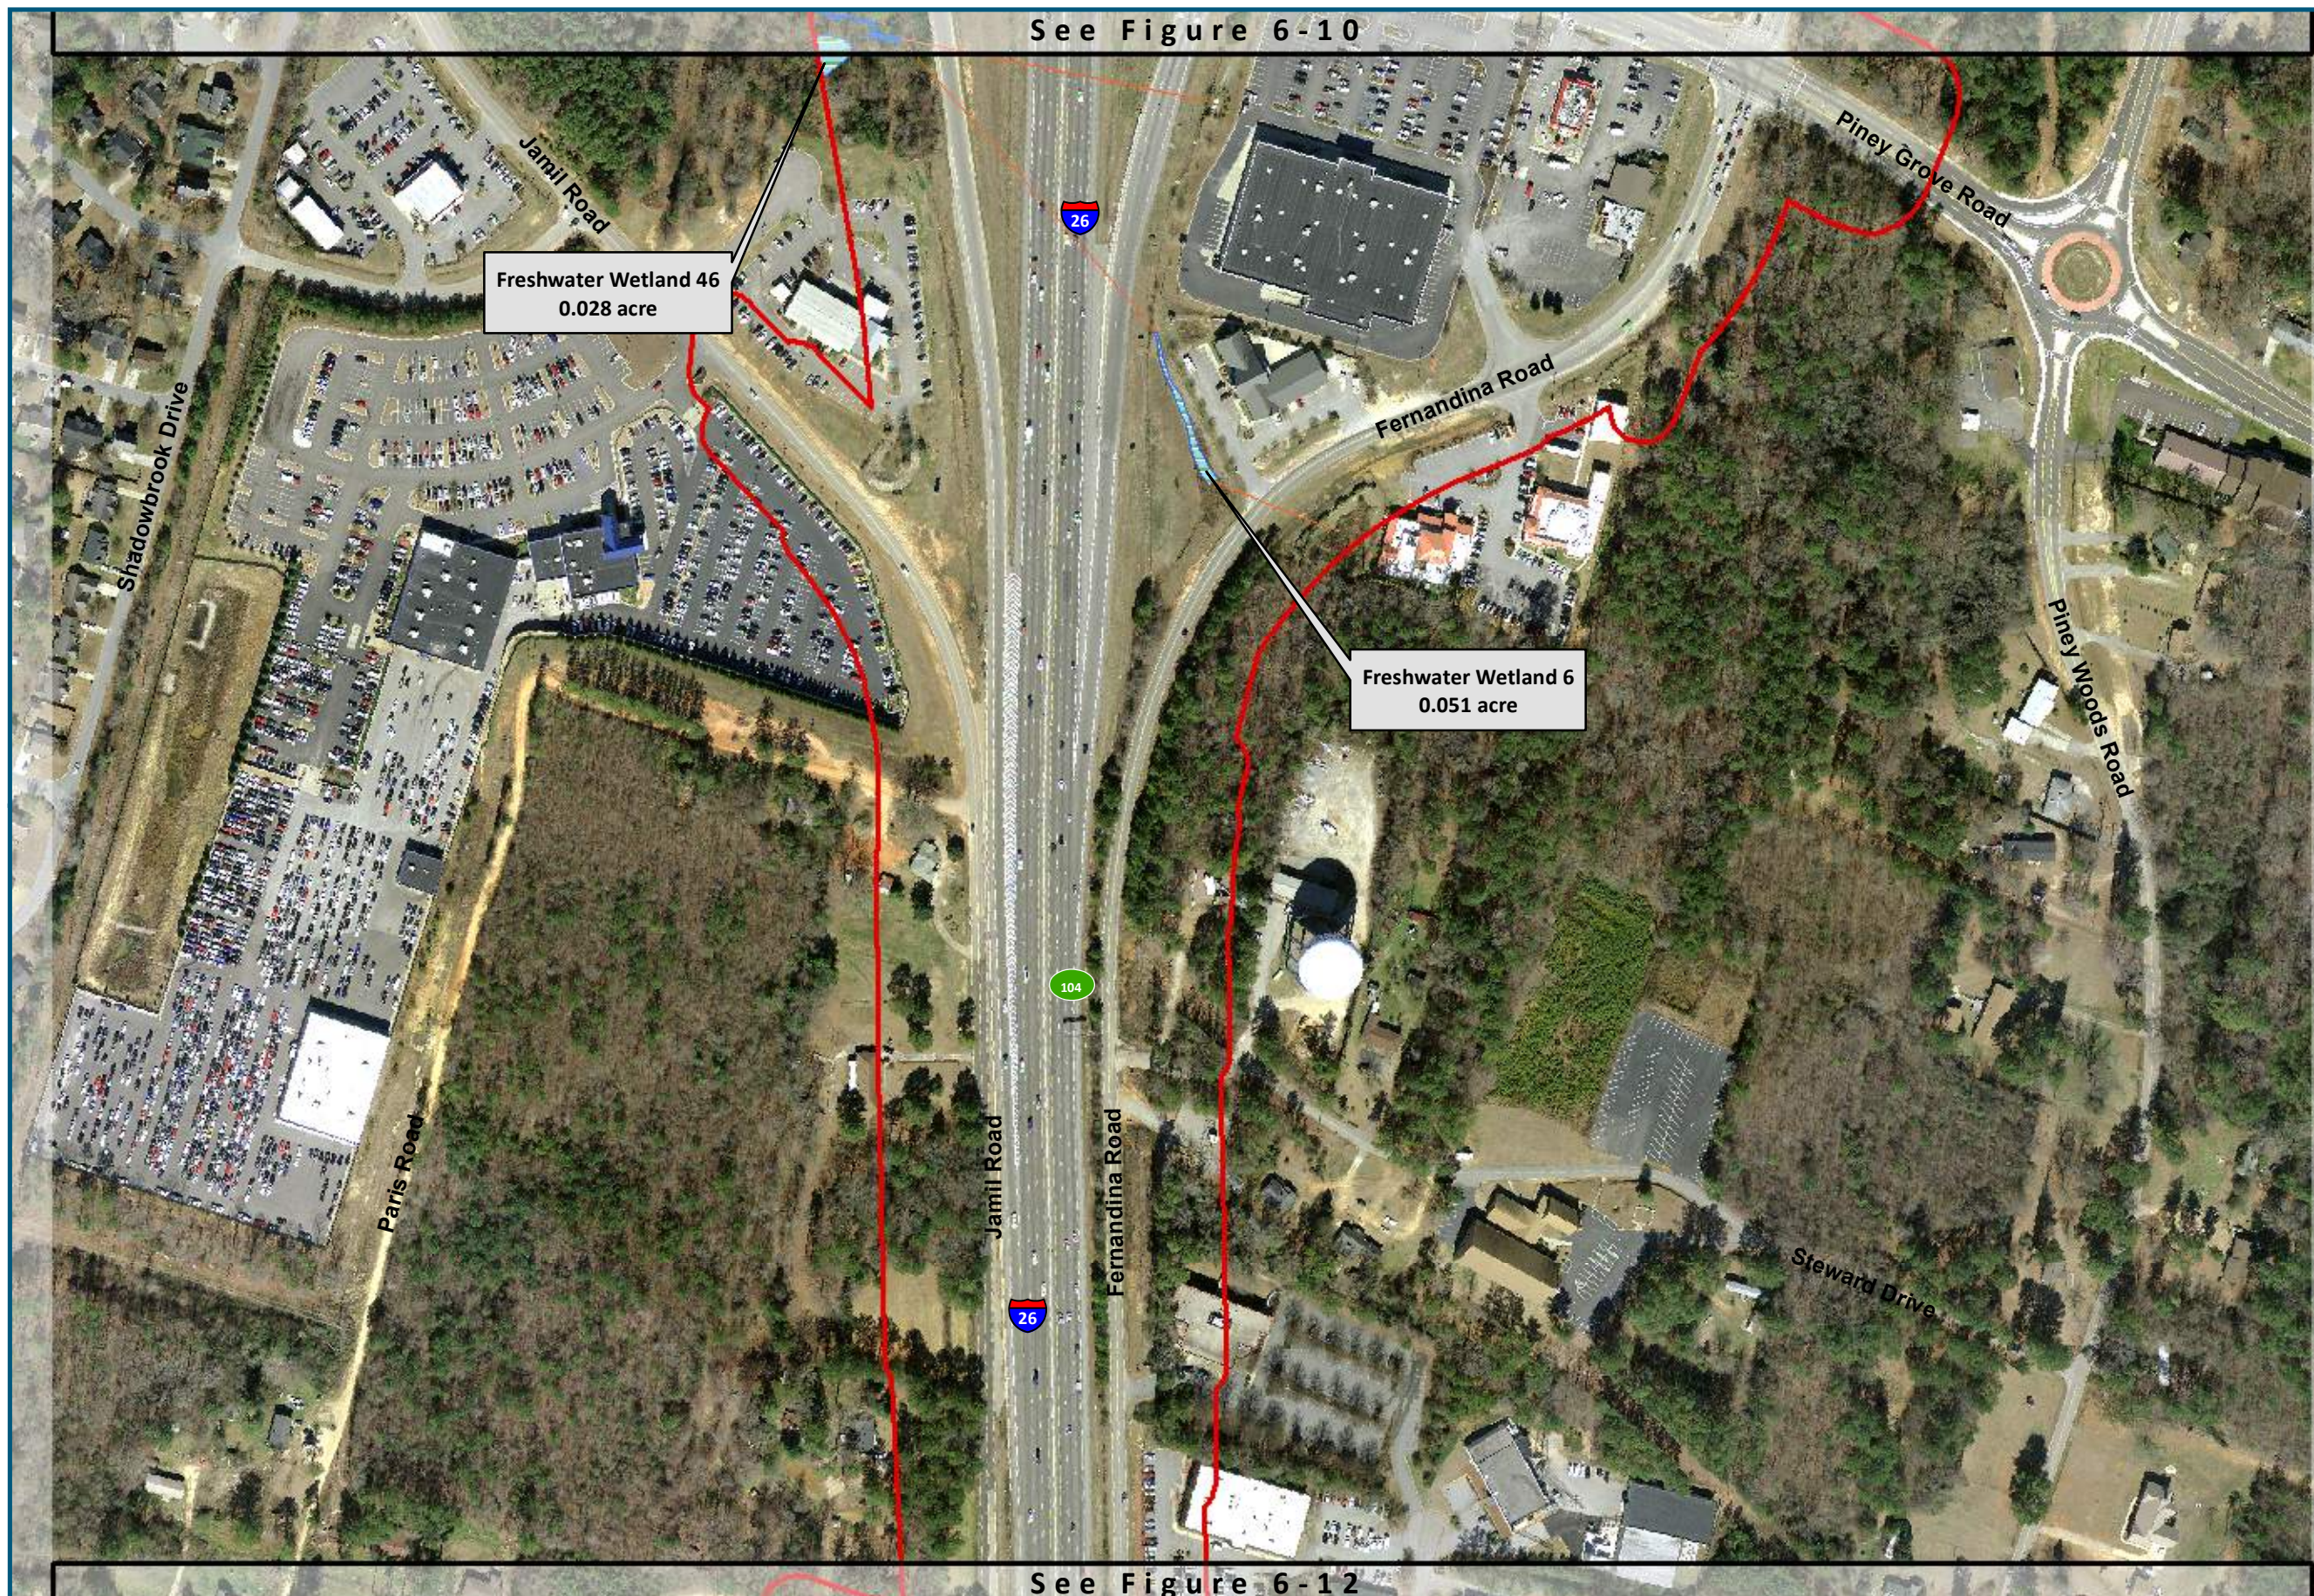
Figure 6-11
Delineated Waters of
the U.S.

- Project Study Area
(1,482 acres)
- Freshwater Wetland
(0.079 acre)
- Pond / Water
- Tributary
- Conveyance / Non-Water
- Culvert / Pipe / Flume
- Exit Location/Number

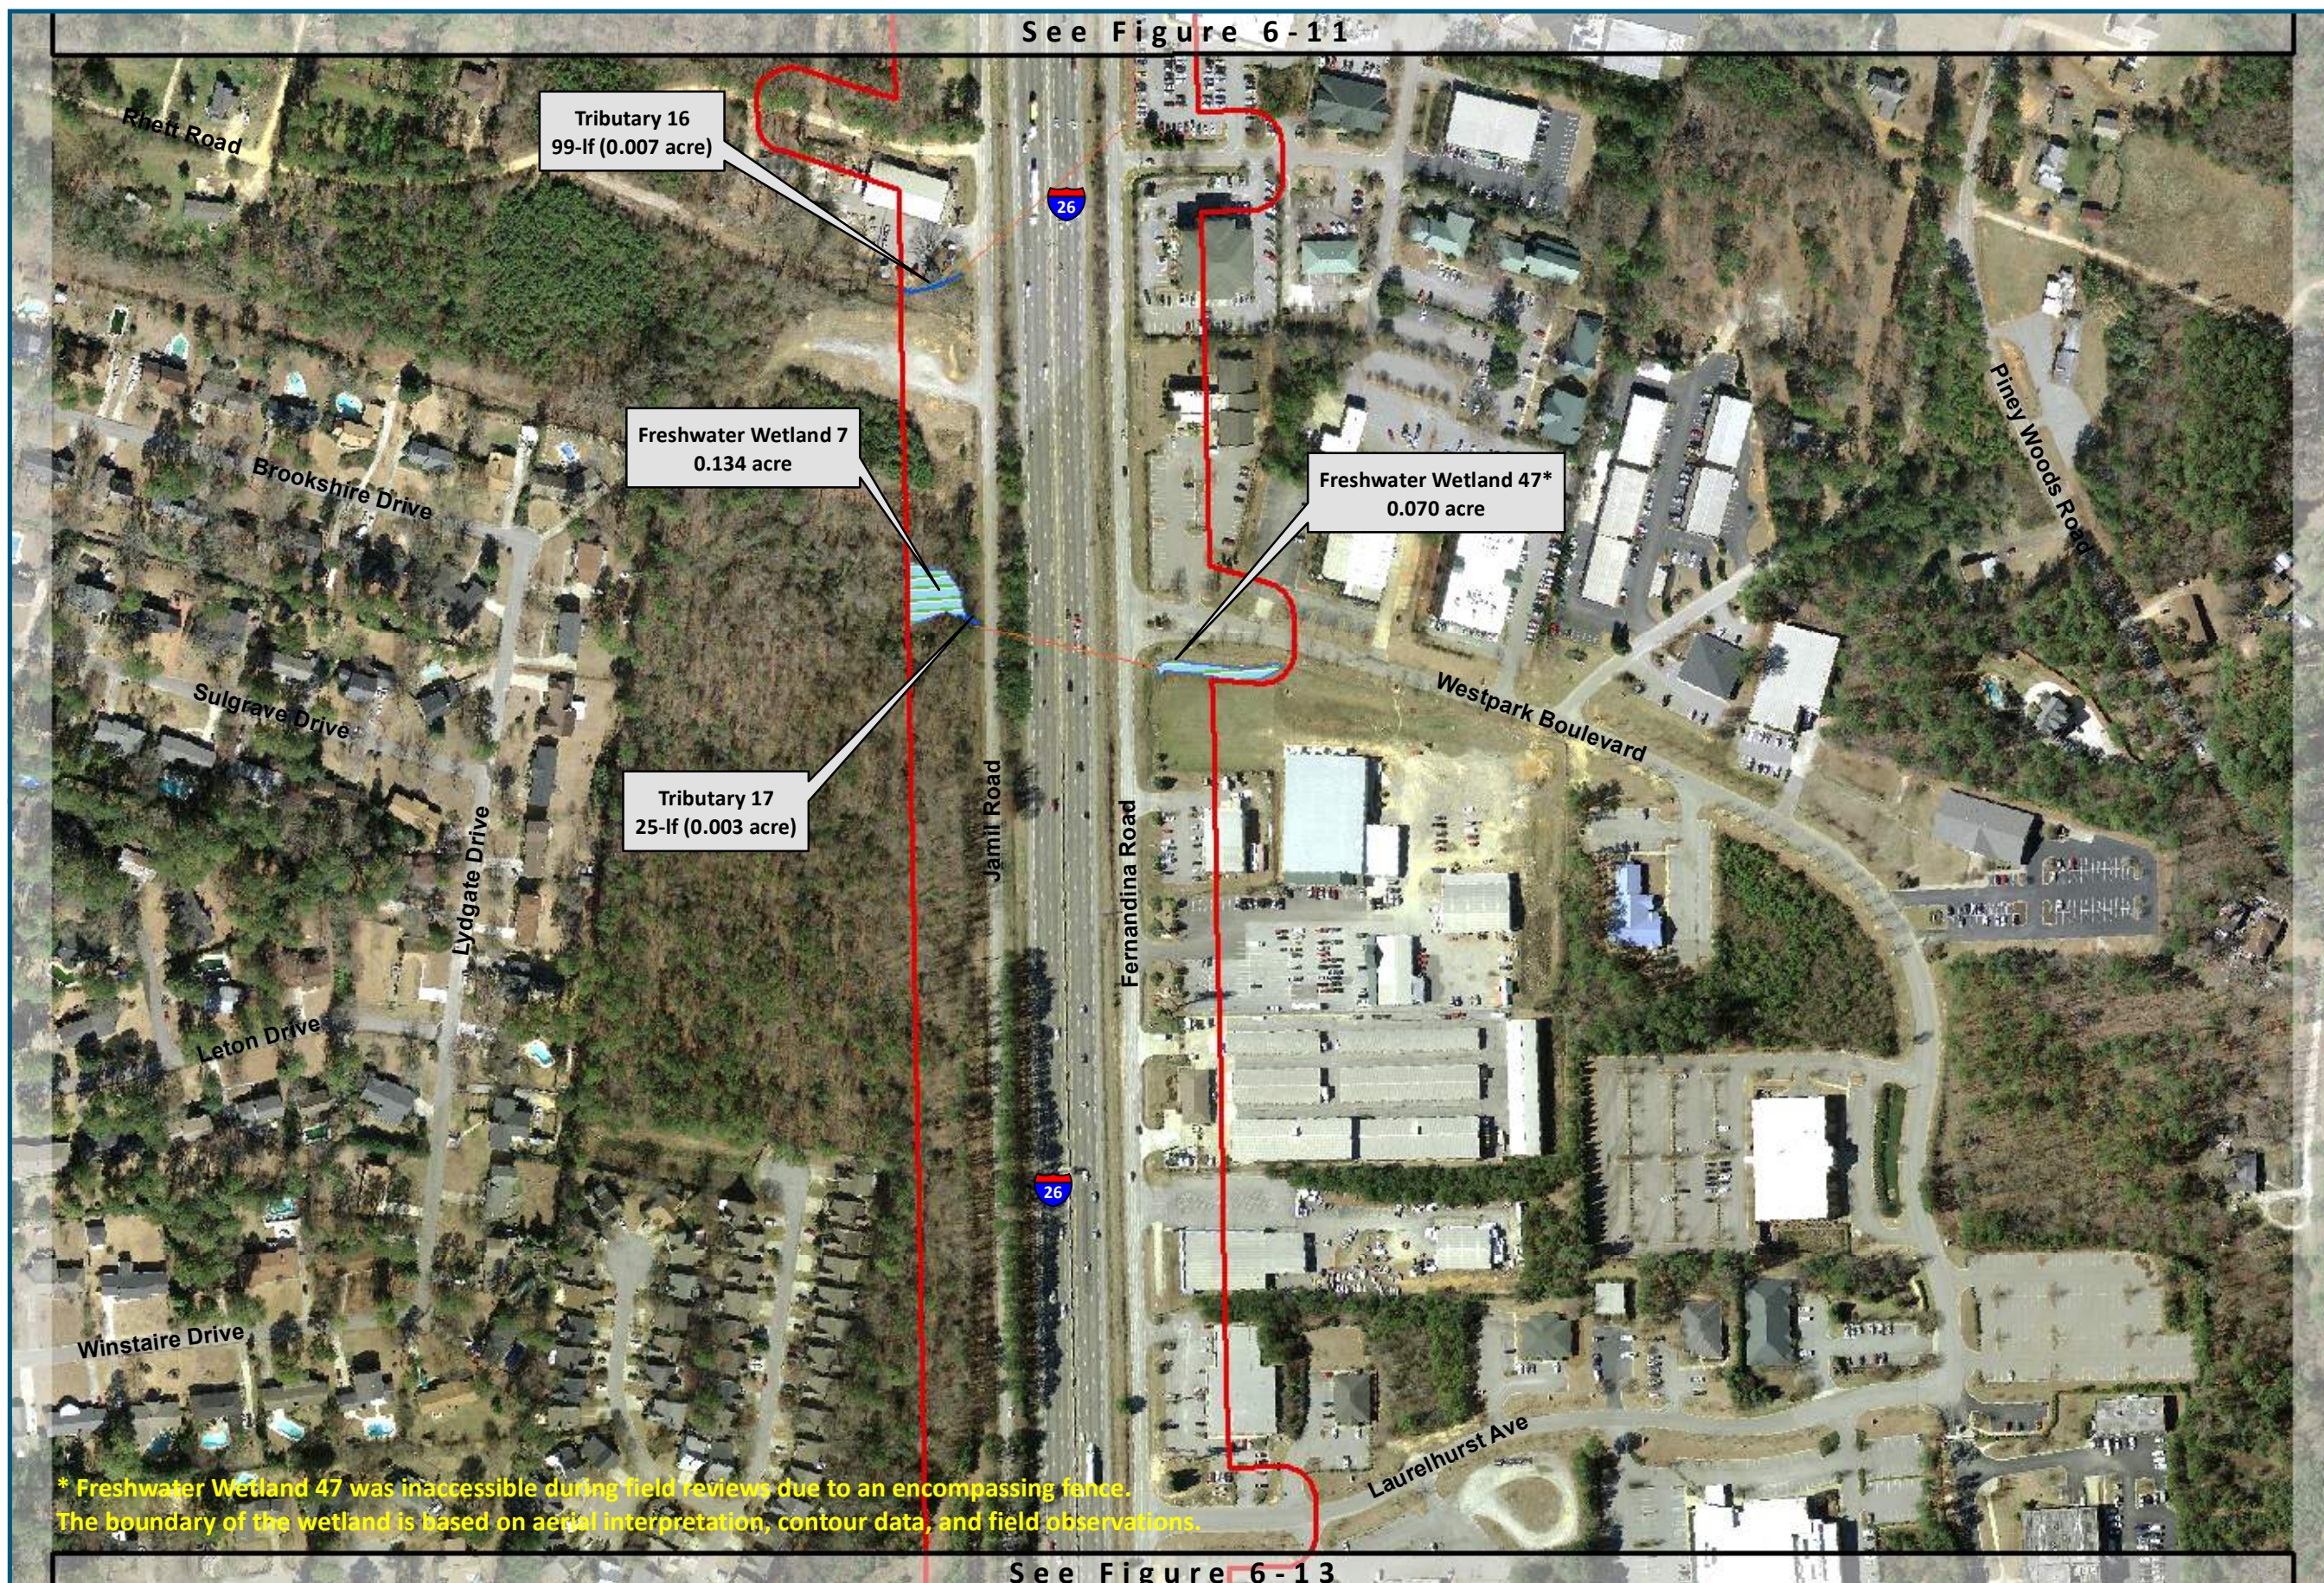
* Freshwater Wetland 47 was inaccessible during field reviews due to an encompassing fence. The boundary of the wetland is based on aerial interpretation, contour data, and field observations.
