Natural Resources Technical Report

Carolina Crossroads

I-20/I-26/I-126 Corridor Improvements

Final (Revised) May 2019

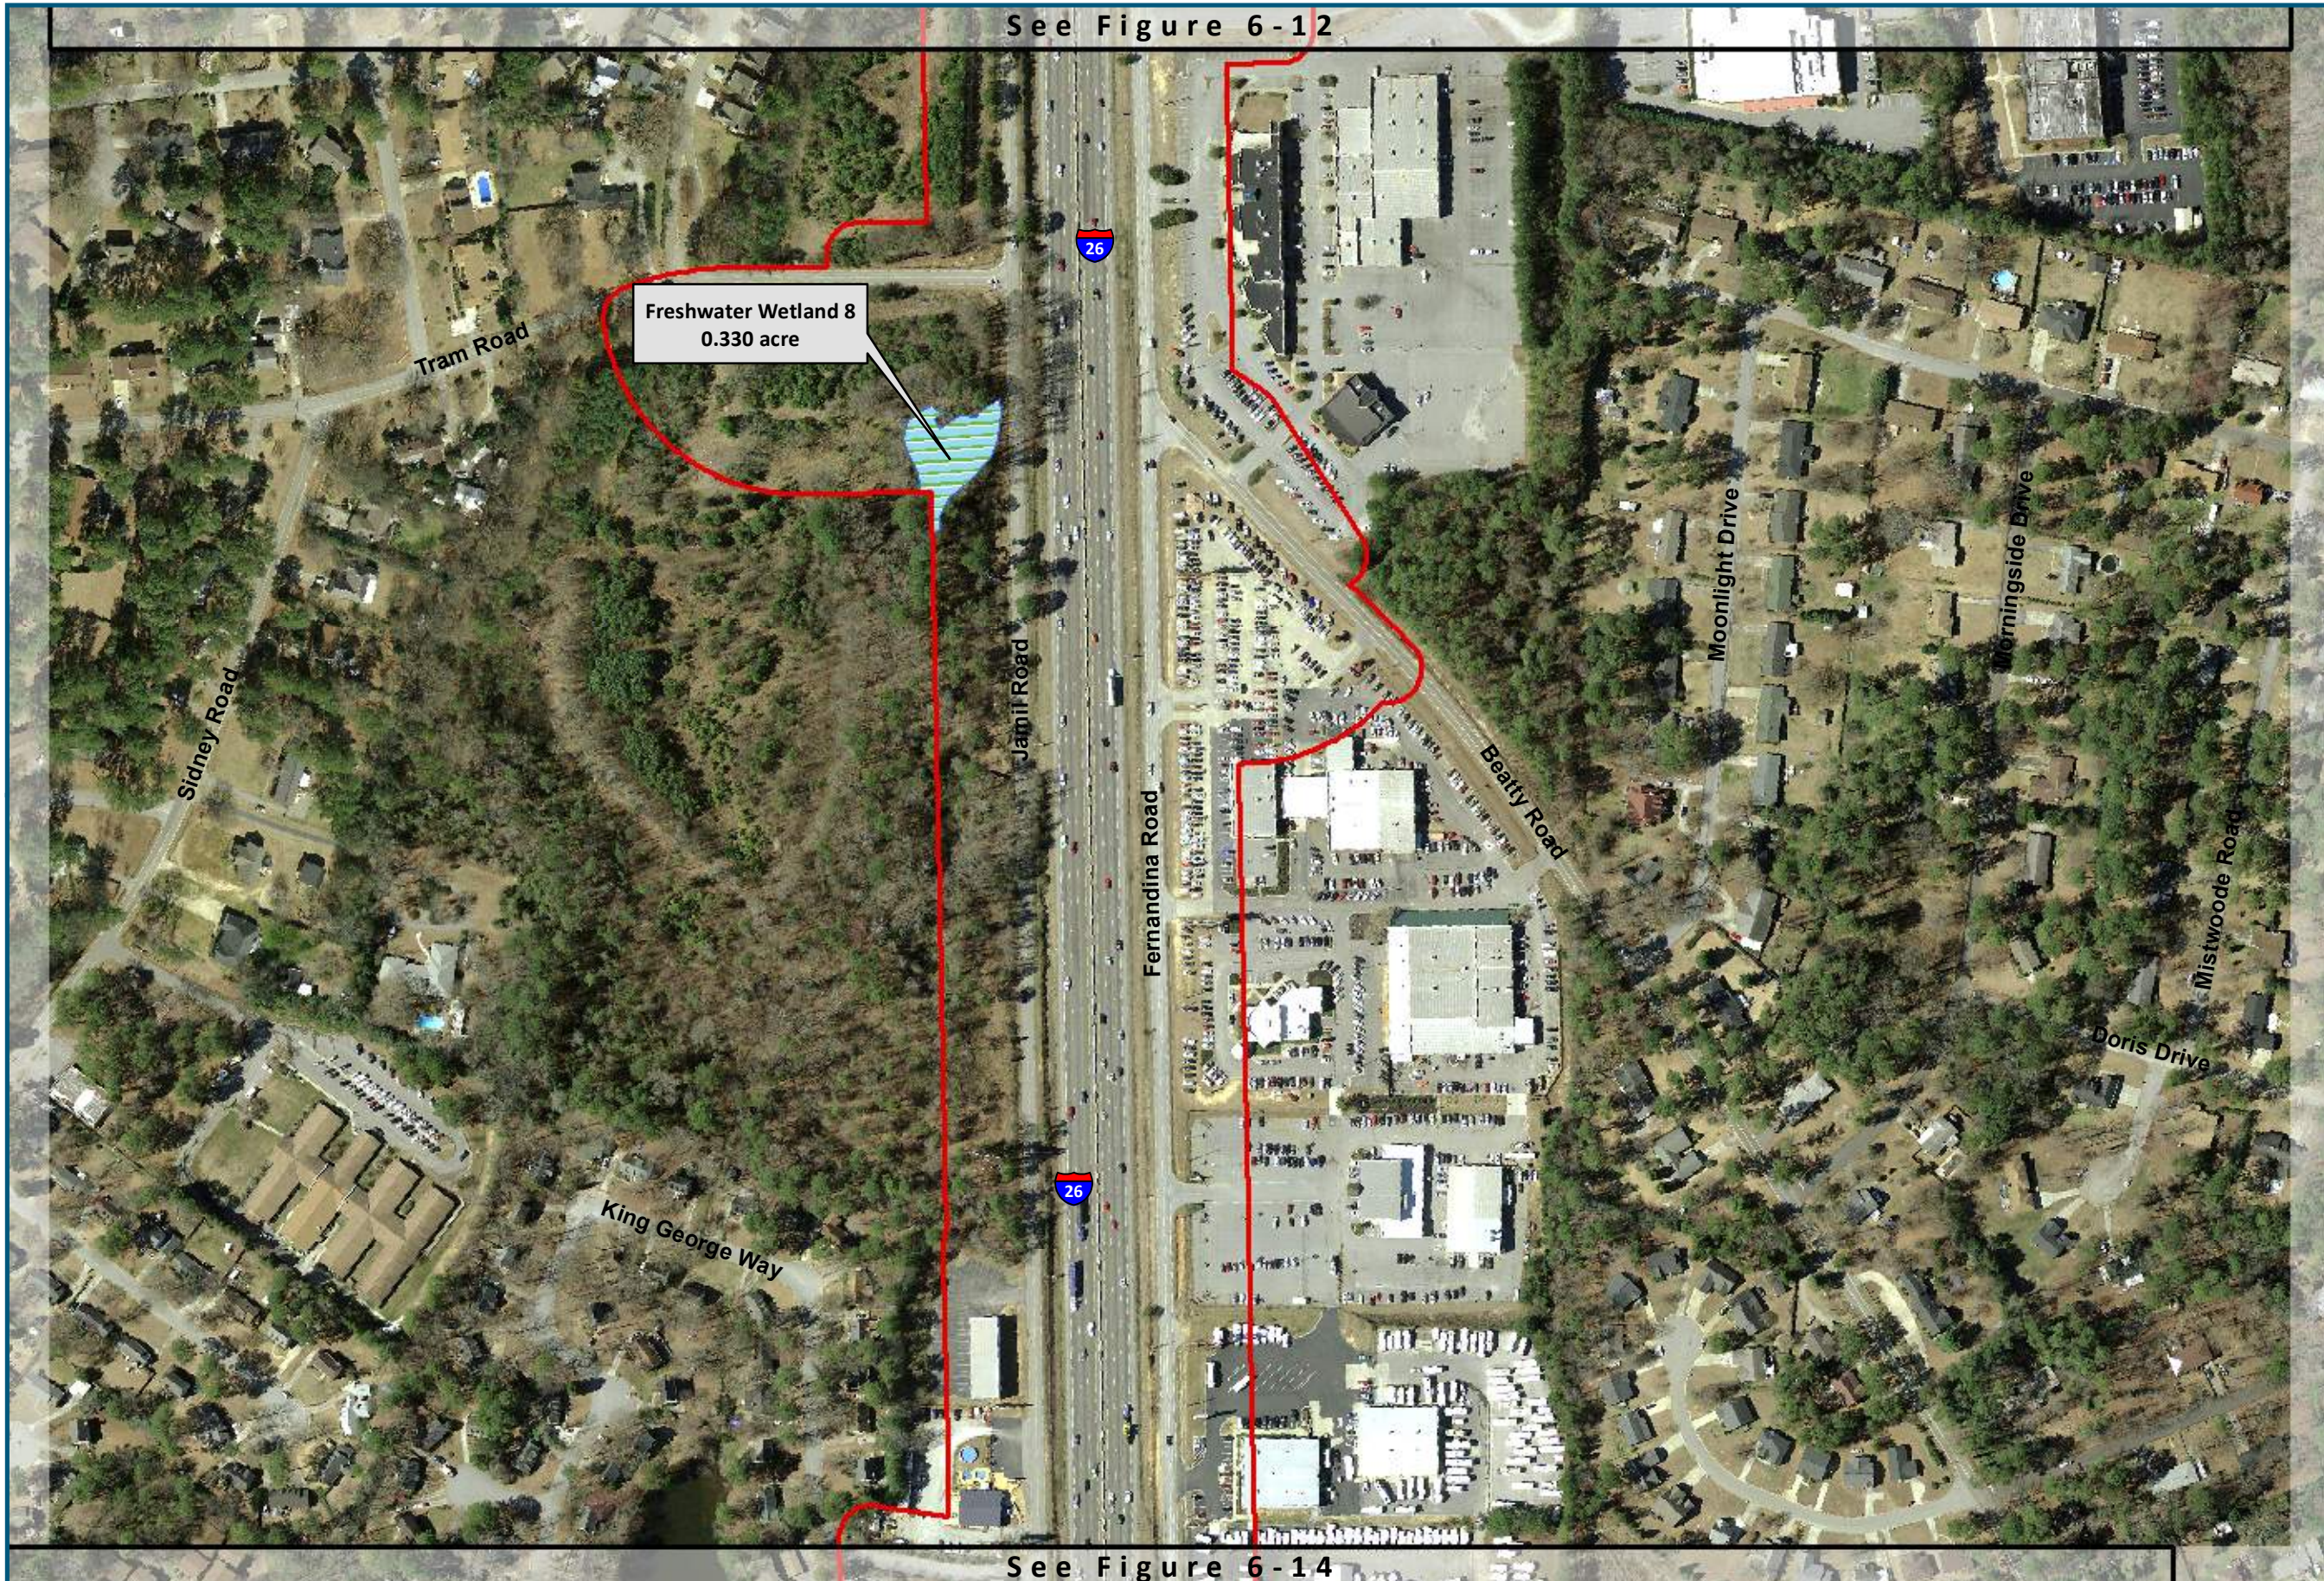
Figure 6-13
Delineated Waters of
the U.S.

- Legend**
- Project Study Area (1,482 acres)
 - Freshwater Wetland (0.330 acre)
 - Pond / Water
 - Tributary
 - Conveyance / Non-Water
 - Culvert / Pipe / Flume
 - Exit Location/Number

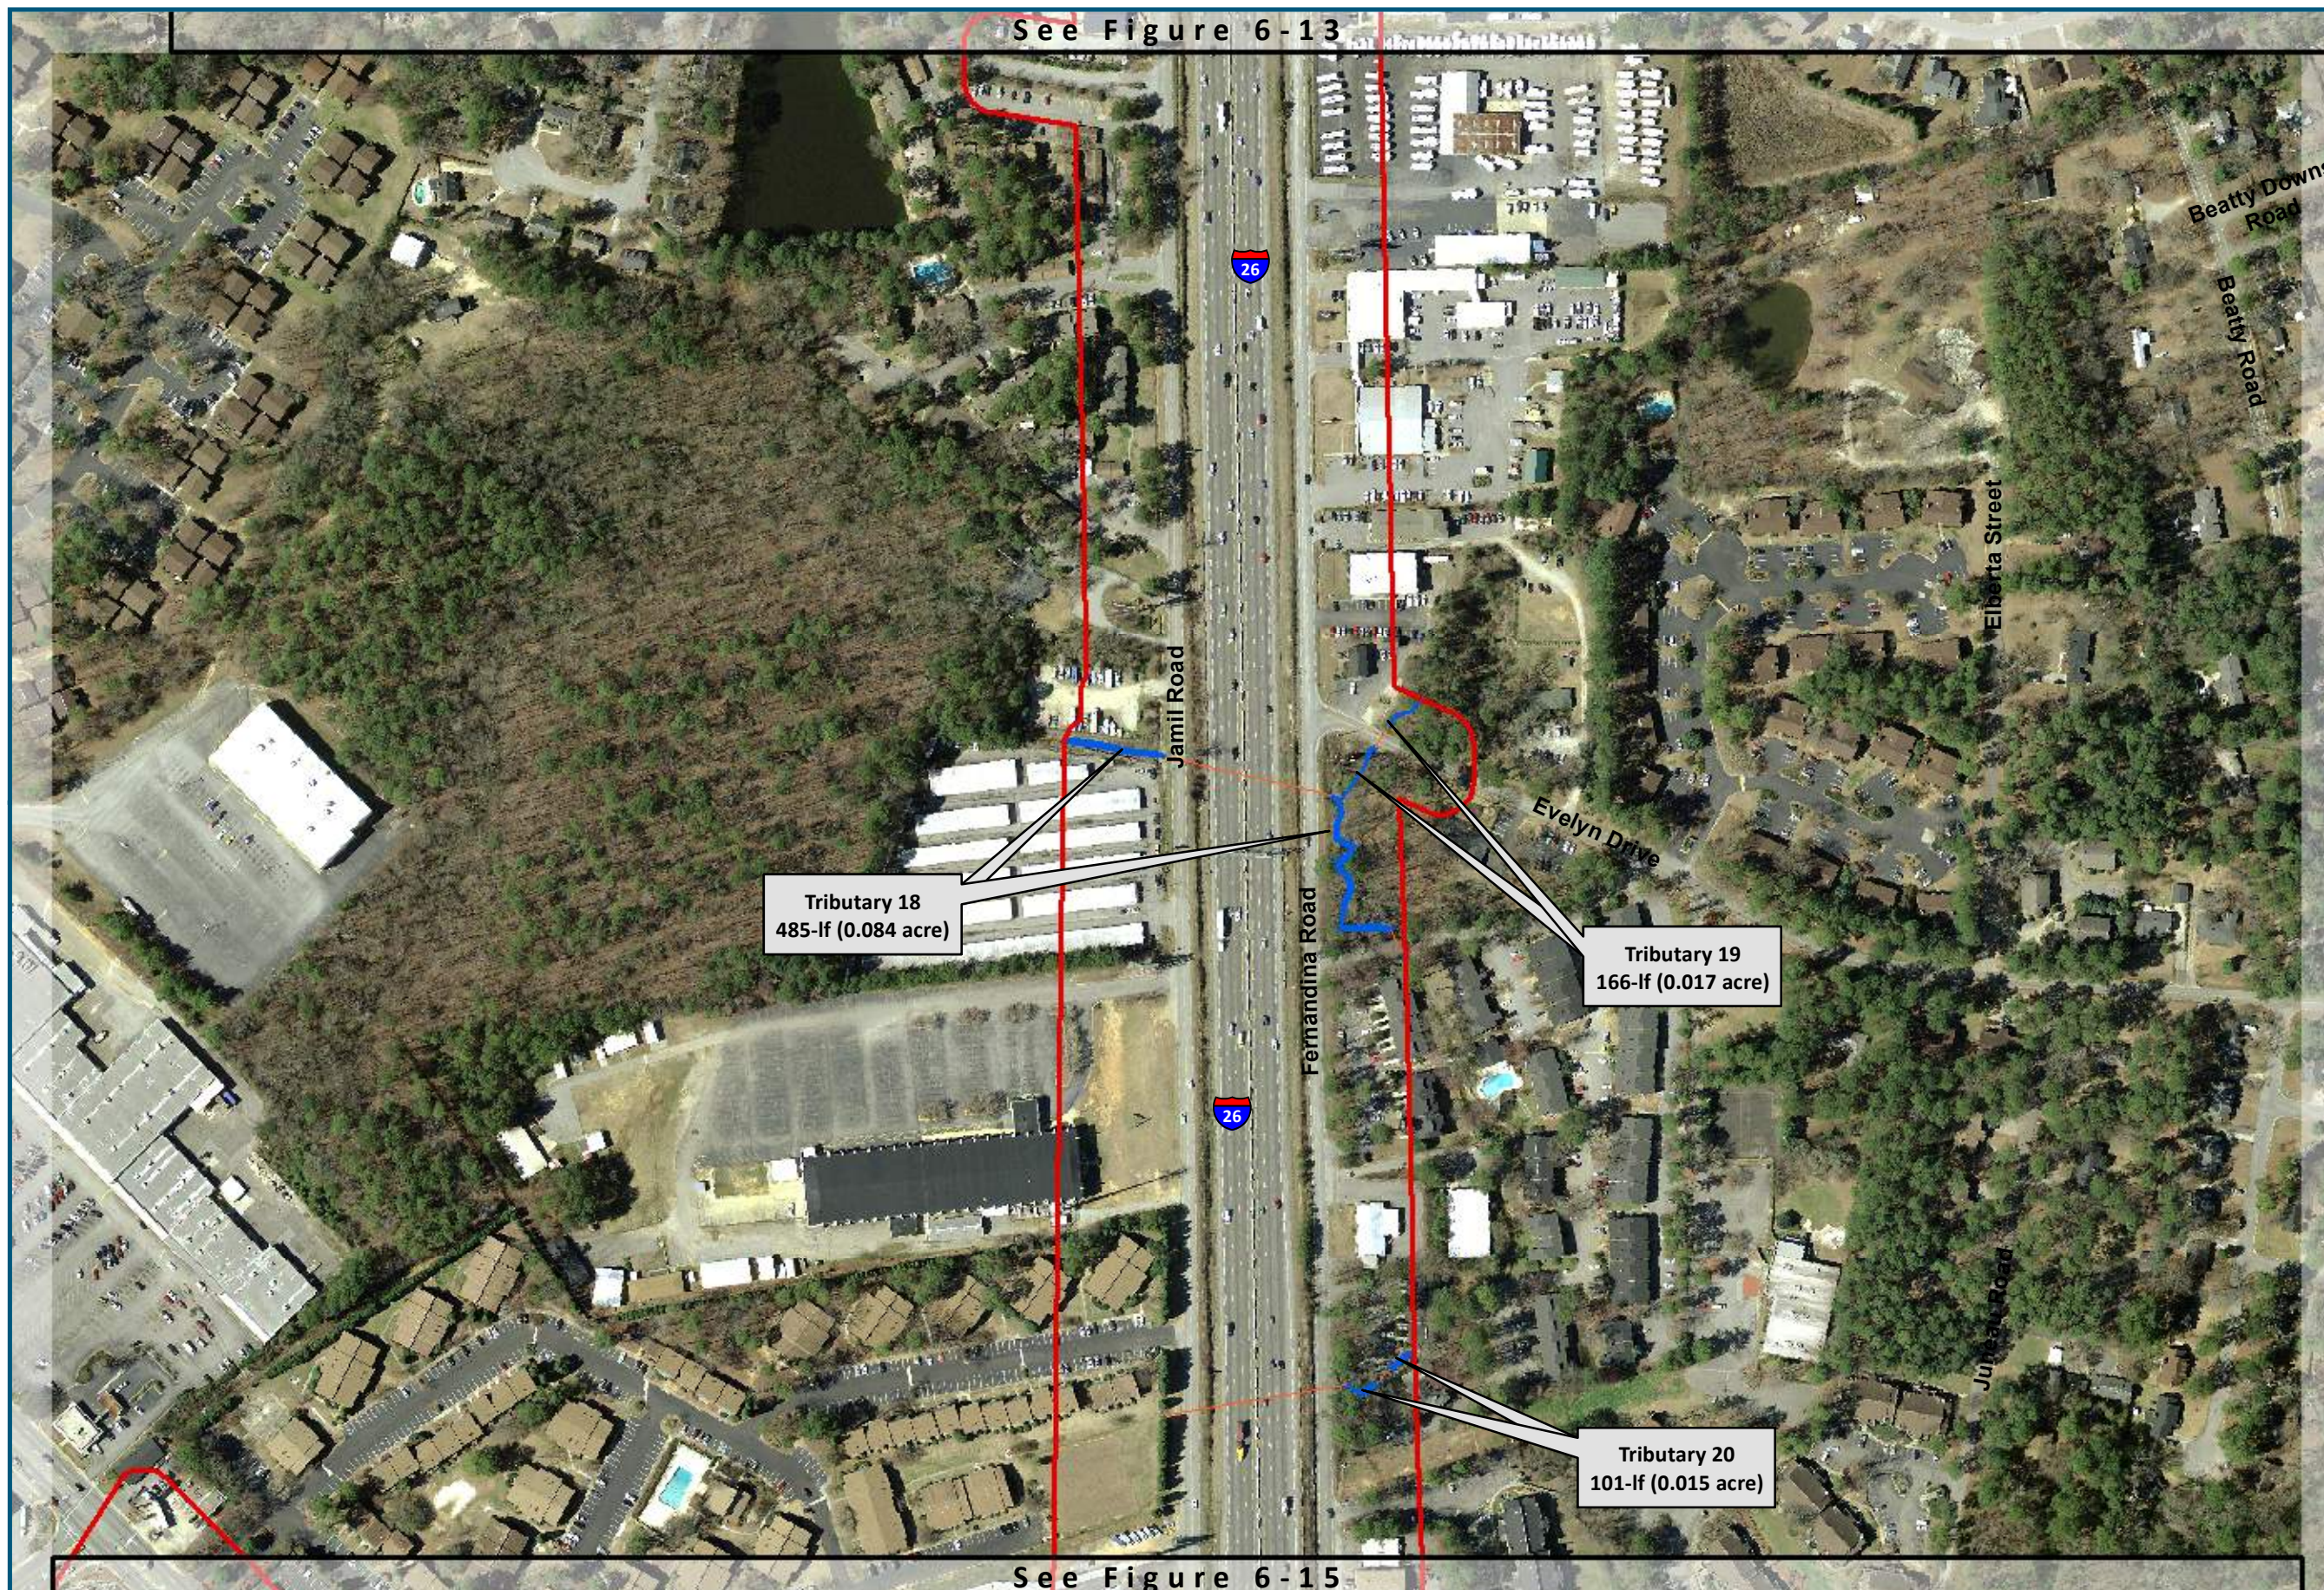
Figure 6-14
Delineated Waters of the U.S.

- Project Study Area (1,482 acres)
- Freshwater Wetland
- Pond / Water
- Tributary (752-lf / 0.116 acre)
- Conveyance / Non-Water
- Culvert / Pipe / Flume
- Exit Location/Number

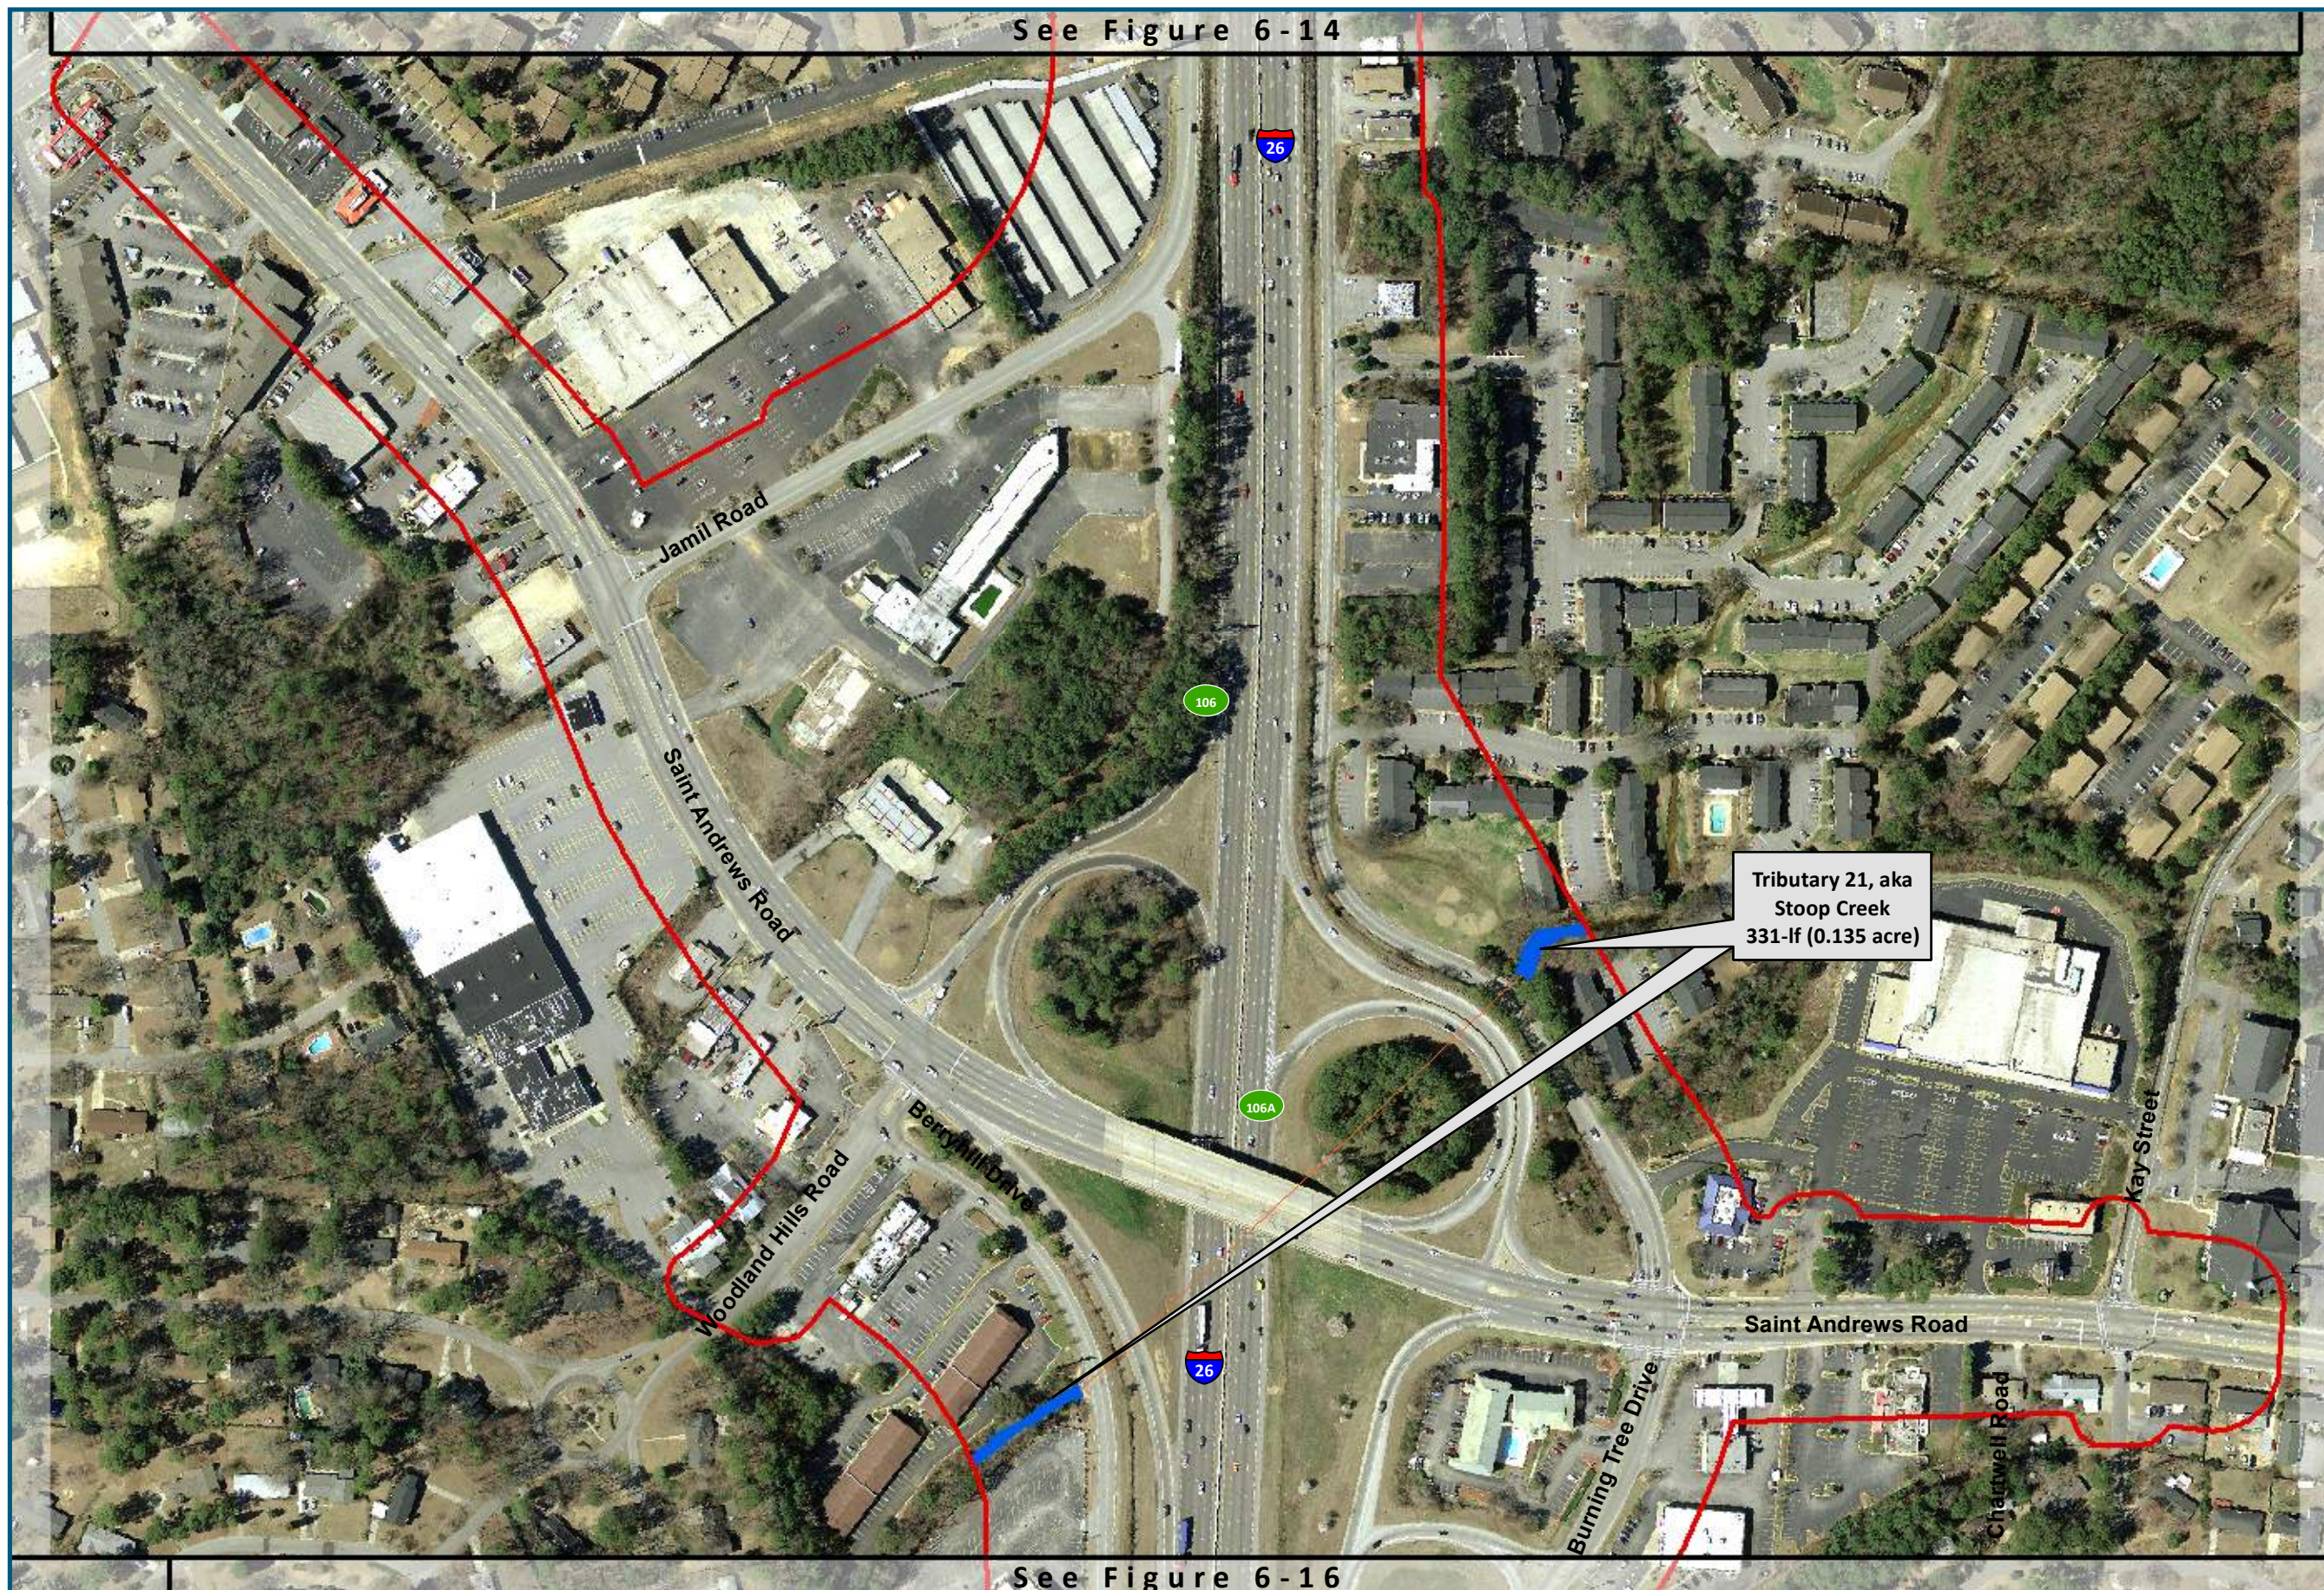
Figure 6-15
Delineated Waters of the U.S.

- Project Study Area (1,482 acres)
- Freshwater Wetland
- Pond / Water
- Tributary (331-lf / 0.135 acre)
- Conveyance / Non-Water
- Culvert / Pipe / Flume
- Exit Location/Number

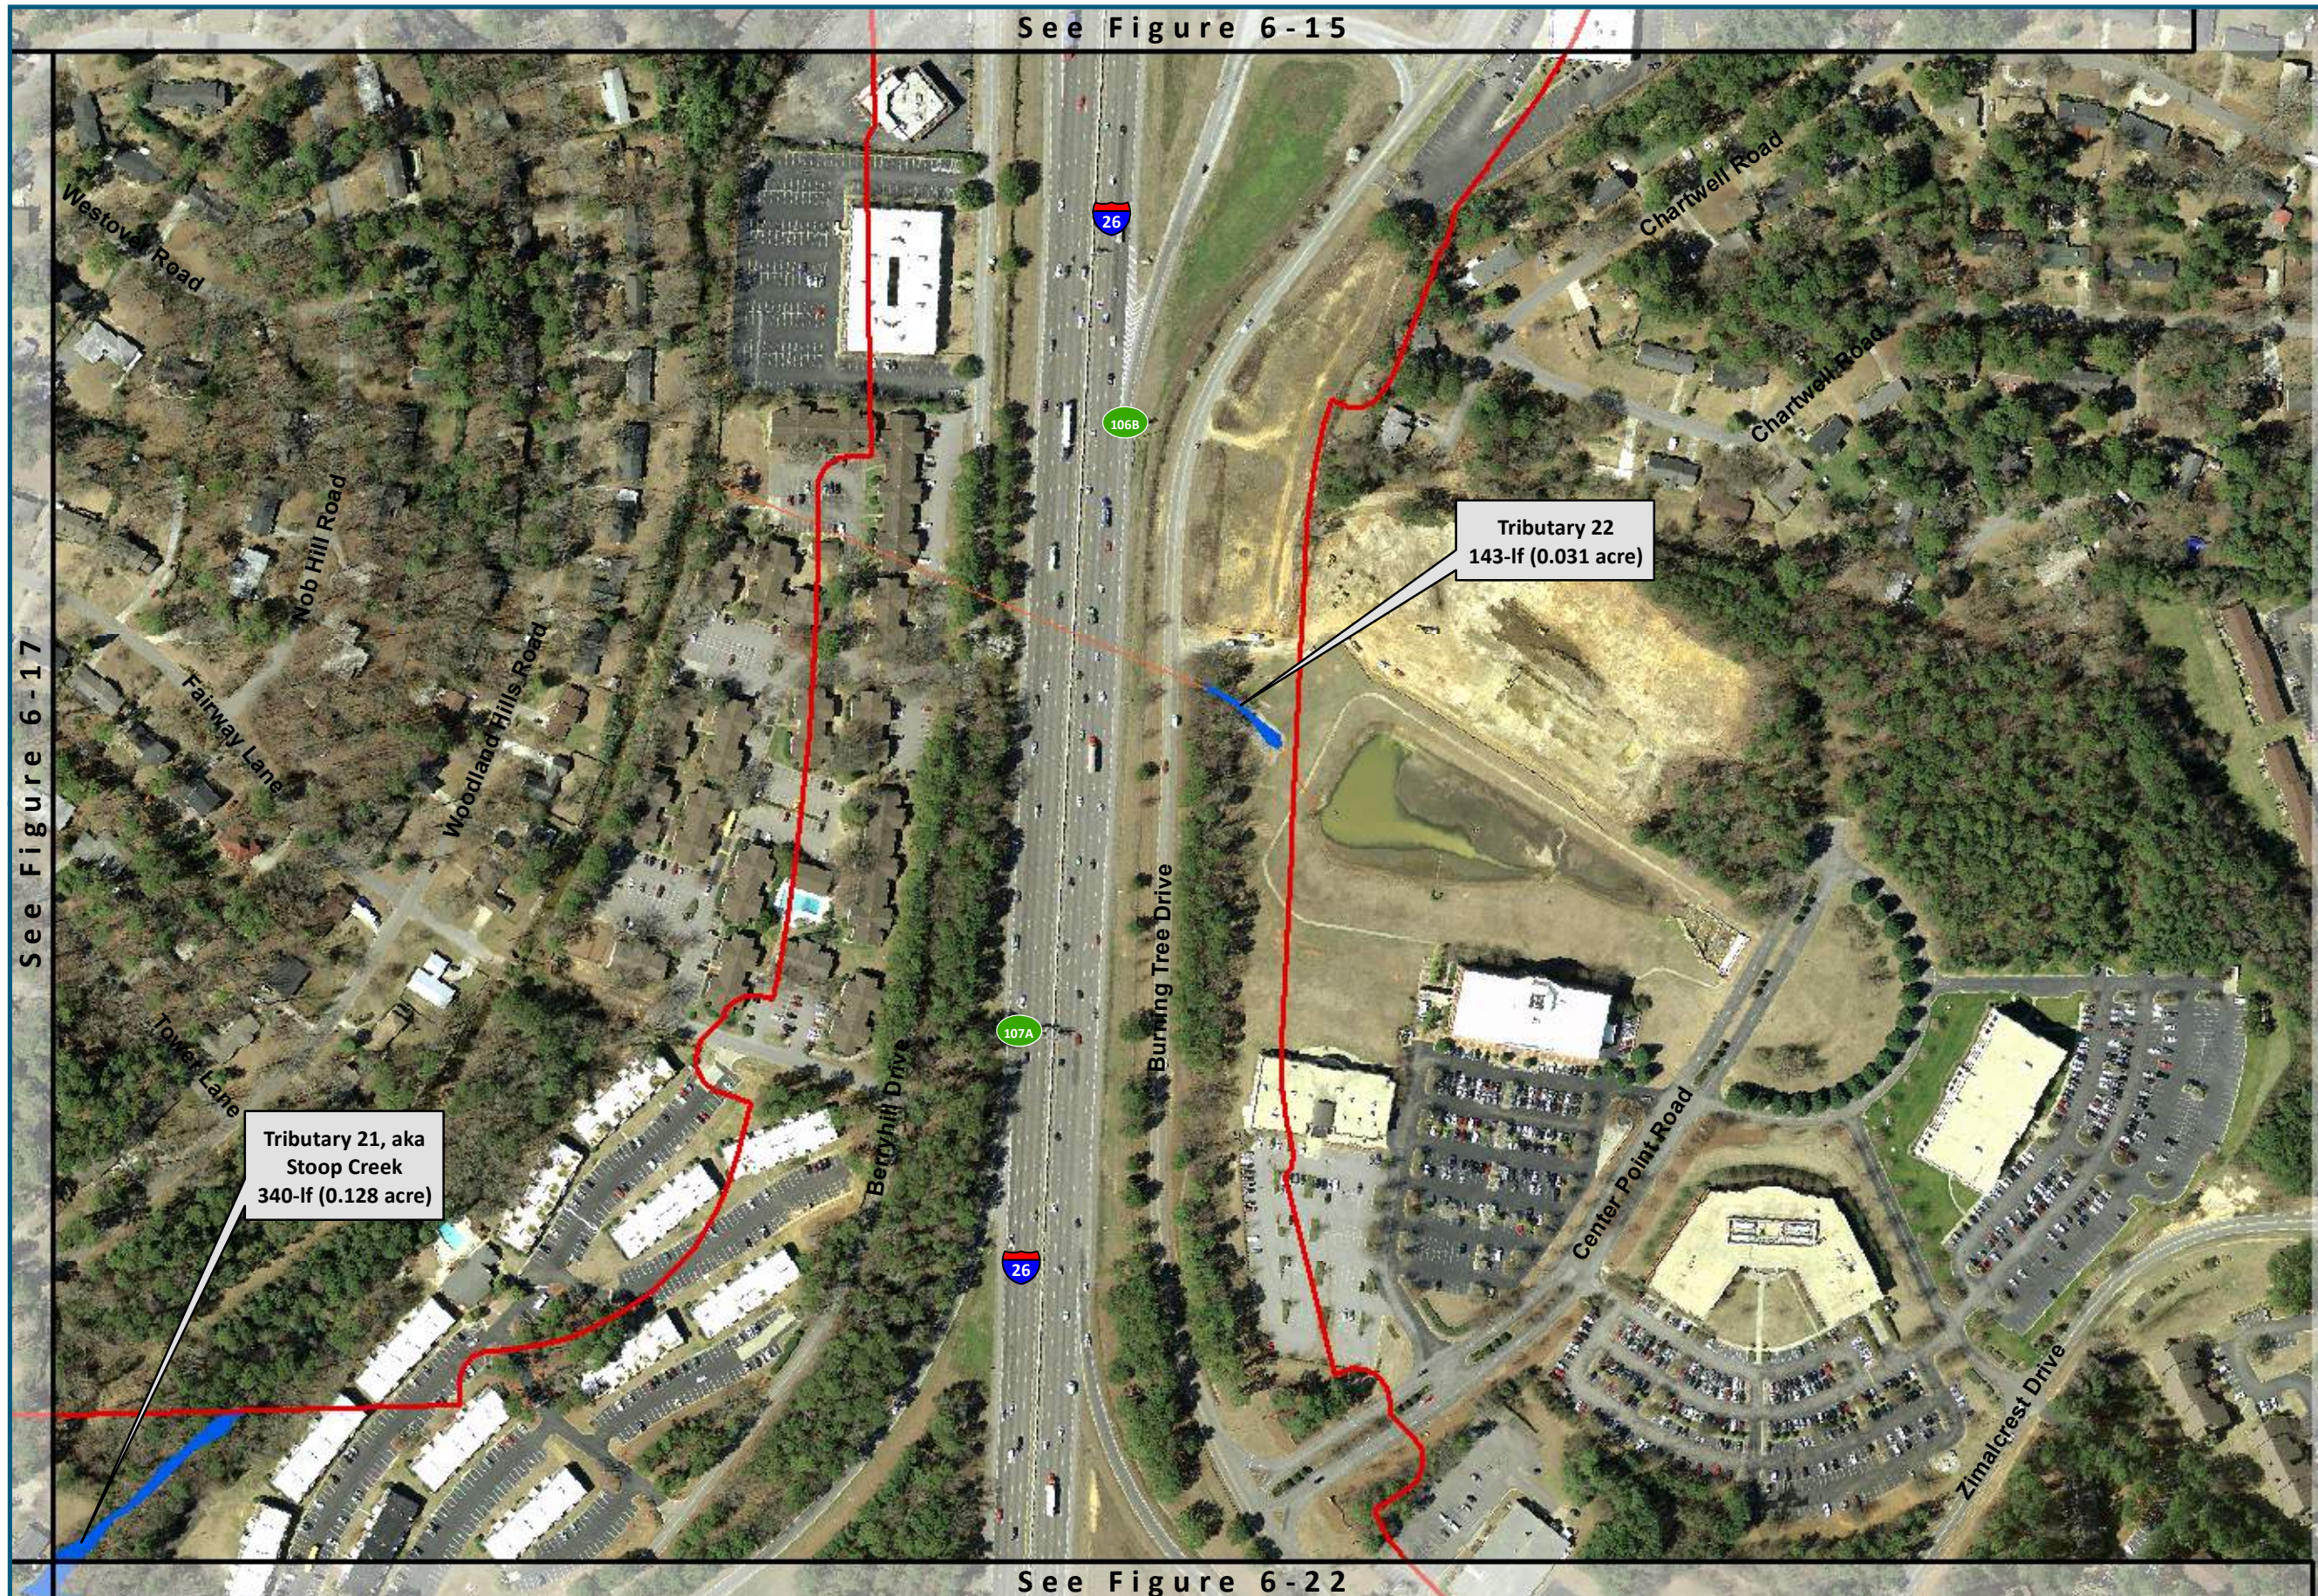
Figure 6-16
Delineated Waters of
the U.S.

- Project Study Area
(1,482 acres)
- Freshwater Wetland
- Pond / Water
- Tributary
(483-lf / 0.159 acre)
- Conveyance / Non-Water
- Culvert / Pipe / Flume
- 83 Exit Location/Number

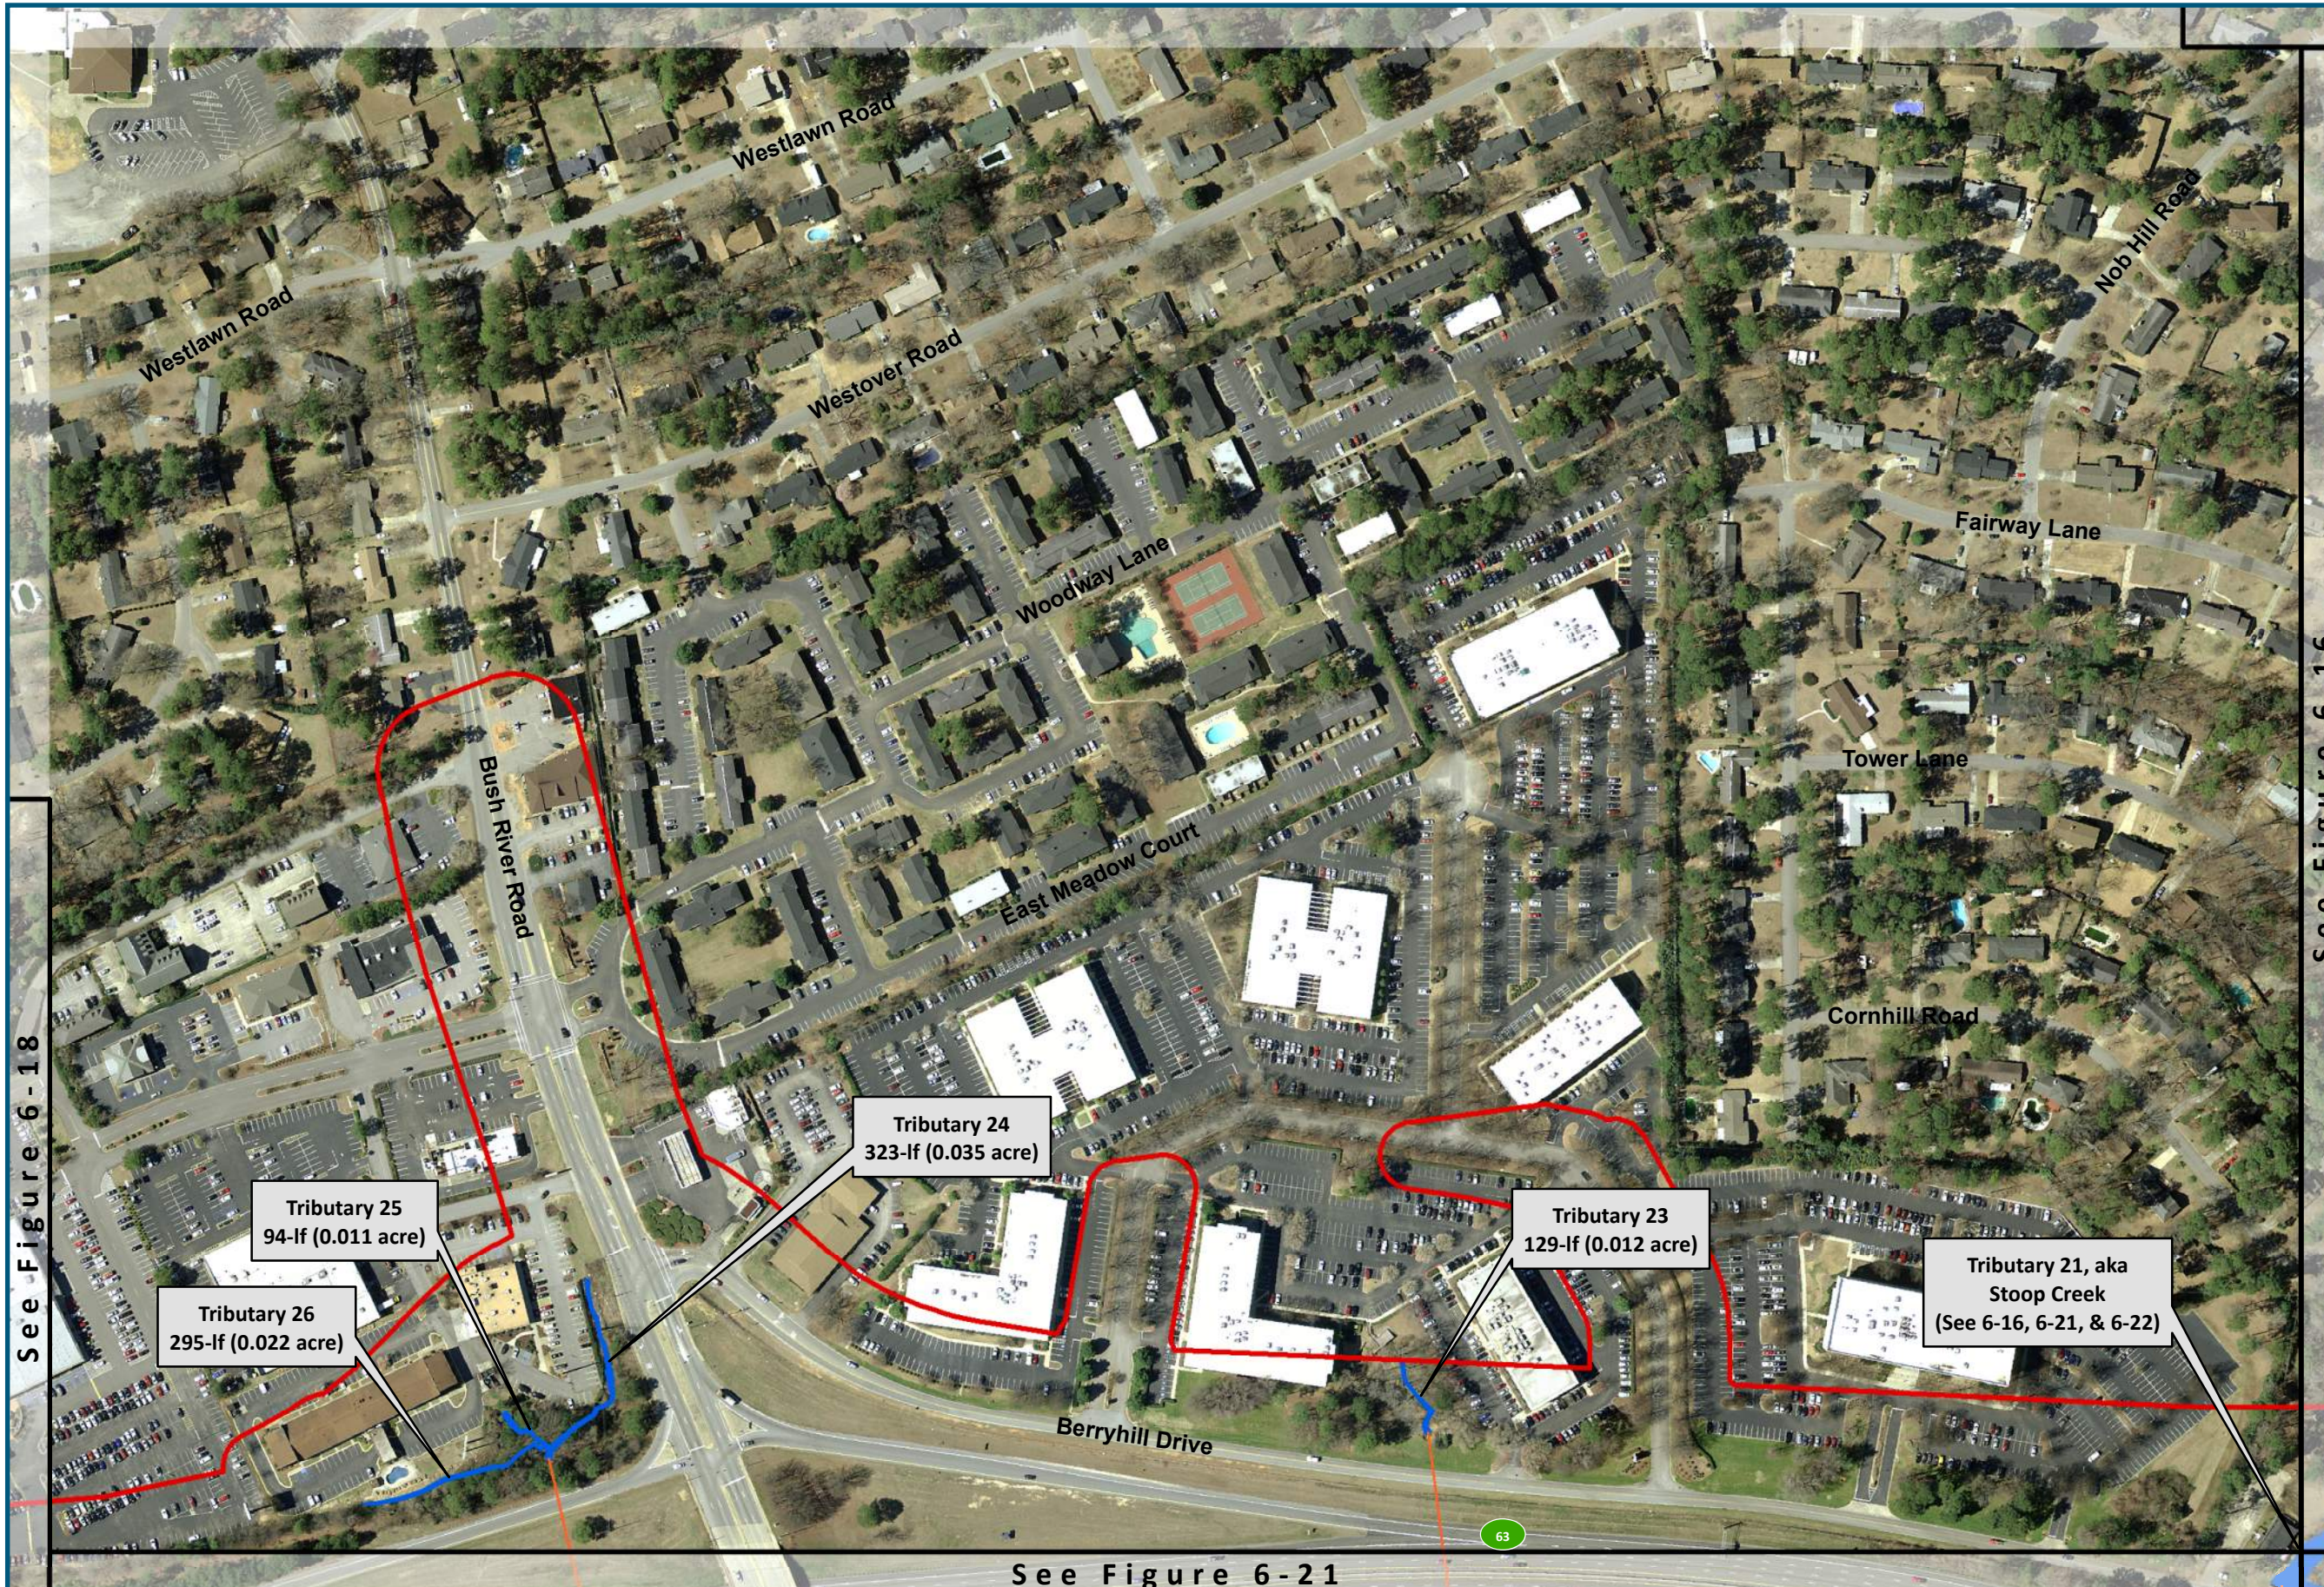
Figure 6-17
Delineated Waters of the U.S.

- Project Study Area (1,482 acres)
- Freshwater Wetland
- Pond / Water
- Tributary (841-lf / 0.080 acre)
- Conveyance / Non-Water
- Culvert / Pipe / Flume
- Exit Location/Number

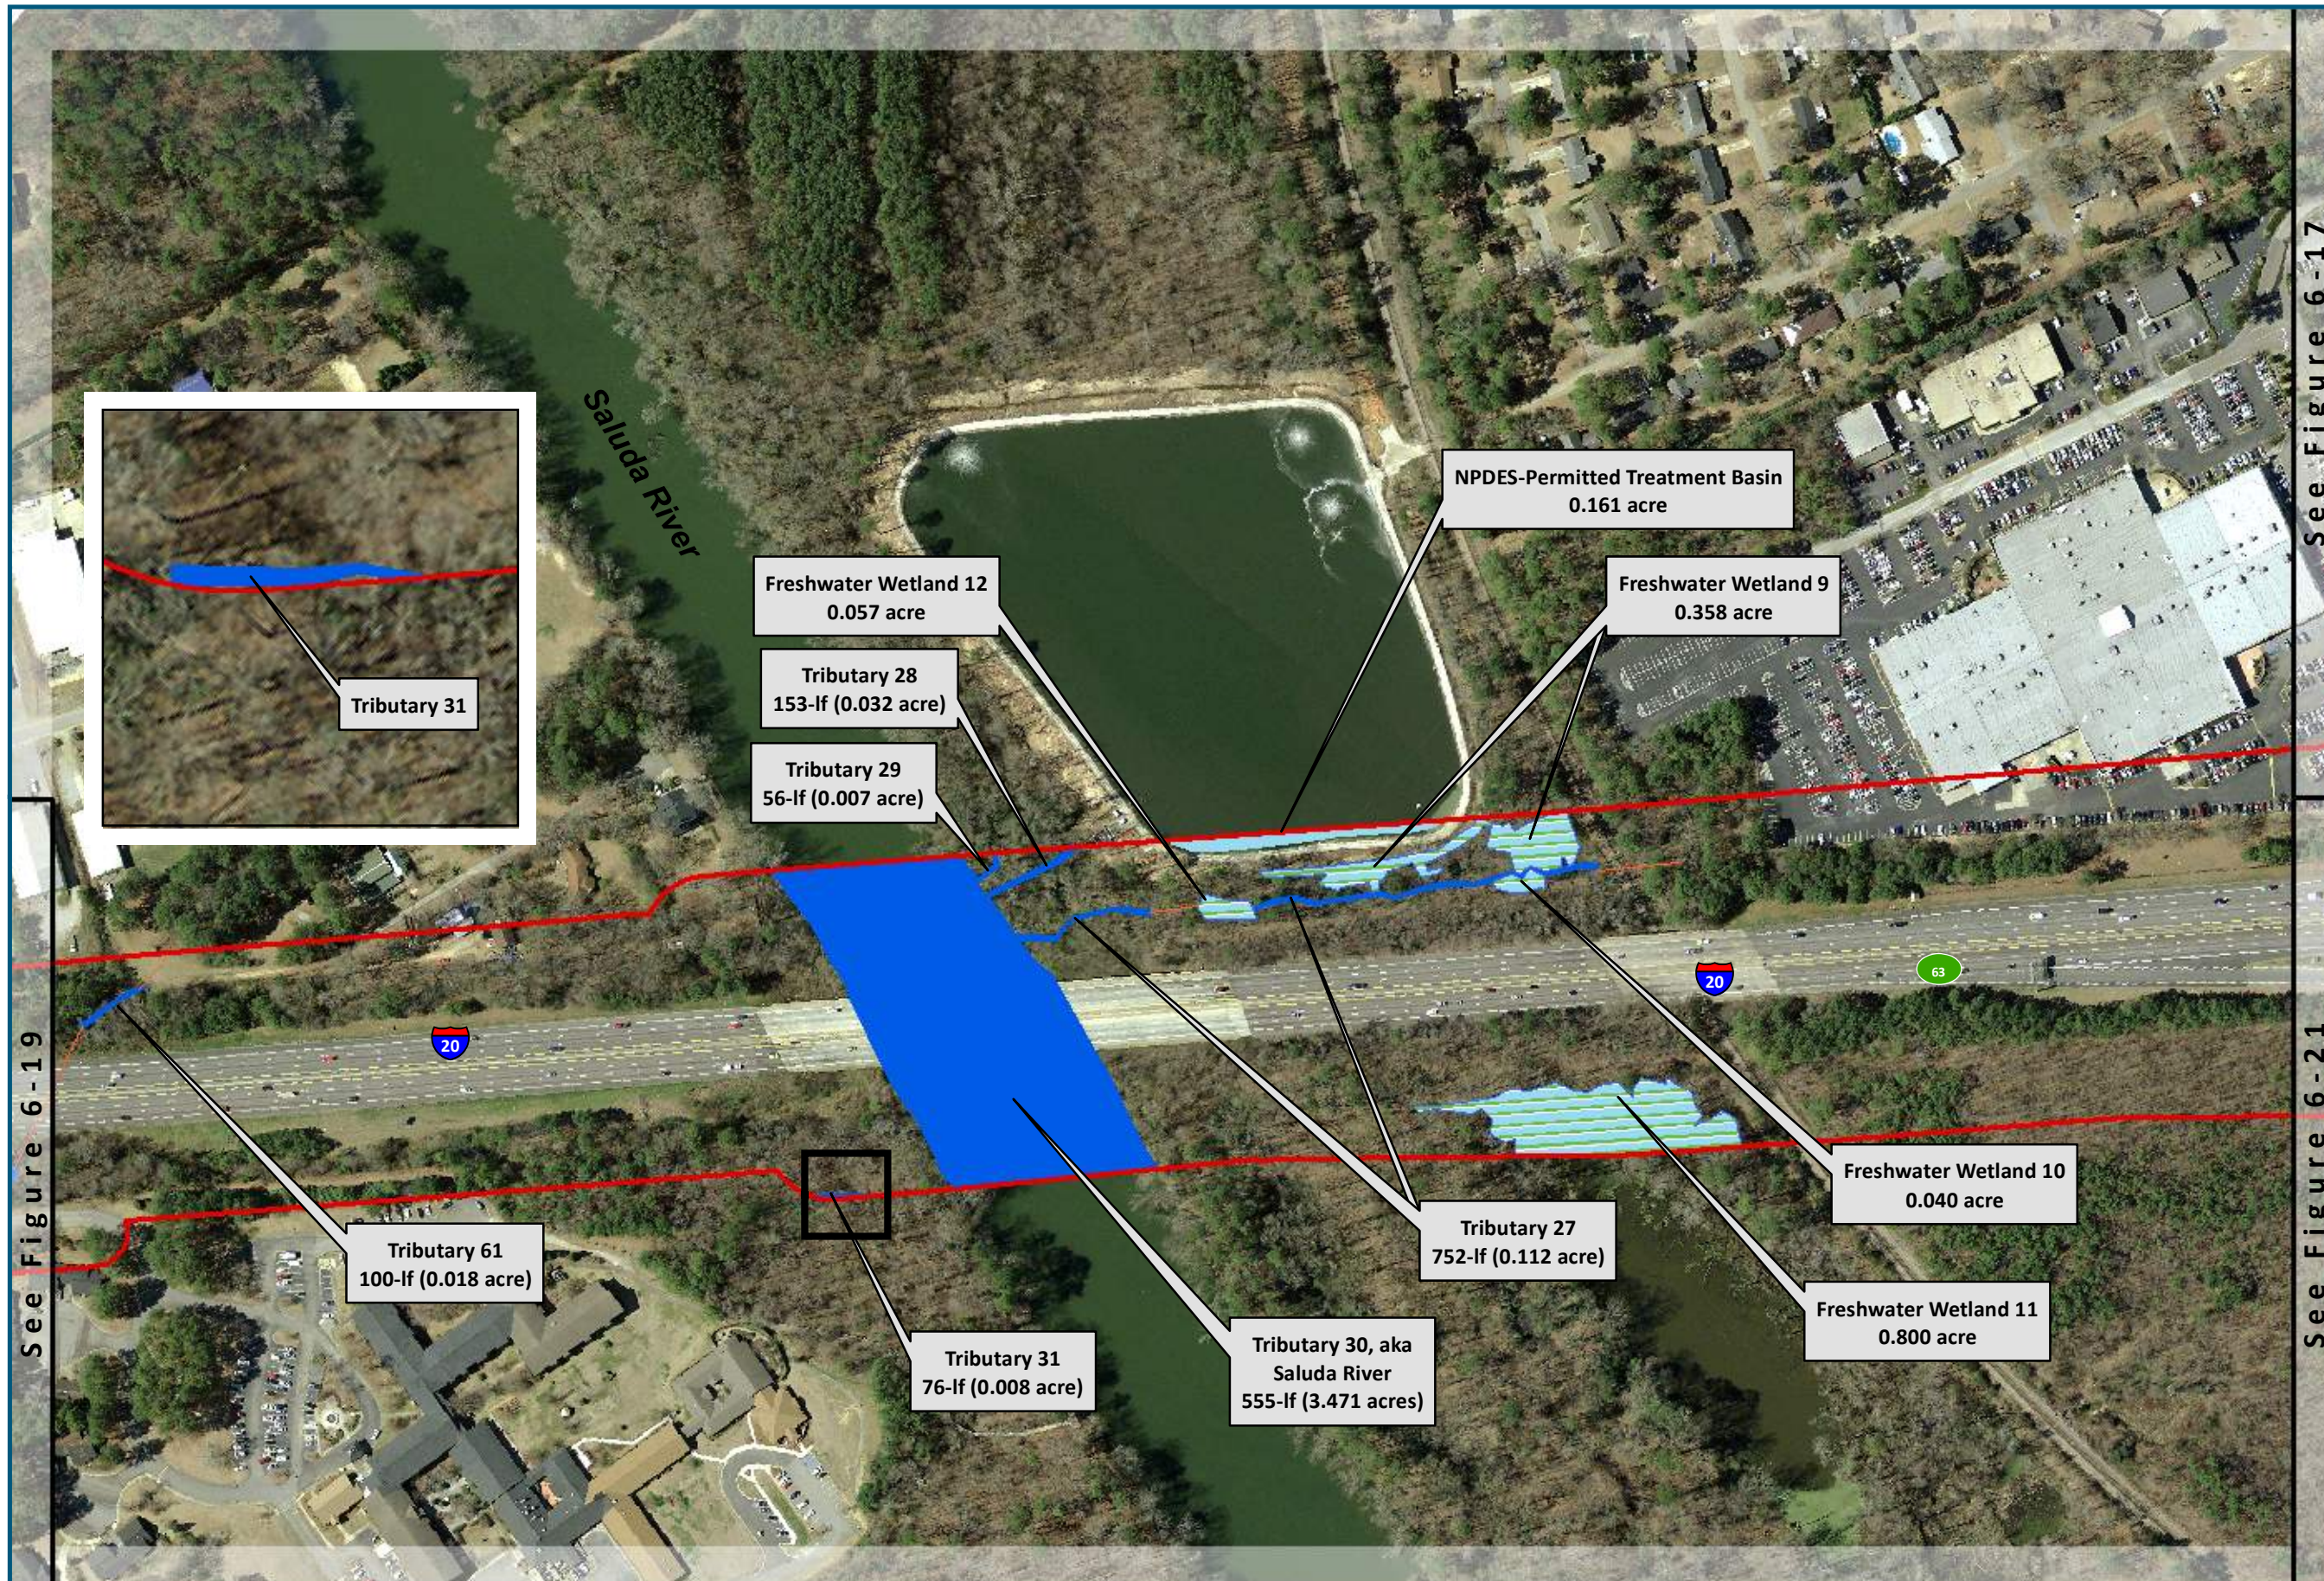
Figure 6-18
Delineated Waters of
the U.S.

- Project Study Area
(1,482 acres)
- Freshwater Wetland
(1,255 acres)
- Pond / Water
(0.161 acre)
- Tributary
(1,692-lf / 3.648 acres)
- Conveyance / Non-Water
- Culvert / Pipe / Flume
- Exit Location/Number
