Natural Resources Technical Report

Carolina Crossroads

I-20/I-26/I-126 Corridor Improvements

Final (Revised) May 2019

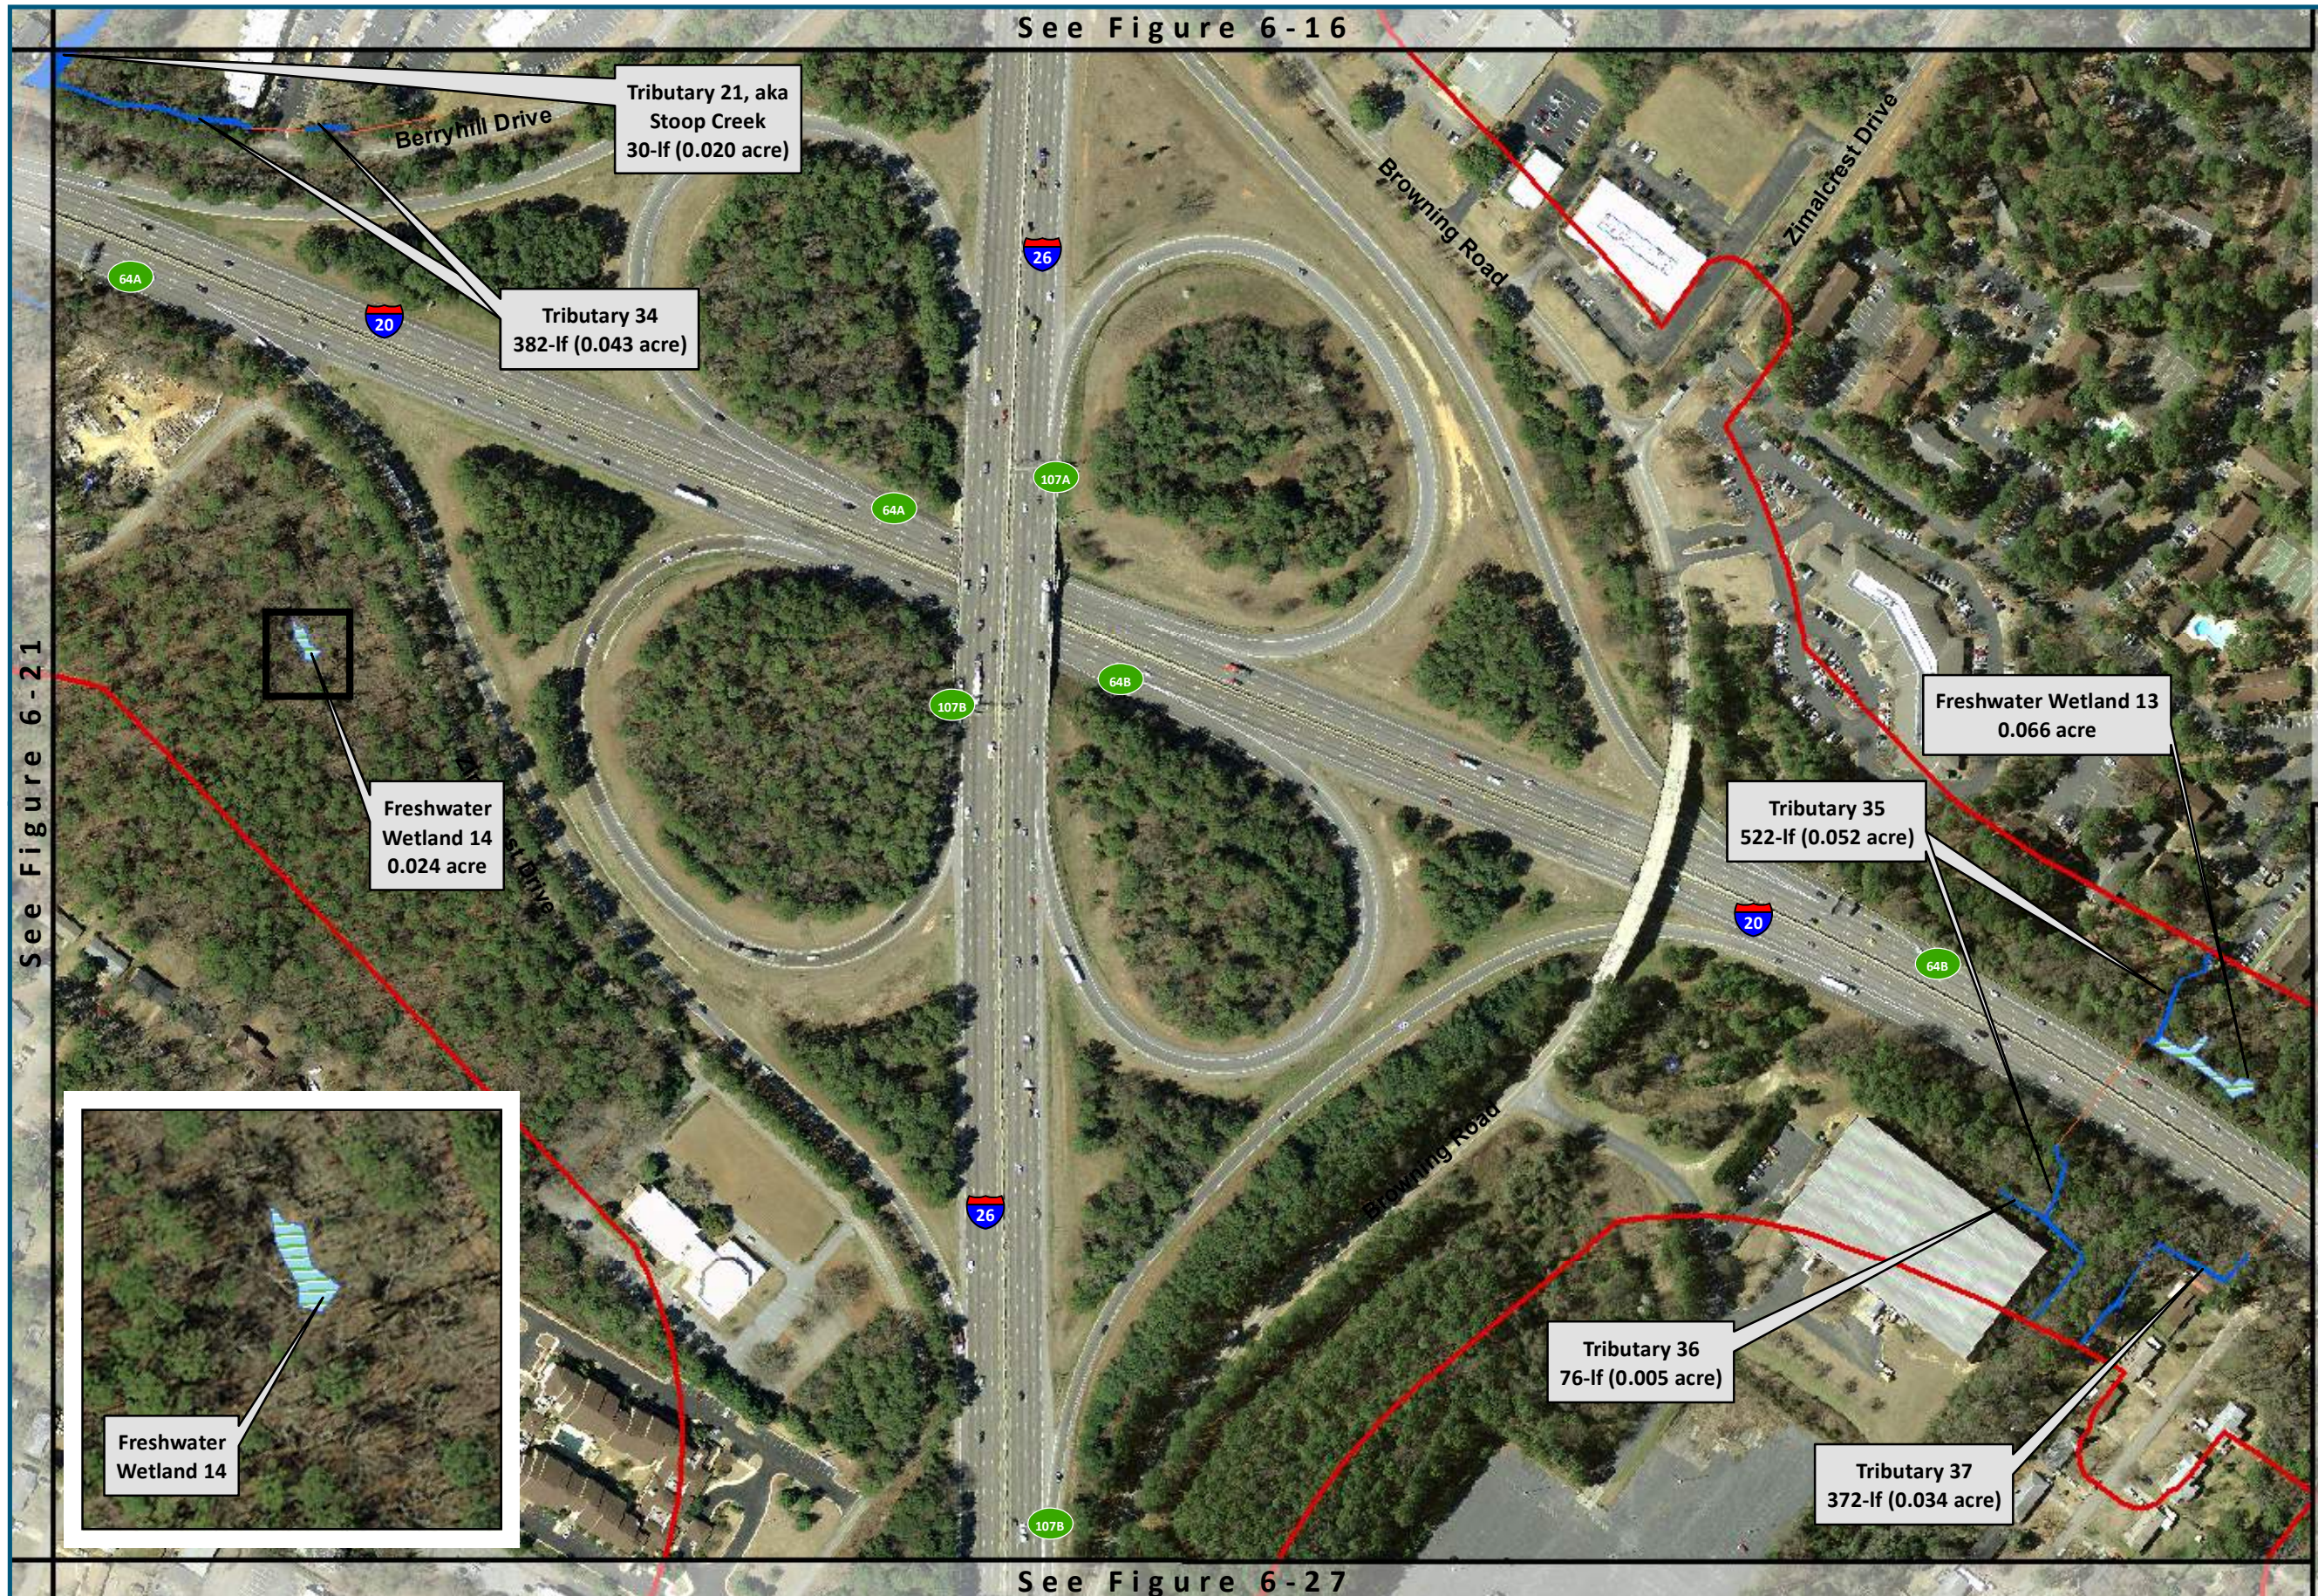
- Legend**
- Project Study Area (1,482 acres)
 - Freshwater Wetland (0.090 acre)
 - Pond / Water
 - Tributary (1.382-lf / 0.154 acre)
 - Conveyance / Non-Water
 - Culvert / Pipe / Flume
 - Exit Location/Number

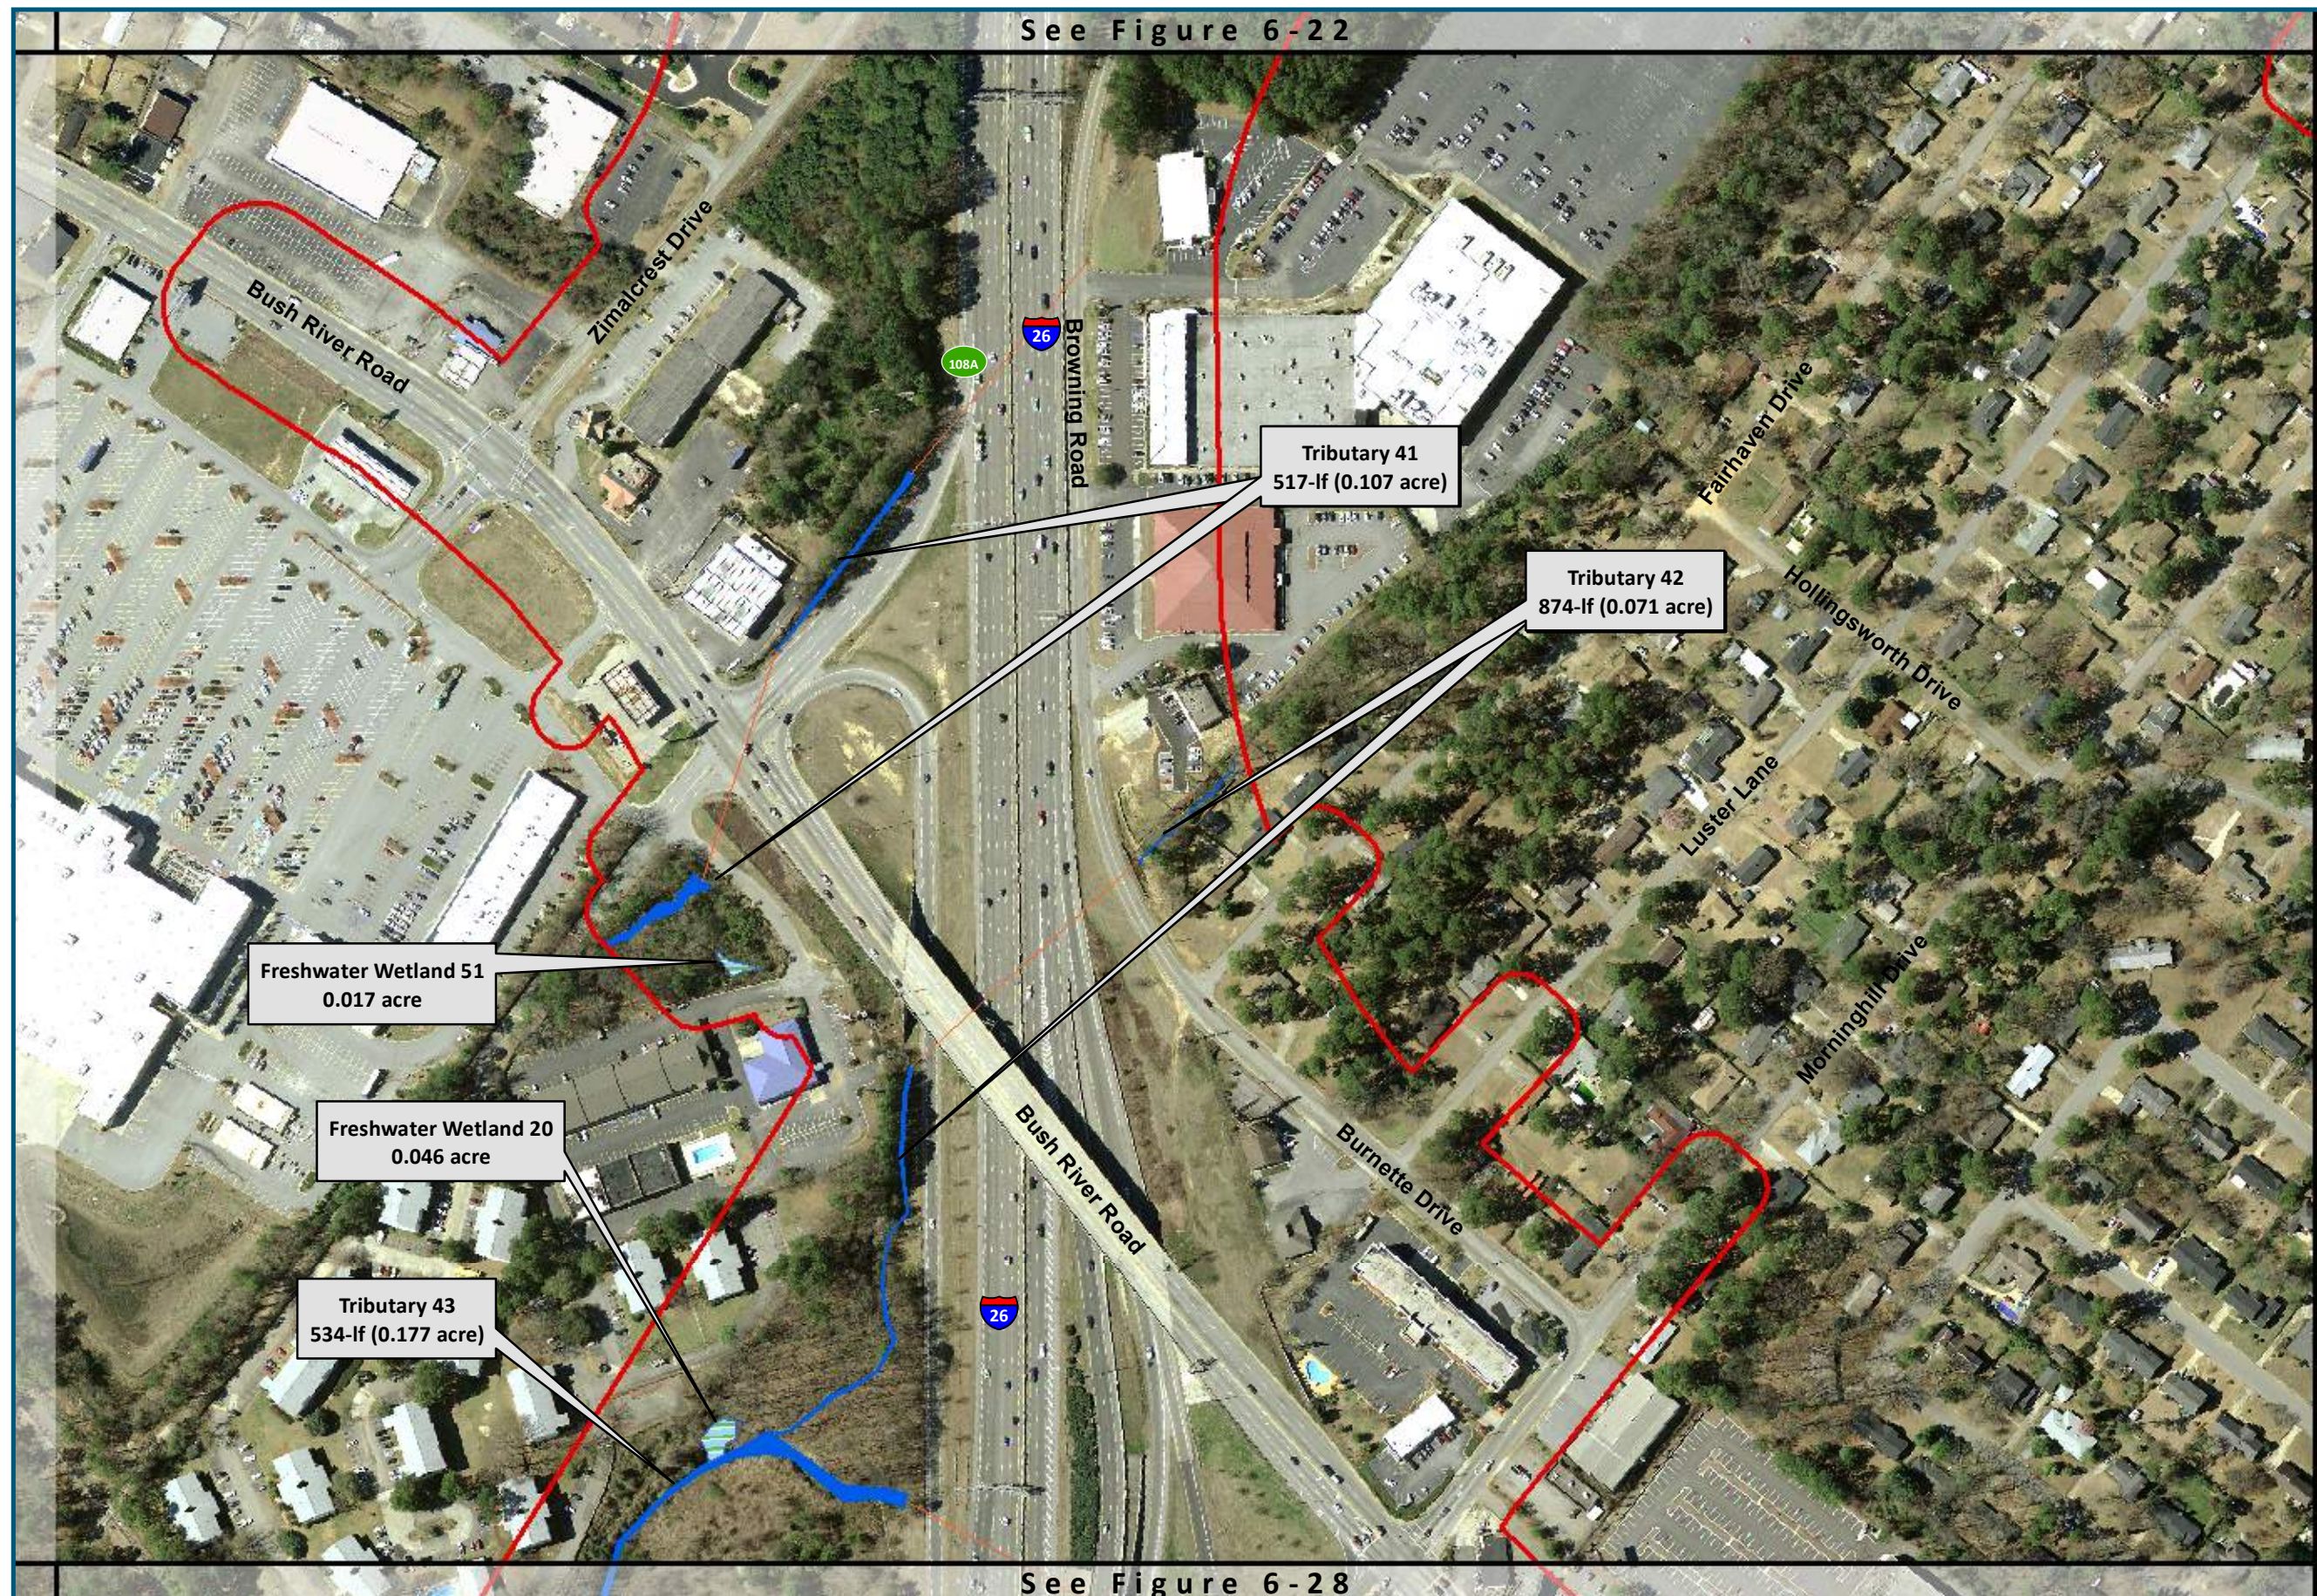
Figure 6-27
Delineated Waters of
the U.S.

- Project Study Area (1,482 acres)
- Freshwater Wetland (0.063 acre)
- Pond / Water
- Tributary (1,925-lf / 0.355 acre)
- Conveyance / Non-Water
- Culvert / Pipe / Flume
- Exit Location/Number

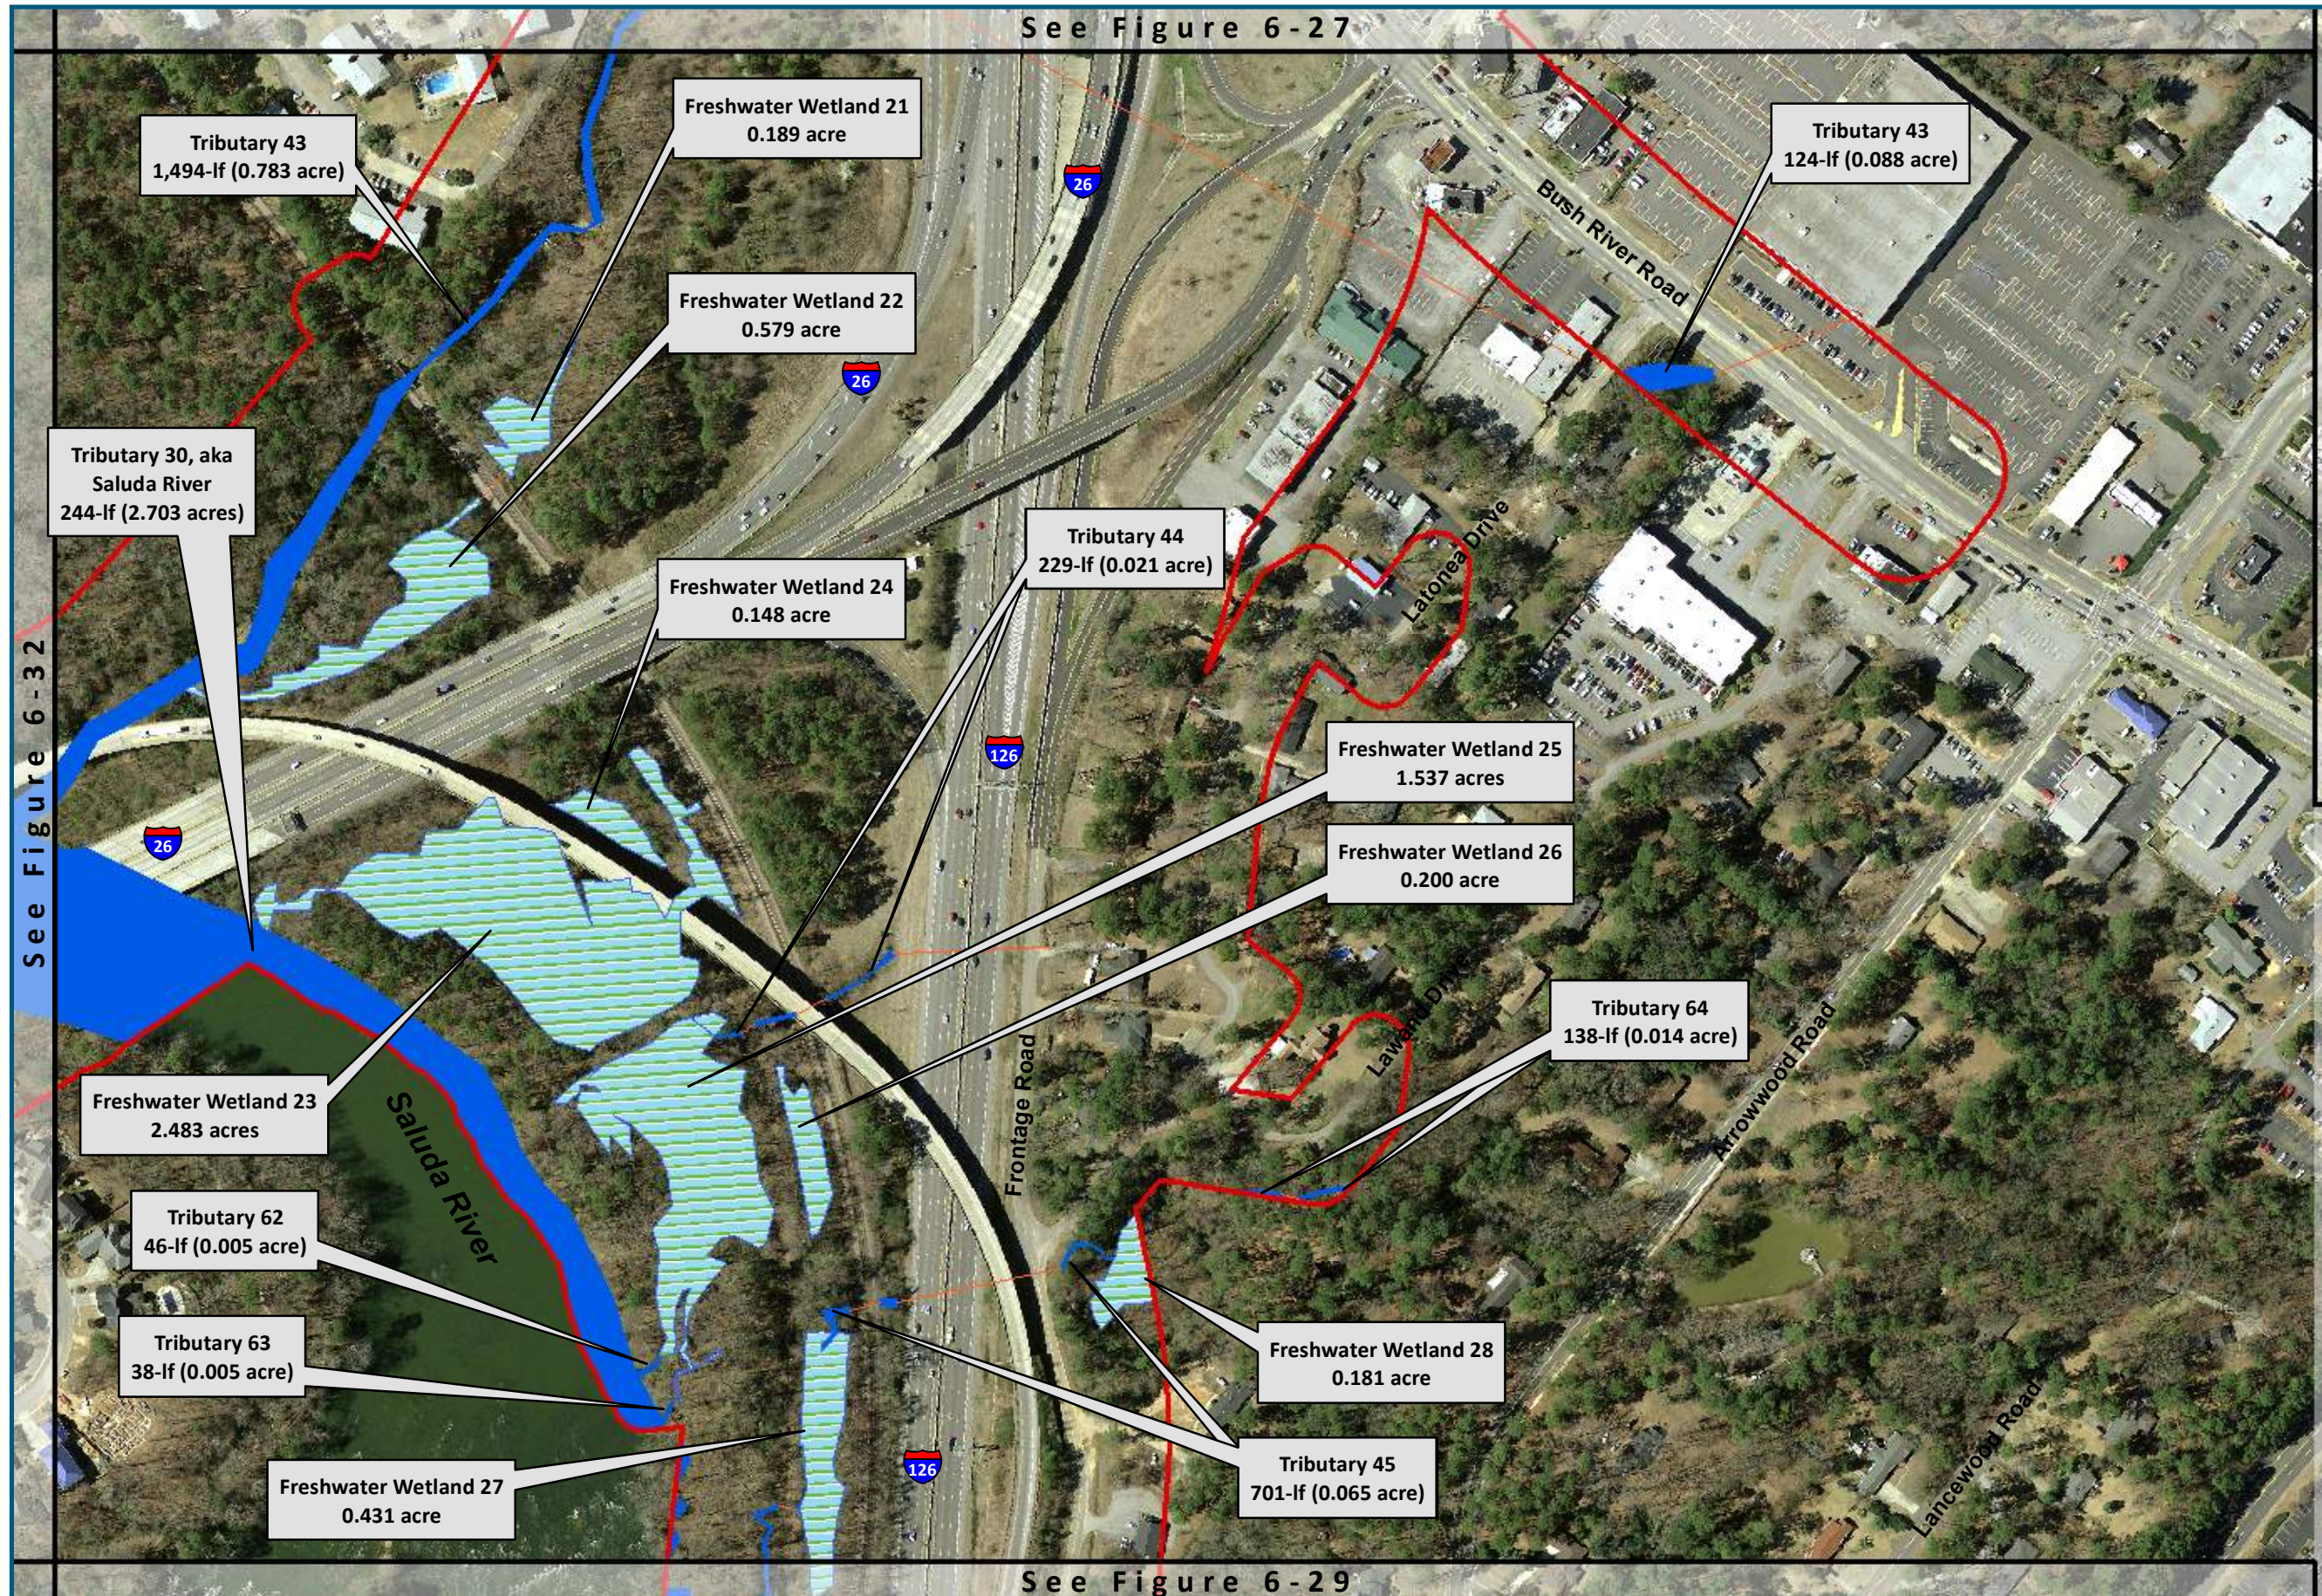
Figure 6-28
Delineated Waters of
the U.S.

- Legend**
- Project Study Area
(1,482 acres)
 - Freshwater Wetland
(5.748 acres)
 - Pond / Water
 - Tributary
(3,014-lf / 3.684 acres)
 - Conveyance / Non-Water
 - Culvert / Pipe / Flume
 - 83 Exit Location/Number

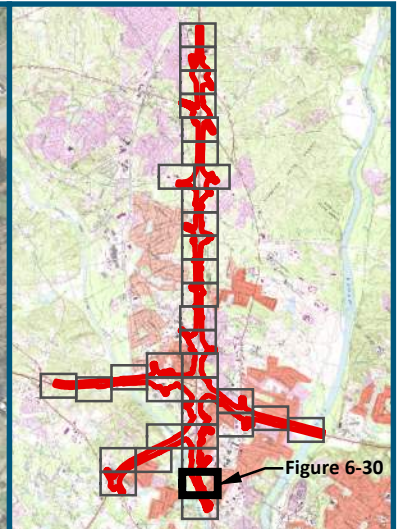
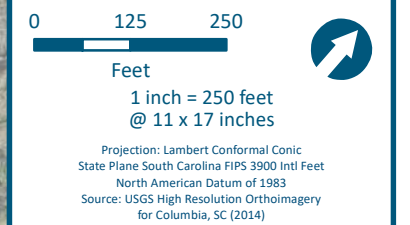
Figure 6-29
Delineated Waters of the U.S.
11/15/2018 Sheet 29 of 35

Freshwater Wetland 31
0.038 acre

Tributary 65
205-lf (0.041 acre)

Tributary 66
60-lf (0.004 acre)

Freshwater Wetland 55
0.015 acre

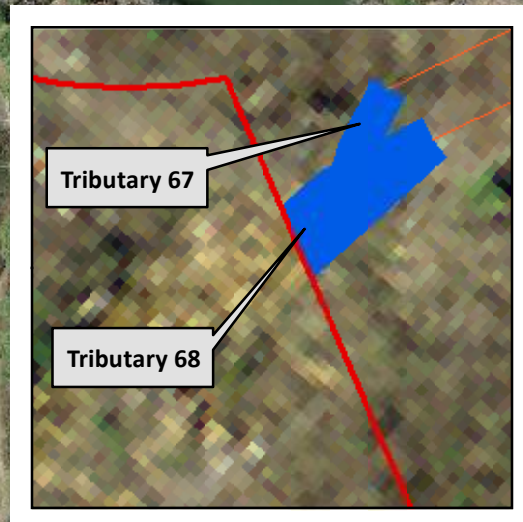
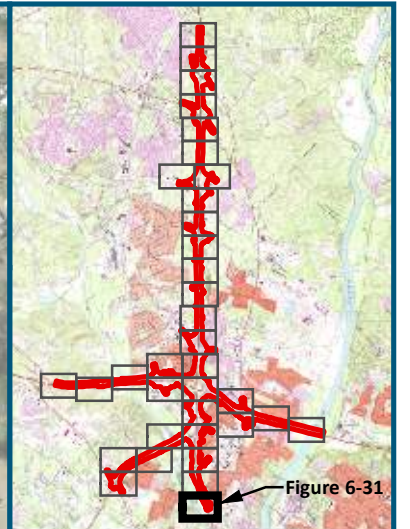
Figure 6-30
Delineated Waters of
the U.S.

Tributary 67
8-lf (0.001 acre)

Tributary 68
19-lf (0.003 acre)

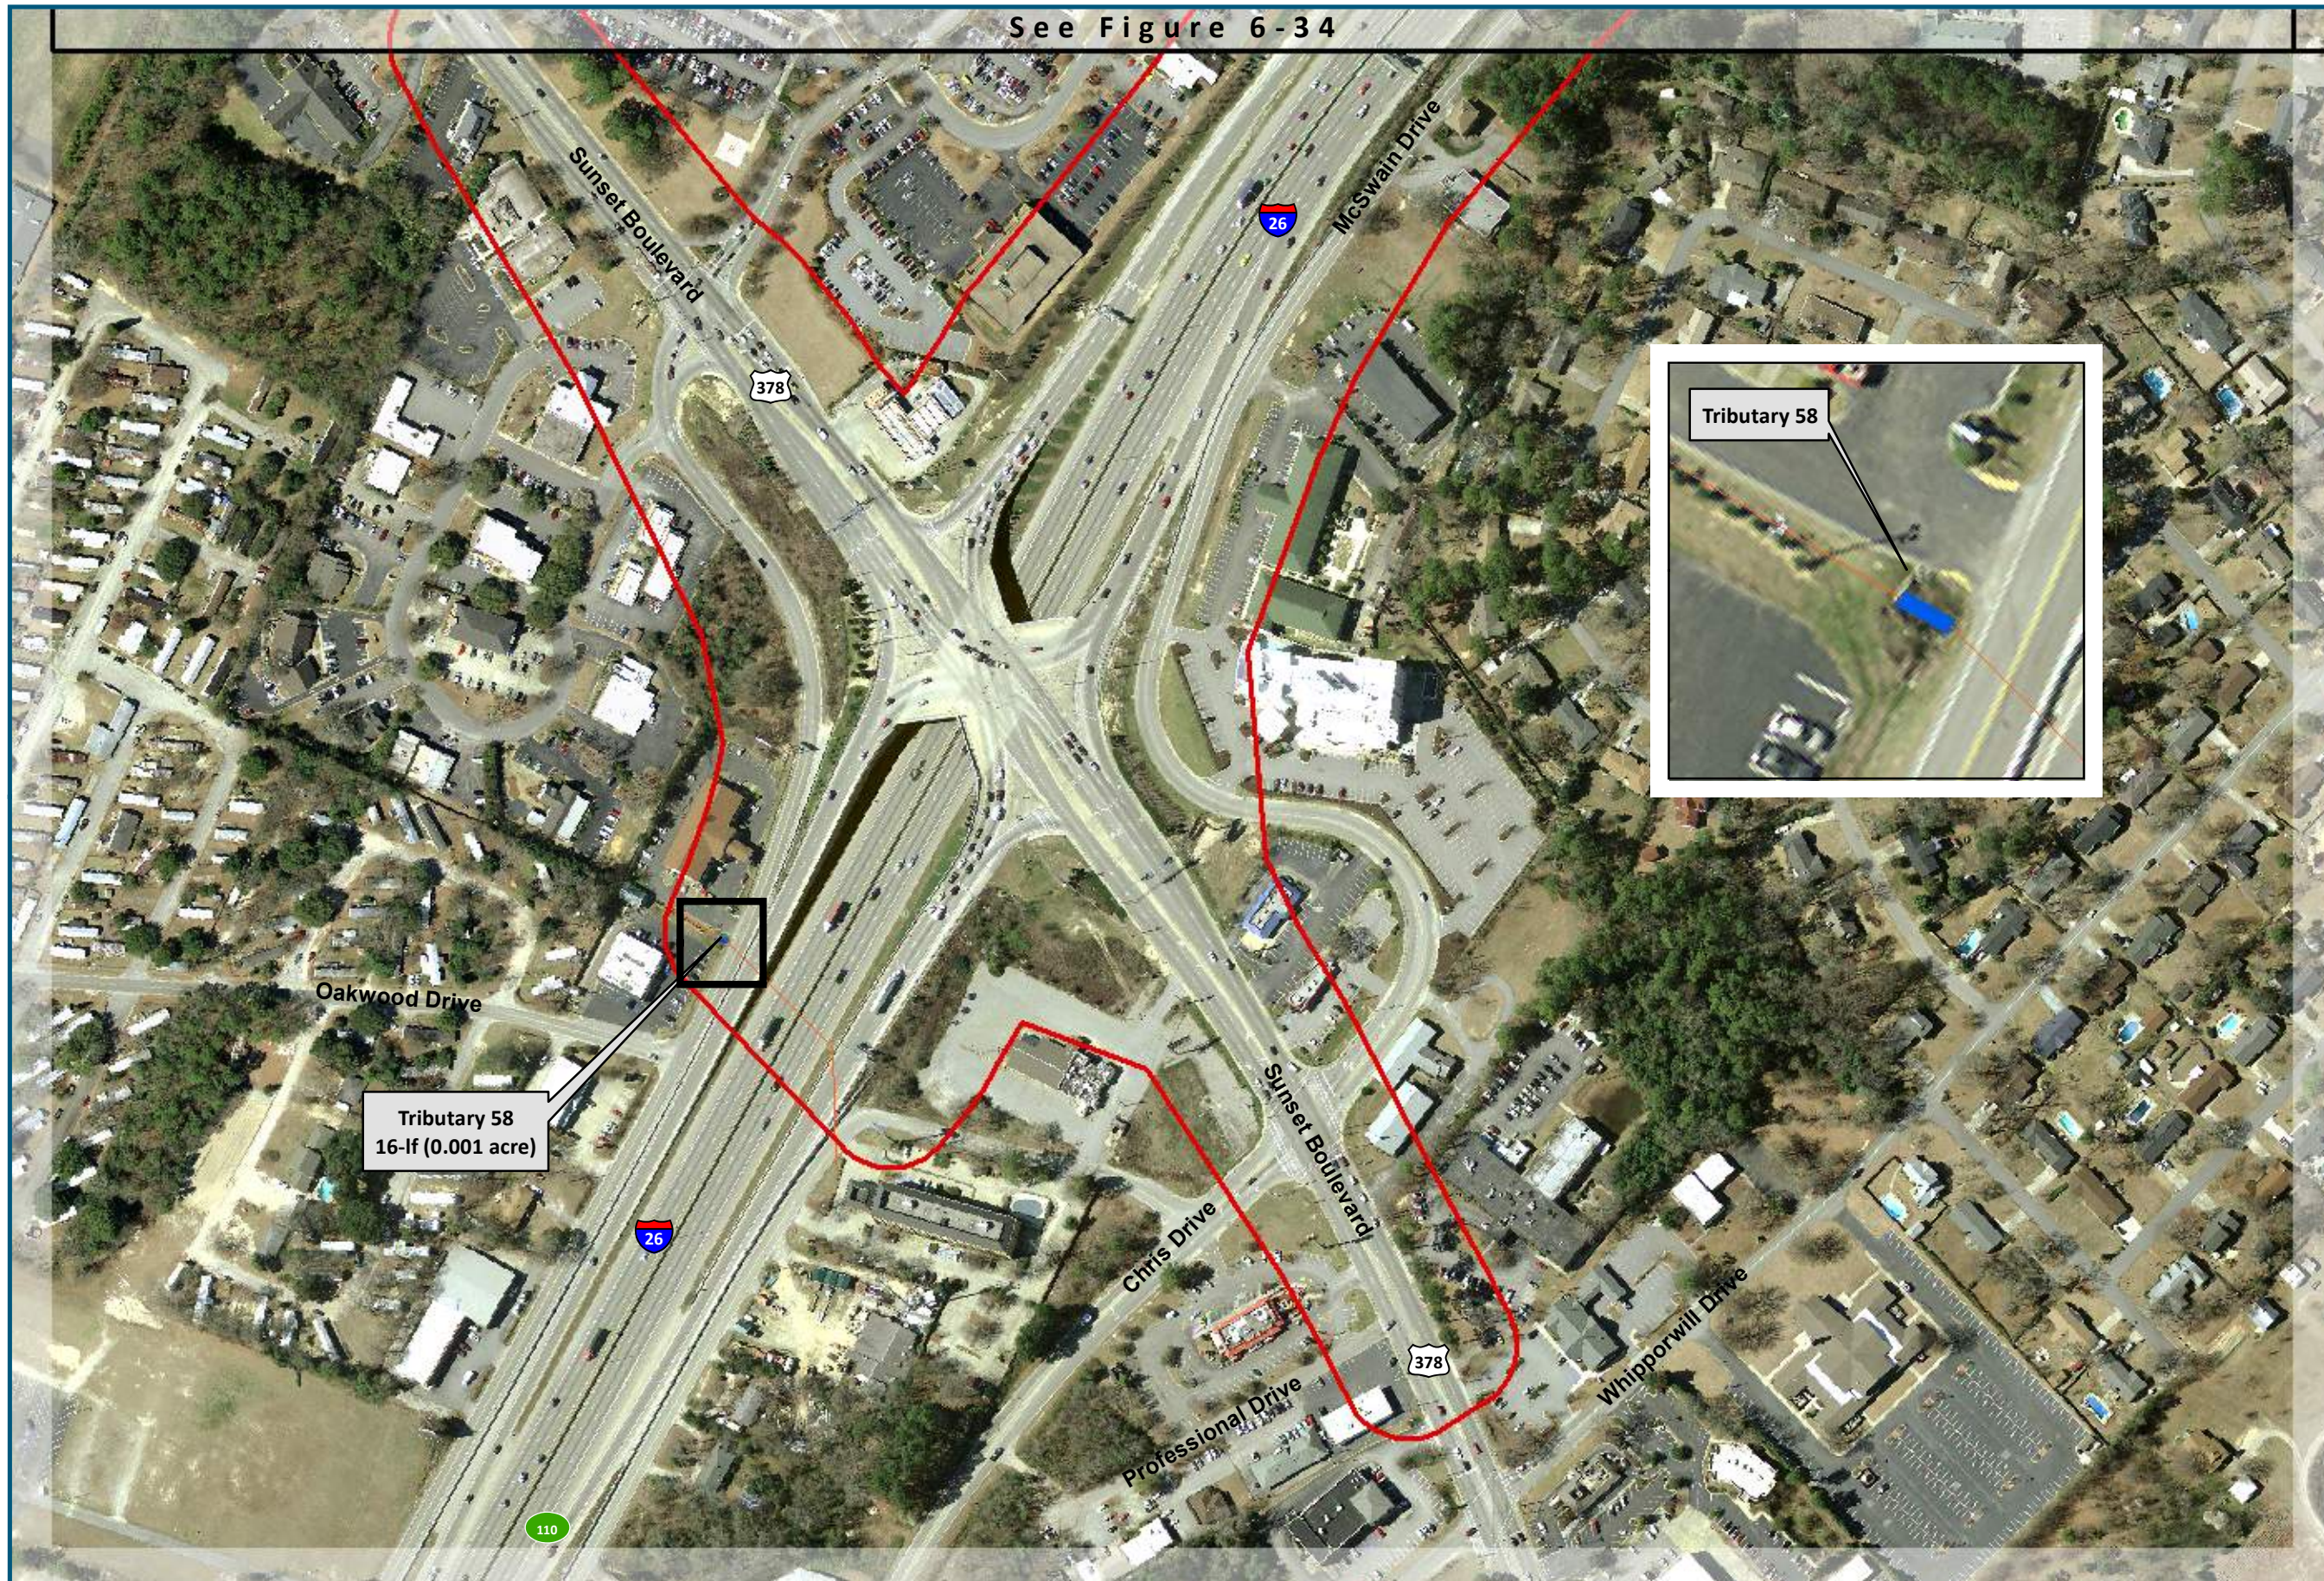
Figure 6-35
Delineated Waters of the U.S.

- Legend**
- Project Study Area (1,482 acres)
 - Freshwater Wetland
 - Pond / Water
 - Tributary (16-lf / 0.001 acre)
 - Conveyance / Non-Water
 - Culvert / Pipe / Flume
 - 83 Exit Location/Number
